Service Bulletin

Bulletin No.: 21-NA-006

Subject: Diagnostic Tip to Diagnose Emission Reduction Fluid Tank Electrical Connector Inspection, Reduced Power Message, Service Emissions System, System Displayed on the Drivers Information Center (DIC) Malfunction Indicator Lamp (MIL) Illuminated - DTC P02C1, P21DD, P221C, P10D9, P10F3, P143C, P20B9, and/or P221E

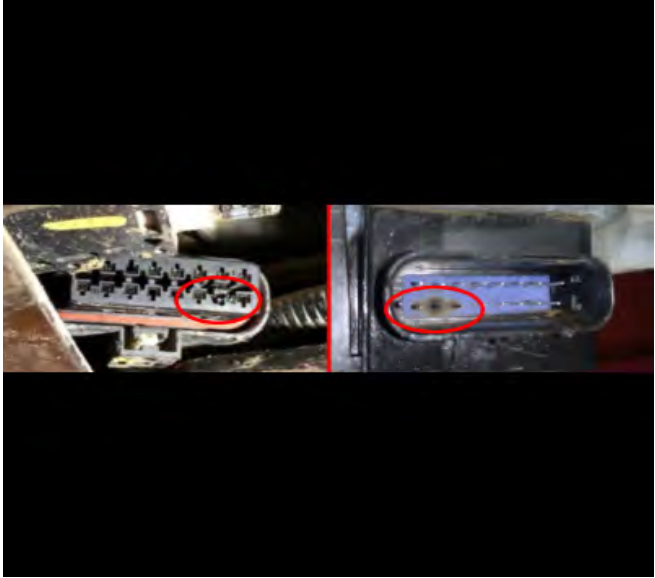
Cause	This condition may be caused by a poor connection at the Emission Reduction Fluid Tank electrical connector.

<p style="text-align: right;">5708899</p> <p>Inspect the Emission Reduction Fluid Tank electrical connector for any signs of damage and repair as necessary. If this condition is not found, refer to normal SI diagnostics</p>
-------------------	------------------------------------------------------------------------------------------------------------------------------------------------------------------------------------------------------------------------------------------------------------------------------------------------------------------------
