# Service Bulletin

Bulletin No.: 21-NA-007

**Subject: Diagnostic Tip to Diagnose Emission Reduction Fluid Tank Electrical Connector Inspection, Reduced Power Message, Service Emissions System, System Displayed on the Drivers Information Center (DIC) Malfunction Indicator Lamp (MIL) Illuminated - DTC P02C1, P21DD, P221C, P10D9, P10F3, P143C, P20B9, and/or P221E**

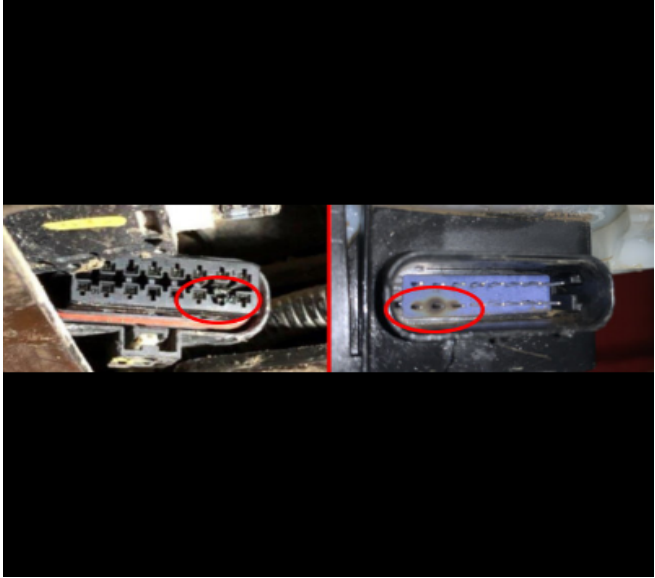
<b>Cause</b>	This condition may be caused by a poor connection at the Emission Reduction Fluid Tank electrical connector.

<p>5708899</p> <p>Inspect the Emission Reduction Fluid Tank electrical connector for any signs of damage and repair as necessary. If this condition is not found, refer to normal SI diagnostics</p>
-------------------	---
