TECHNICAL SERVICE BULLETIN

6.7L - Illuminated MIL With DTCs U029D, U029E, P22A7 And/Or P2209 - Built On Or Before 10-Jun-2020

20-206701 February
2021

Ford 2017-2020 F-Super Duty	Engine: 6.7L
---------------------------------------	--------------

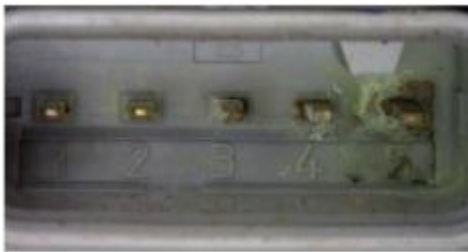
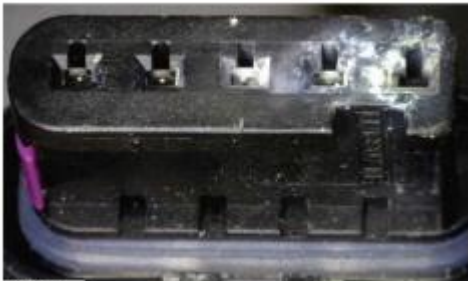
- Disconnect the affected NOx sensor module and inspect for moisture or corrosion on the pins of the harness and module. Are there any signs of moisture or corrosion present? (Figures 1-2)
 - Yes - replace the NOx sensor module. Refer to Workshop Manual (WSM), Section 303-14. Proceed to Step 2.
 - No - this article does not apply. Refer to the Powertrain Controls and Emissions Diagnosis (PC/ED) Manual for normal diagnostics.
