SERVICE BULLETIN

NUMBER: 16-132-20R

SUBJECT: Diagnostic Information for Alleged Chain Slip Condition
 on TR580 / TR690 Transmissions

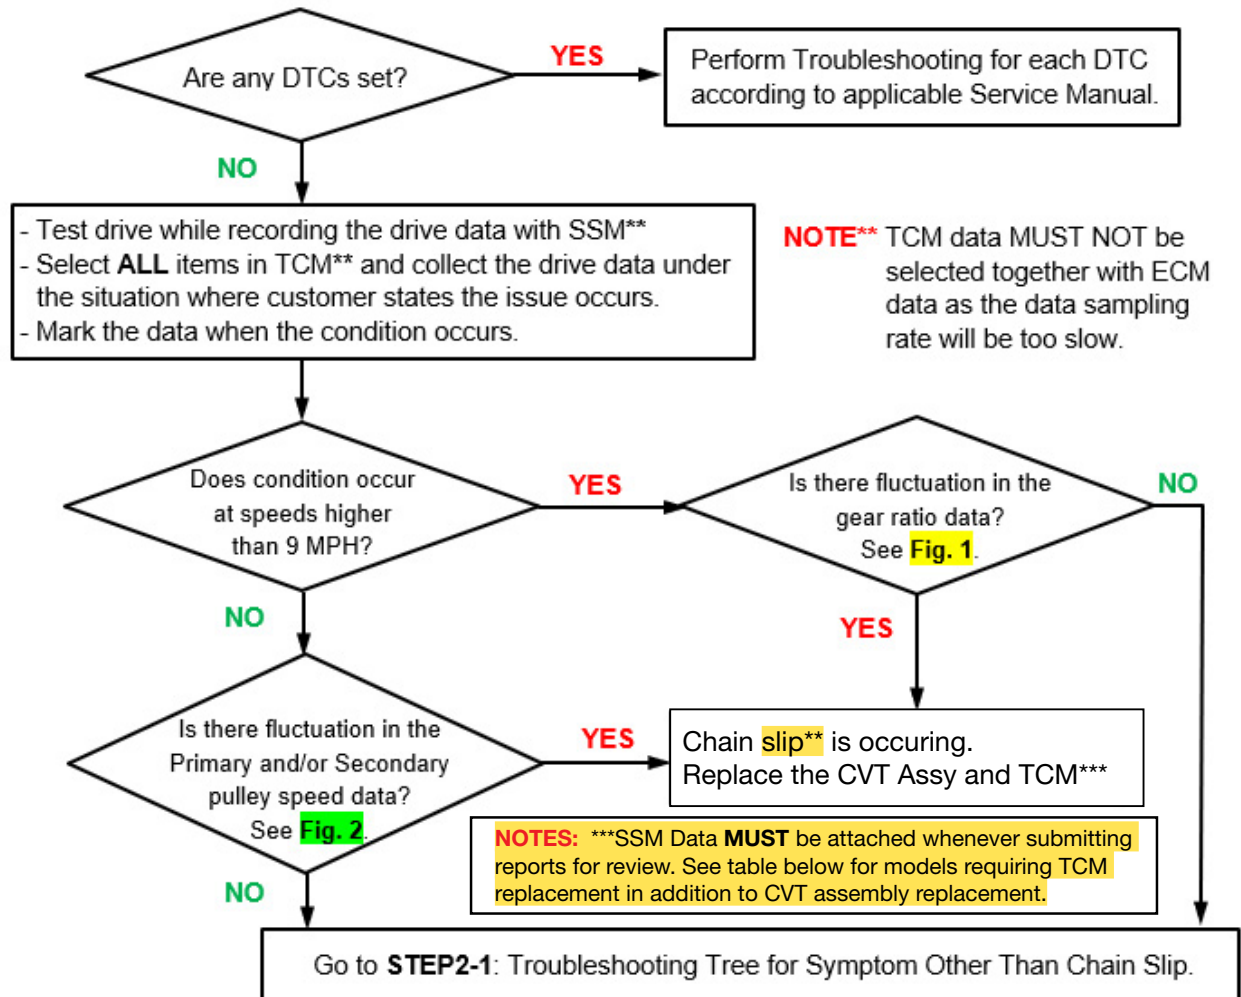
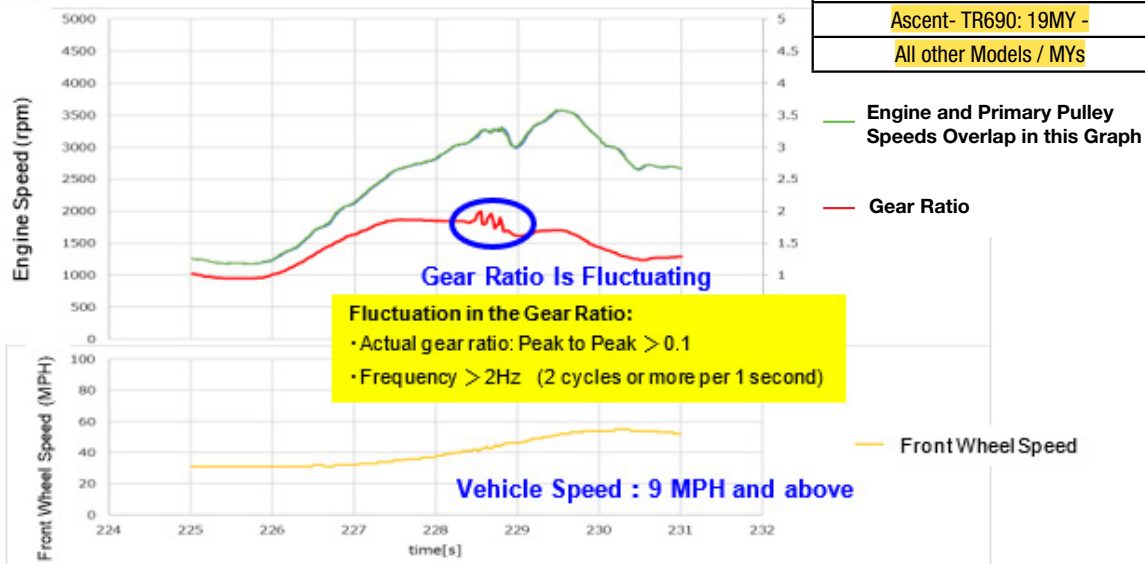
FIG. 1

Troubleshooting Flow Chart for Alleged CVT Chain Slip:

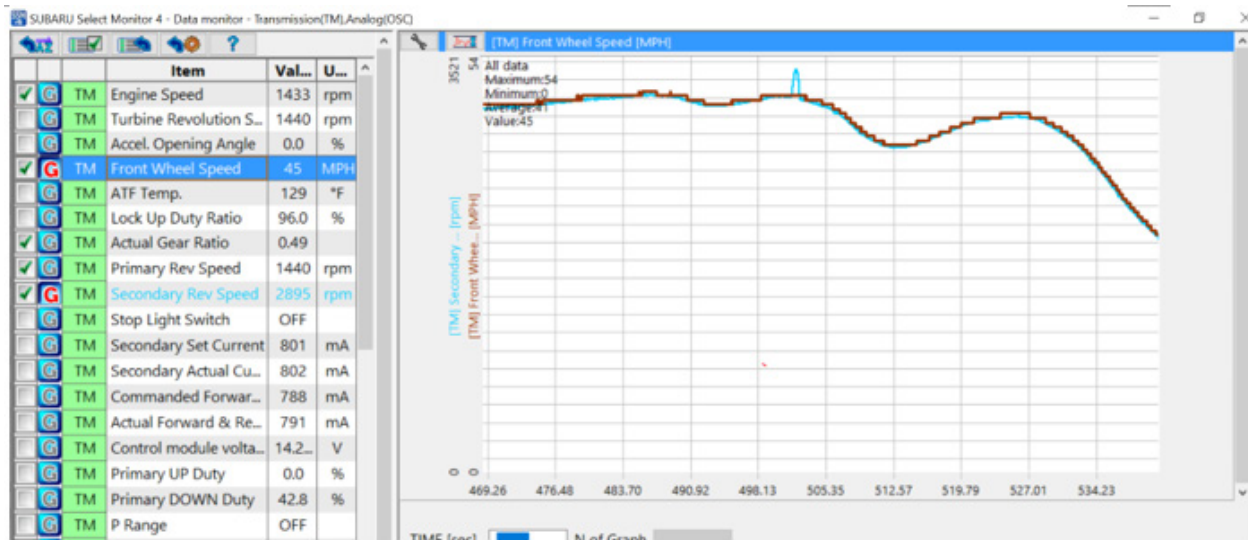
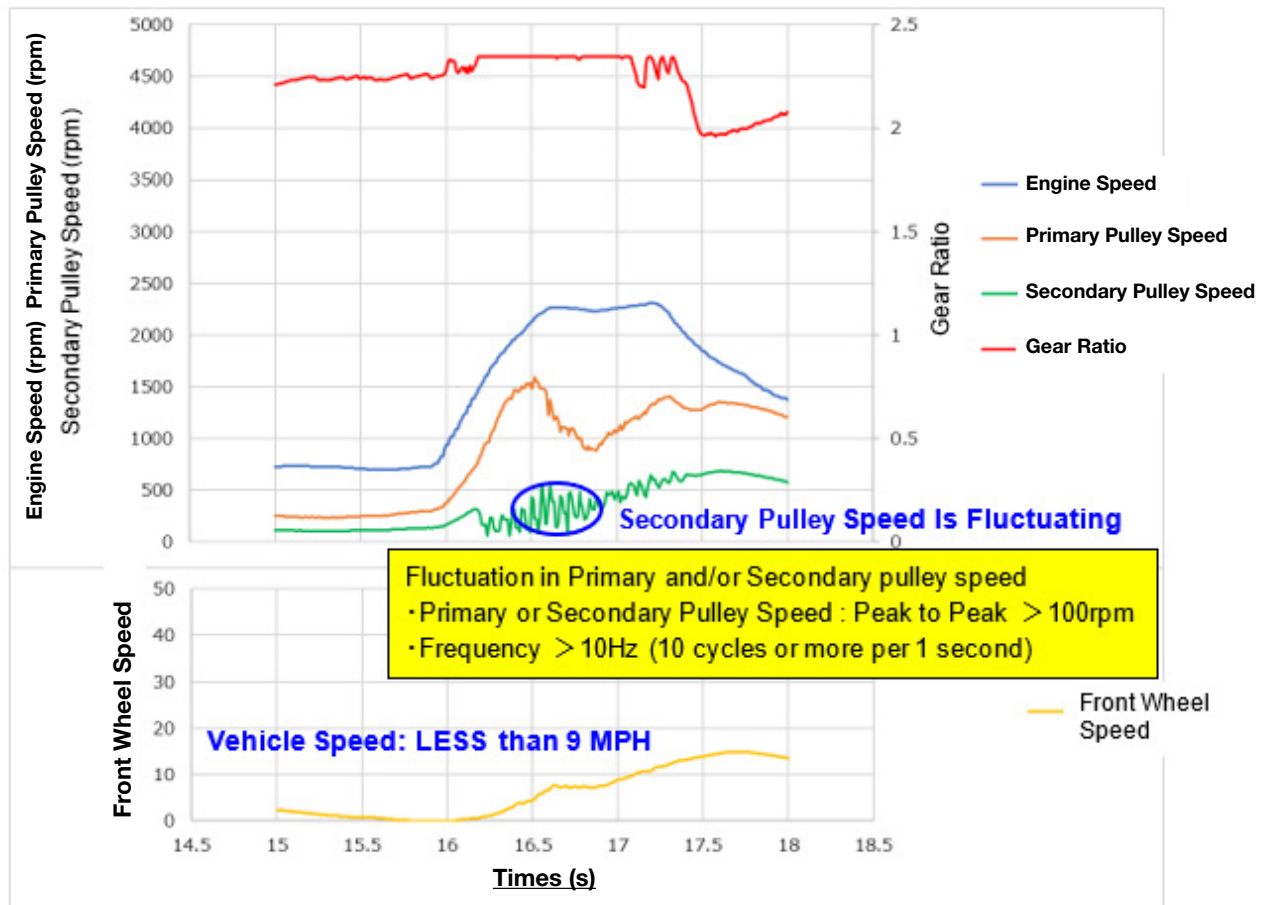
FIG. 2

Example screenshot of TCM PIDS with **Front Wheel Speed** and **Secondary Revolution Speed** selected.

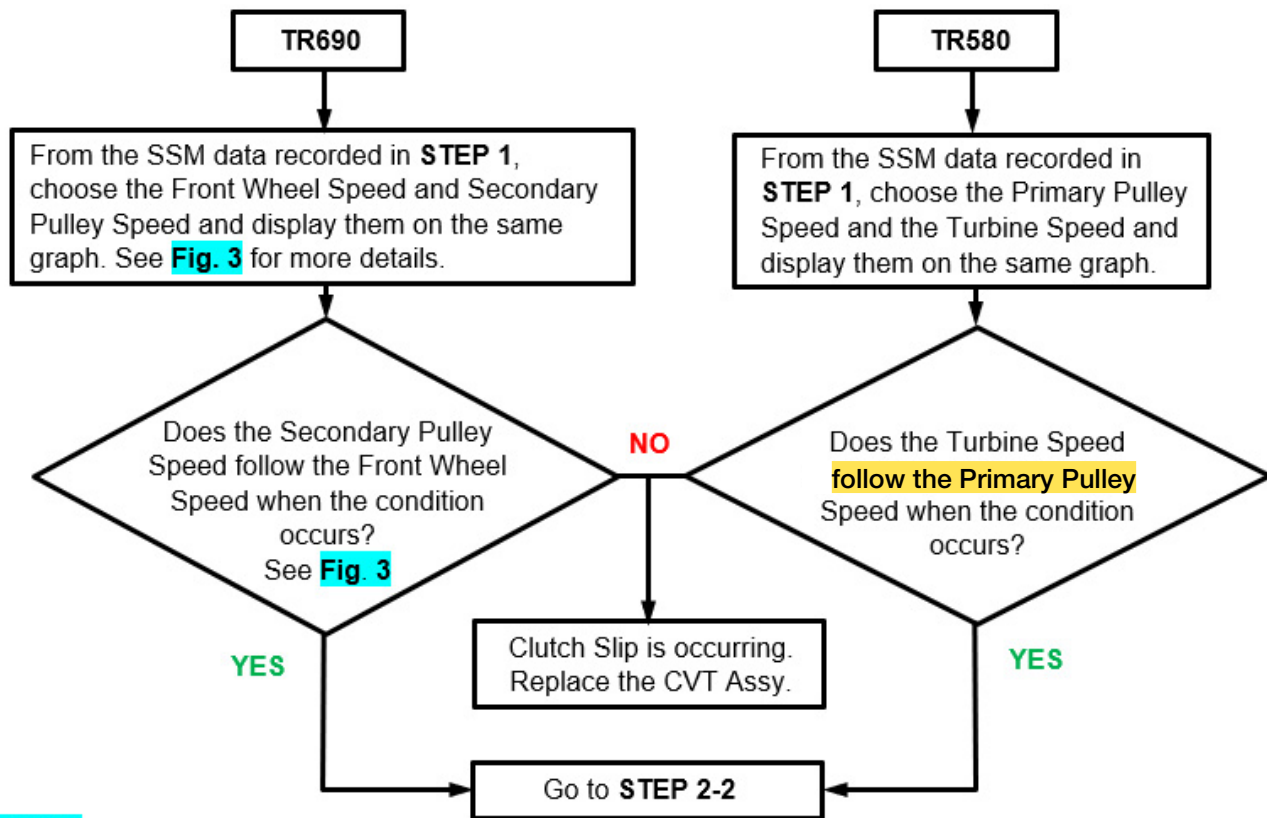
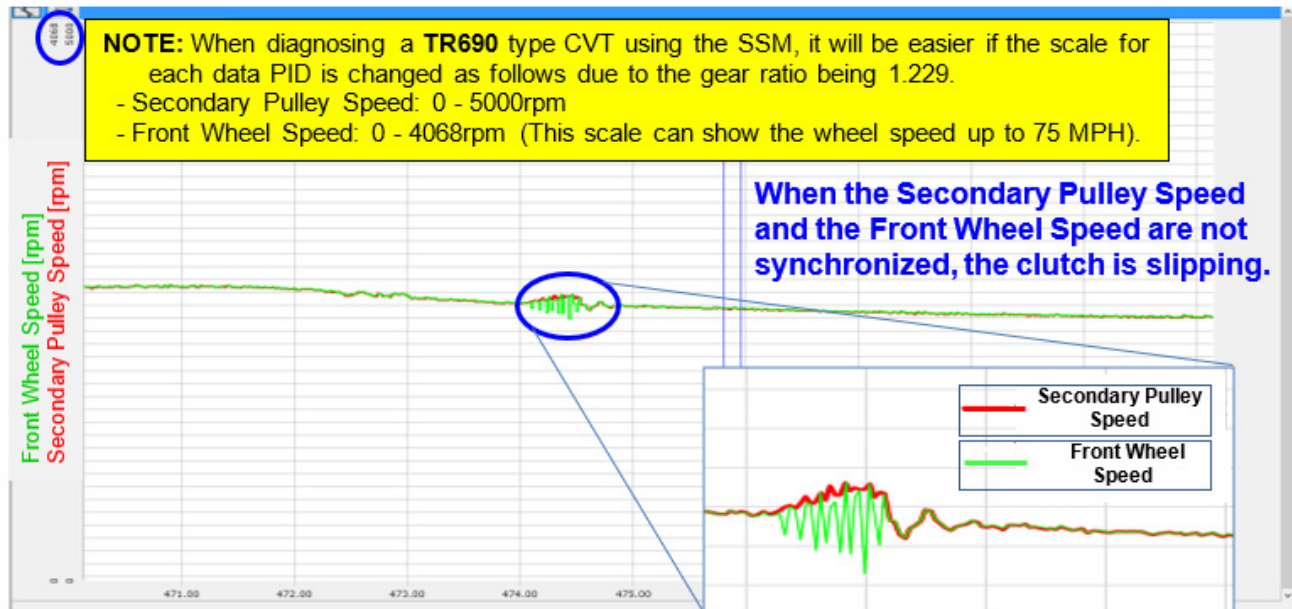
FIG. 3

Troubleshooting Flow Chart for Symptom Other Than Chain Slip: -1

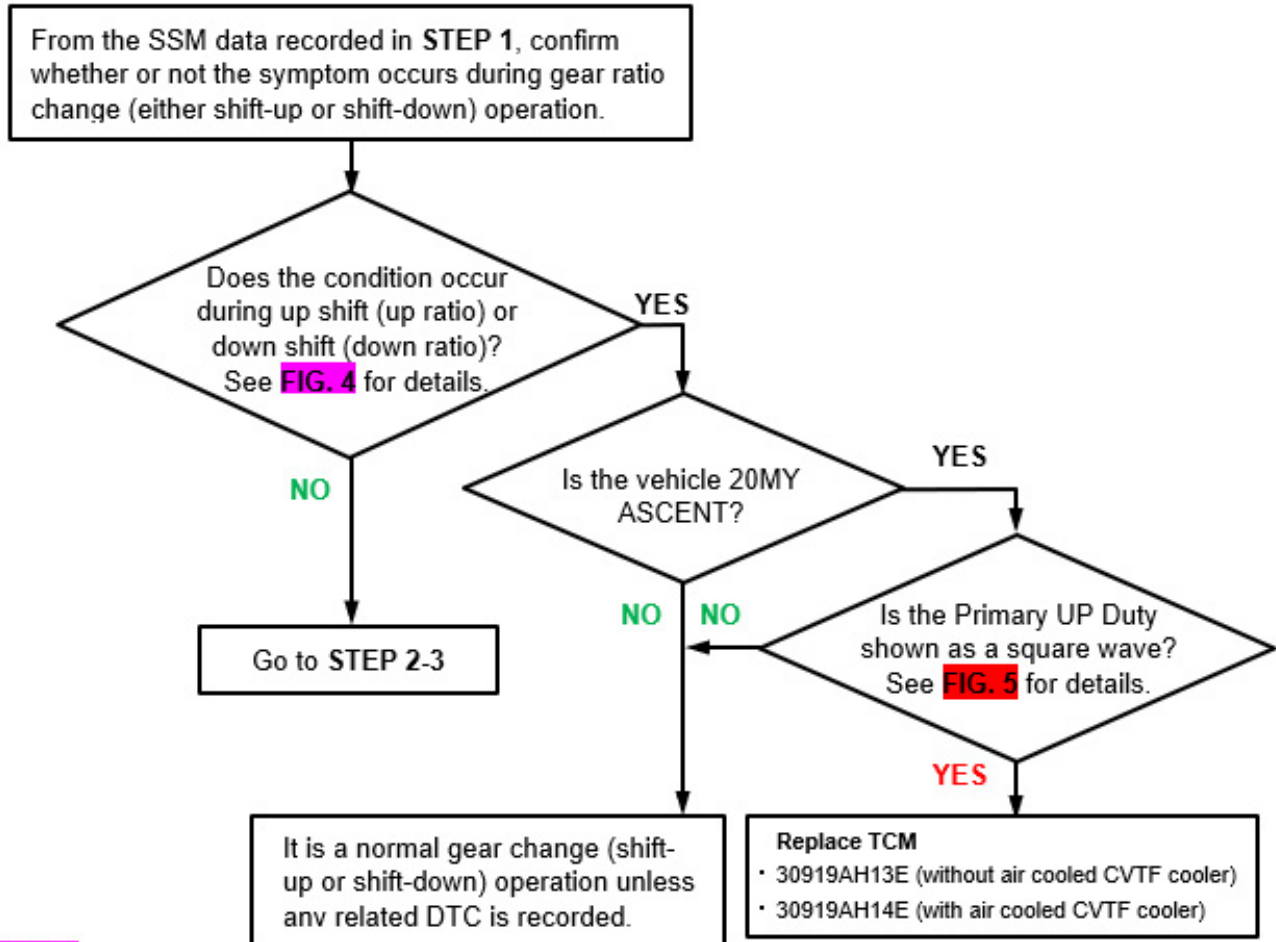
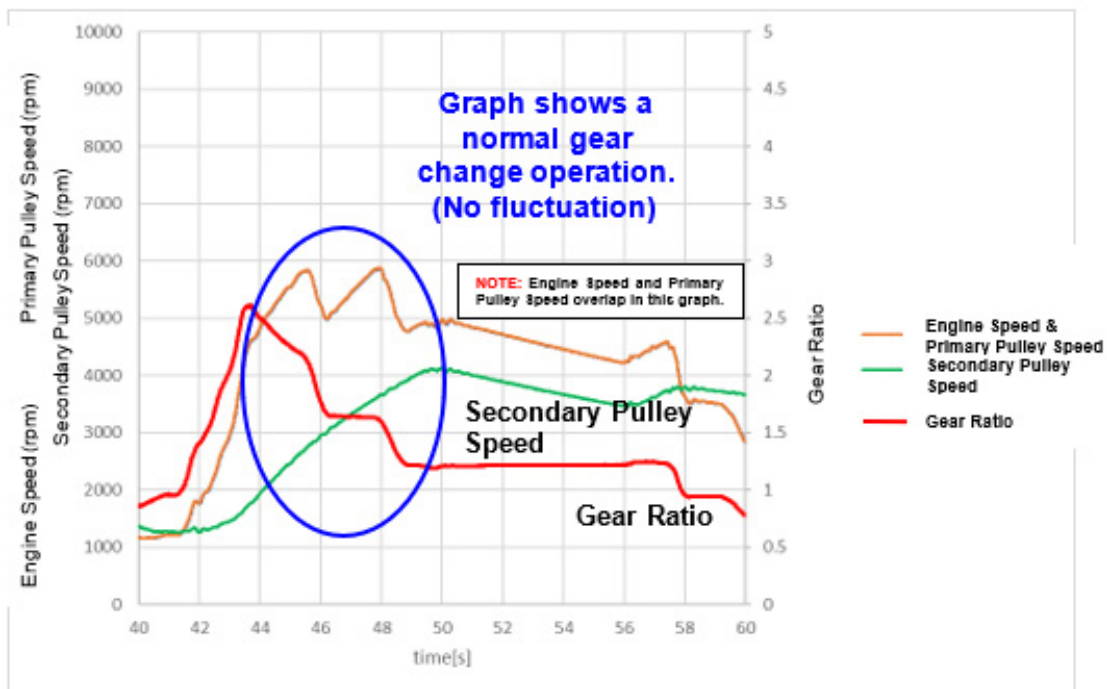
FIG. 4

STEP 2-2: Troubleshooting Flow Chart for Symptom Other Than Chain Slip: -2 (Gear Change)

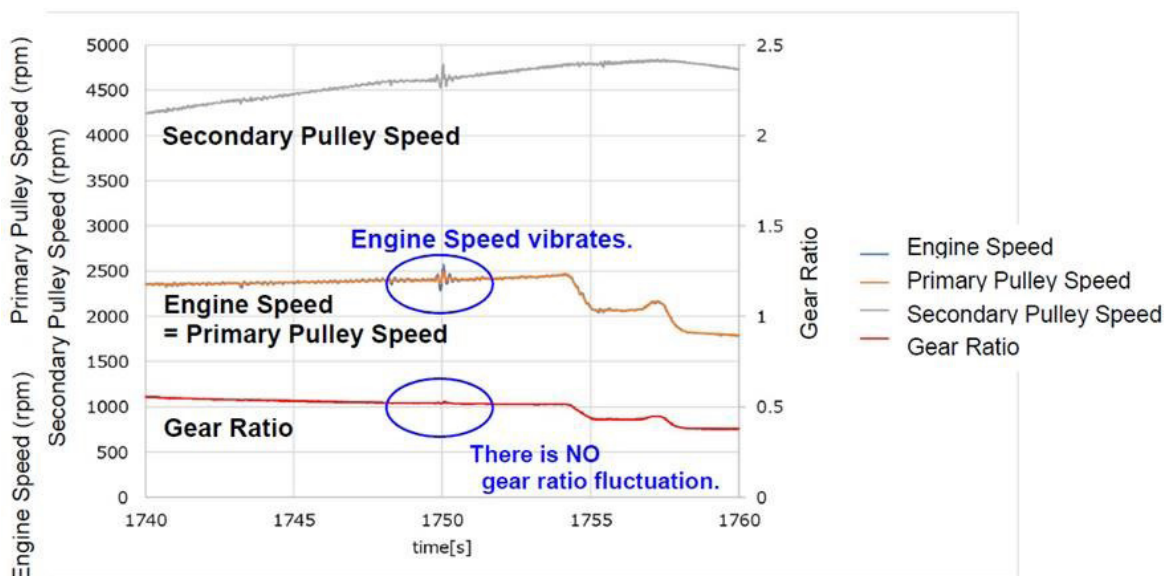
FIG. 6

The graph above is an example of recorded SSM data showing the torque fluctuation is NOT being caused by the transmission but by torque fluctuation of the engine.
