## **Subarunet Announcement**

**SUBJECT: Denso Gen 4 CP1 MOTA Update notification**

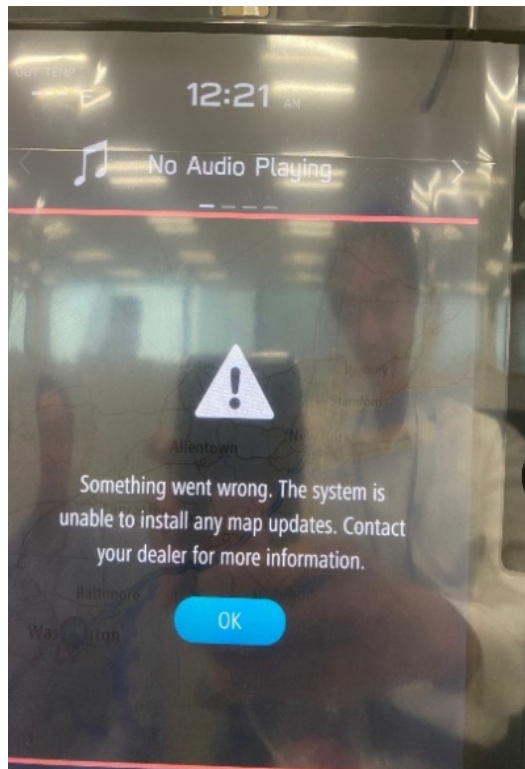
We have been informed Denso Gen 4 CP1 MOTA (map over the air) update portal became operational starting February 5, 2021. Customers with navigation equipped vehicles will be receiving an e-mail about this map release along with the link to the update procedure. The process to perform an update is very straight forward and can easily be completed if one of the latest software versions is installed. CP1 units with older software versions prior to the update RC2003, released in summer 2020, will receive an installation error shown below.

Older software versions do not support MOTA updates. The work around in these cases will be to update the CP1 system to the latest software version RC2011 released in December 2020. See applicable recall WRH-20R or campaign WRI-20R bulletins for details. Once the software is updated, MOTA may be completed.
