## SERVICE BULLETIN

**NUMBER:** 15-236-18R

**REVISED:** 02/10/21

**SUBJECT:** Reprogramming File Availability for Optimization of Harman Gen 3.1 and Gen 3.1α Audio and Navigation Head Units

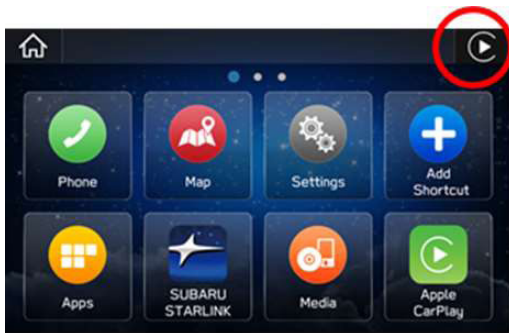
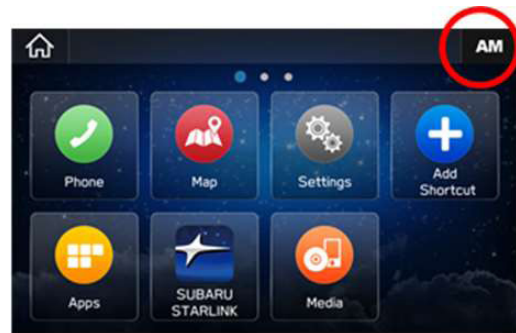
**On Ver. 6.0 and before:**

**Music playing via iPhone in CarPlay.**

**After disconnecting, the music source changes to Radio automatically.**

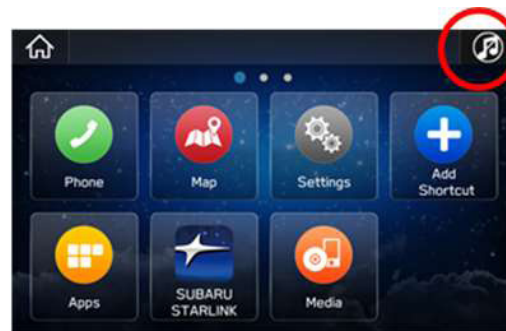
**Music playing via iPhone in CarPlay.**

**After disconnecting, no music source is selected automatically.**

If a source of music other than CarPlay has been playing when the iPhone is disconnected, the music source remains same (it is not turned off.)

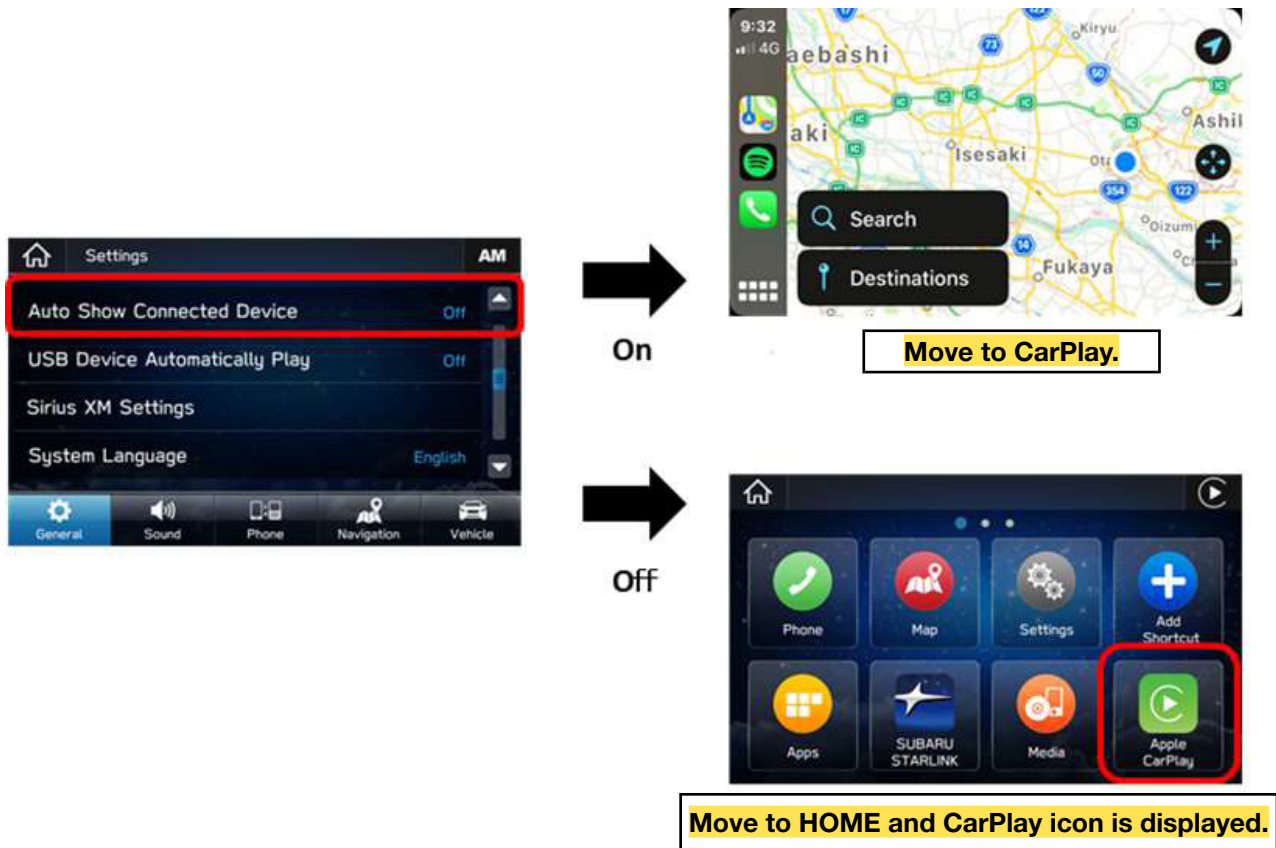
**On Ver. 6.0 and before:**

In a case where the iPhone was disconnected while playing music then reconnected while it is playing music, the system moves to CarPlay screen no matter what is set in <Auto Show Connected Device> in Setting (depending on iOS version of the iPhone.)

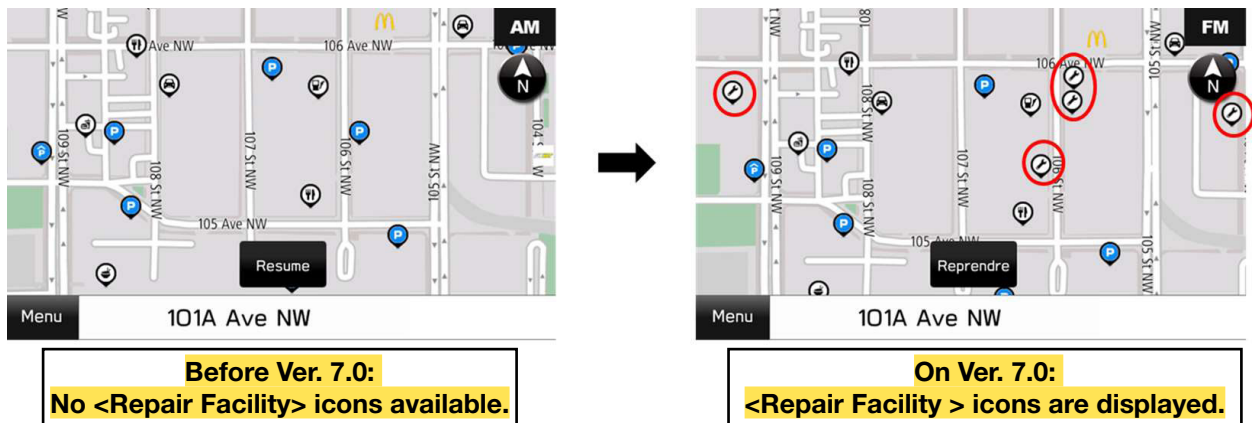
**NOTE 4:** Displaying Repair Facility POI icons:

<Repair Facility> Icons can be displayed in the NAVI Map.

<Repair Facility> Icons can be turned On or OFF by going to: Settings > Navigation > POI Icons.

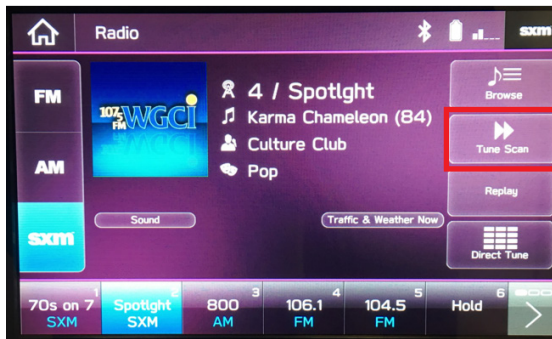
<Scan> previously displayed on SXM screen was changed to <Tune Scan> (a.k.a. SEEK).
