SERVICE BULLETIN

APPLICABILITY: 2013-14MY Legacy and Outback Models
 with 2.5L FB Engines
 2011-14MY Forester Models with 2.5L FB Engines
 2015 MY Forester (Manual Transmissions Only)
 with 2.5L FB Engines
 2012-13 MY Impreza and XV Crosstrek Models
 with 2.0 FB Engines
 2014-15 MY Impreza and XV Crosstrek Models
 (Manual Transmissions Only) with 2.0 FB Engines

NUMBER: 02-157-14R

SUBJECT: Engine Oil Consumption

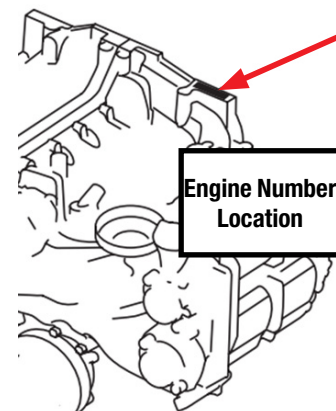
*** NOTE:** When determining the engine number, use the **LAST 8** characters of the number stamped into the boss on top of the block adjacent to the starter and shown in the illustration. The engine number range for the FA1 assembly line is 800000 to 930025 and the FB2 range is 000000 to 652640.

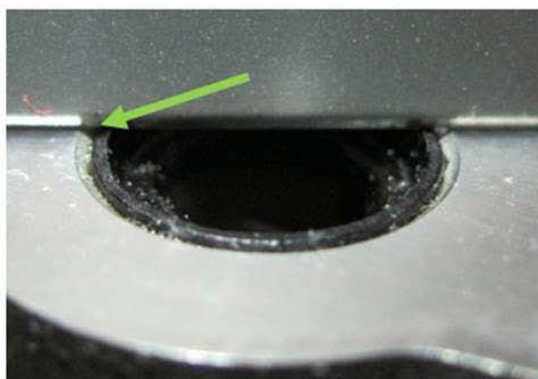
OK- Filter Screen flush with machined surface of camshaft carrier.

- **IMPORTANT:** The **one-time use** AVCS filter screens in the cam carriers are available separately (p.n. 14451AA050). **NOTE:** Although the filter screens are not directional, they **must be installed flush with the machined surface of the cam carrier as shown in the OK photo below.** The **NG photo** shows the screen installed too deep into the camshaft carrier. Engines with AVCS on both intake and exhaust will have 2 filters in each carrier as opposed to just one (intake only AVCS).

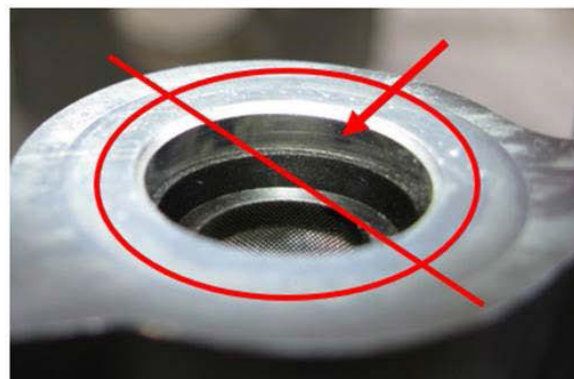
NG- Filter Screen installed too deep into the camshaft carrier bore.

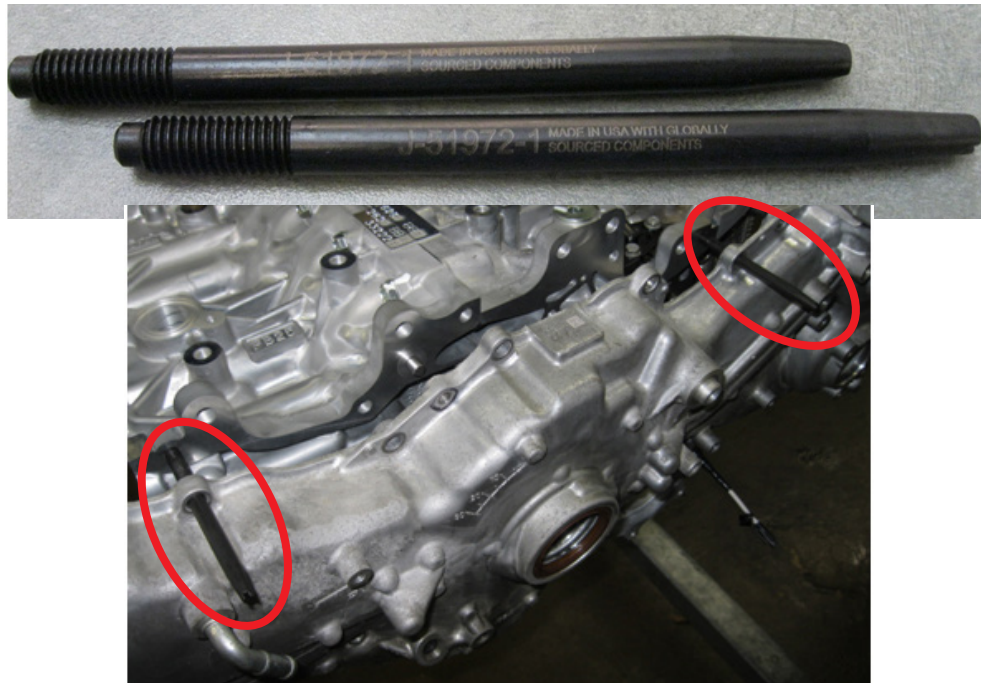
IMPORTANT: When re-installing the front cover assembly, be very careful to not allow it to contact any of the timing sprockets. If contact does occur, it will most likely be with the exhaust sprockets and it is almost a guarantee the fresh silicone sealer beads applied to the cover will be disturbed. To minimize the possibility of this happening, alignment pins as shown in the photos below have been developed to “guide” the cover into its proper position without disturbing the fresh sealer. The Subaru Special Tool number for the alignment pin kit is J-51972. Each kit includes 2 pins.

- If alignment pins are not used and the sealer gets disturbed during the cover installation, unless properly addressed, the affected area(s) will most likely be the source of an oil leak after reassembly. Don't hesitate to use a helper for the cover installation to prevent this from happening.
