SERVICE BULLETIN

APPLICABILITY: 2019MY Forester

NUMBER: 07-192-21

SUBJECT: DTCs B112C and / or B112E in Driver Monitoring System (DMS)

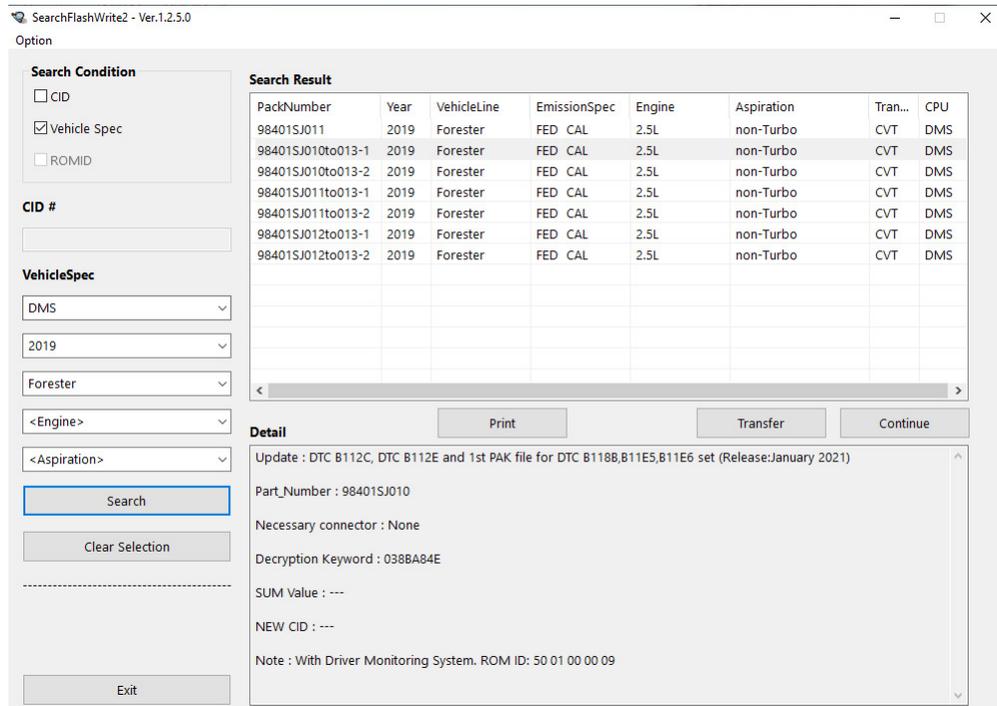
- These update files were included in the January, 2021 Select Monitor update .
- Each of the PAK Files in the table above consists of TWO (2) separate update files in FlashWrite. **BOTH** files listed in FlashWrite must be installed to complete the applicable update.
- A screenshot of the current FlashWrite screen is supplied below for reference.

IMPORTANT: This DMS update requires installation of 2 reprogramming files as shown in the FlashWrite screenshot above. Each file will take about 15 minutes to install. **BOTH update files MUST be installed.** If this update has been performed previously, a “Latest version already installed” message will be displayed. Due to the system structure, the FlashWrite reprogramming procedure must be performed twice (once for each file) to complete the update successfully.

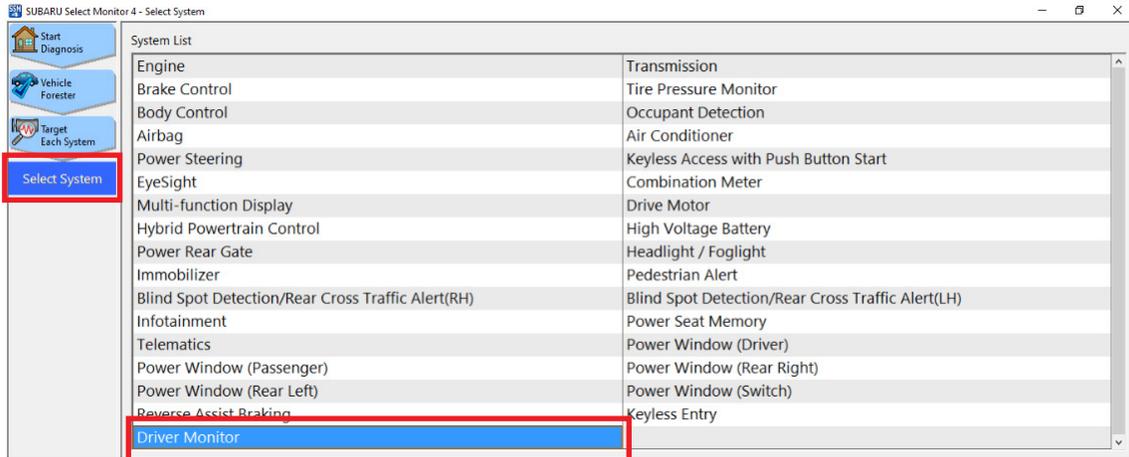
Step 5) Check the ROM ID numbers of the DMS C/M using the screen shots below as a guide:

Go to: **Diagnosis > Each System > select Driver Monitor from the System List.**

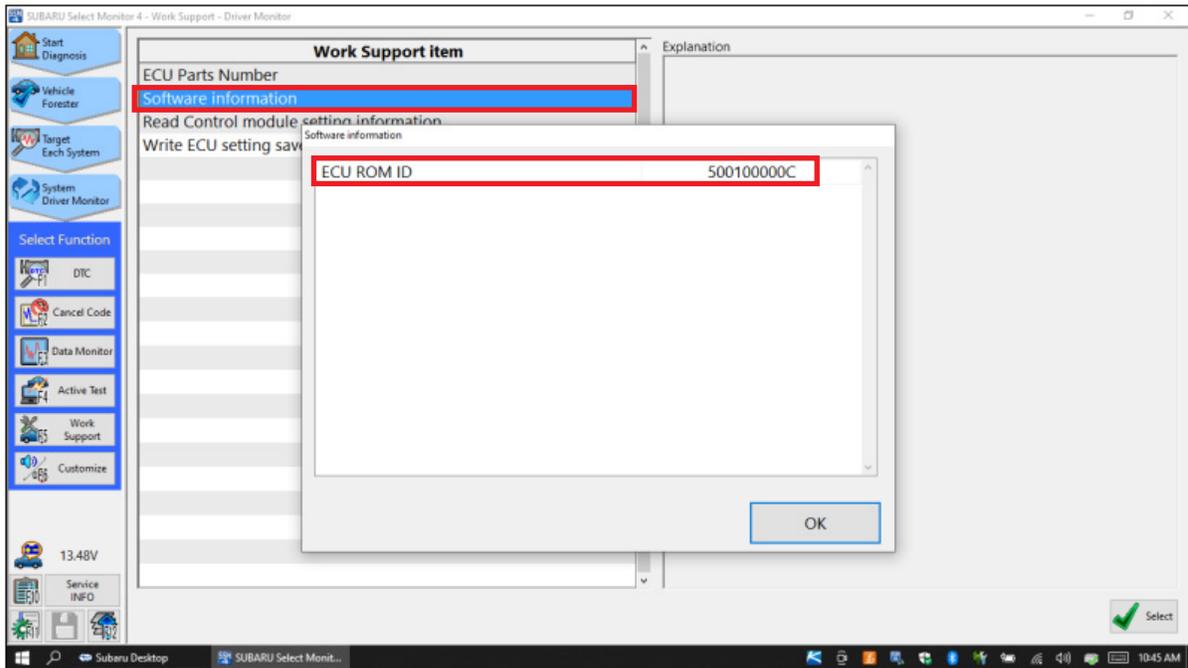
To check the ROM ID, select Software information to display the ROM ID.

CHECK: Is the ROM ID **50 0* 00 00 09**, **50 0* 00 00 0C** or **50 0* 00 00 0D**?

YES: Proceed with reprogramming the DMS using the normal FlashWrite procedure. Use the Pack File table above to select the proper reprogramming files from the FlashWrite result after entering the Vehicle Spec. parameters.
