SERVICE BULLETIN

APPLICABILITY: Manual Transmission Vehicles with Push Button Start ONLY

NUMBER: 15-279-21R

SUBJECT: Gen1 Telematics DCM Replacement for 3G Sunset

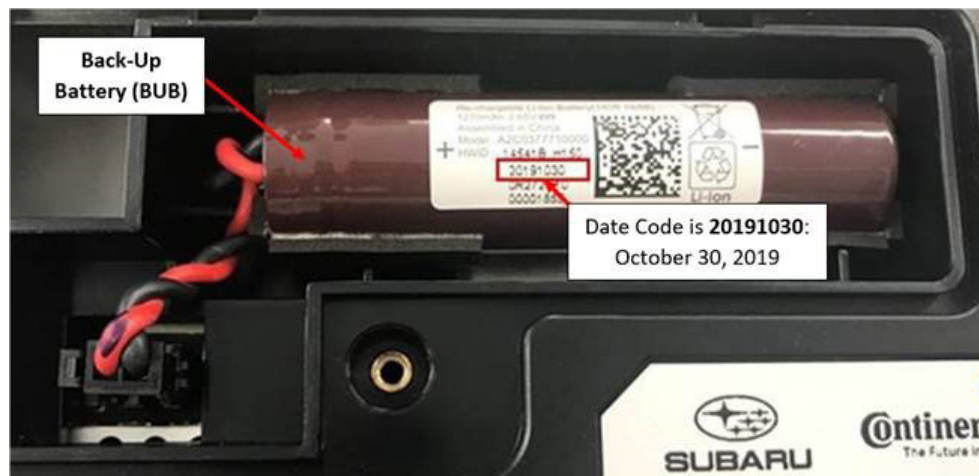
9. Visually inspect the date code on the outside of the BUB as shown below.

NOTE: The photo above illustrates where the BUB production date is located.

- a. If the date code is over five (5) years old, the BUB has passed its life cycle and should be replaced before installing the new DCM. The customer must be informed of the expired date code and the need for a replacement since the BUB is a maintenance item. The replacement cost is not covered by this no-charge DCM replacement service.
- b. If the BUB is less than four (4) years old and no related DTCs are present, no action is required.

10. Transfer the existing BUB (or new replacement BUB) into the new DCM.
