TECHNICAL SERVICE BULLETIN

Drivers Seatbelt Locking Up And Difficult To Extend

21-2054
04 March 2021

Lincoln 2017-2020 Continental

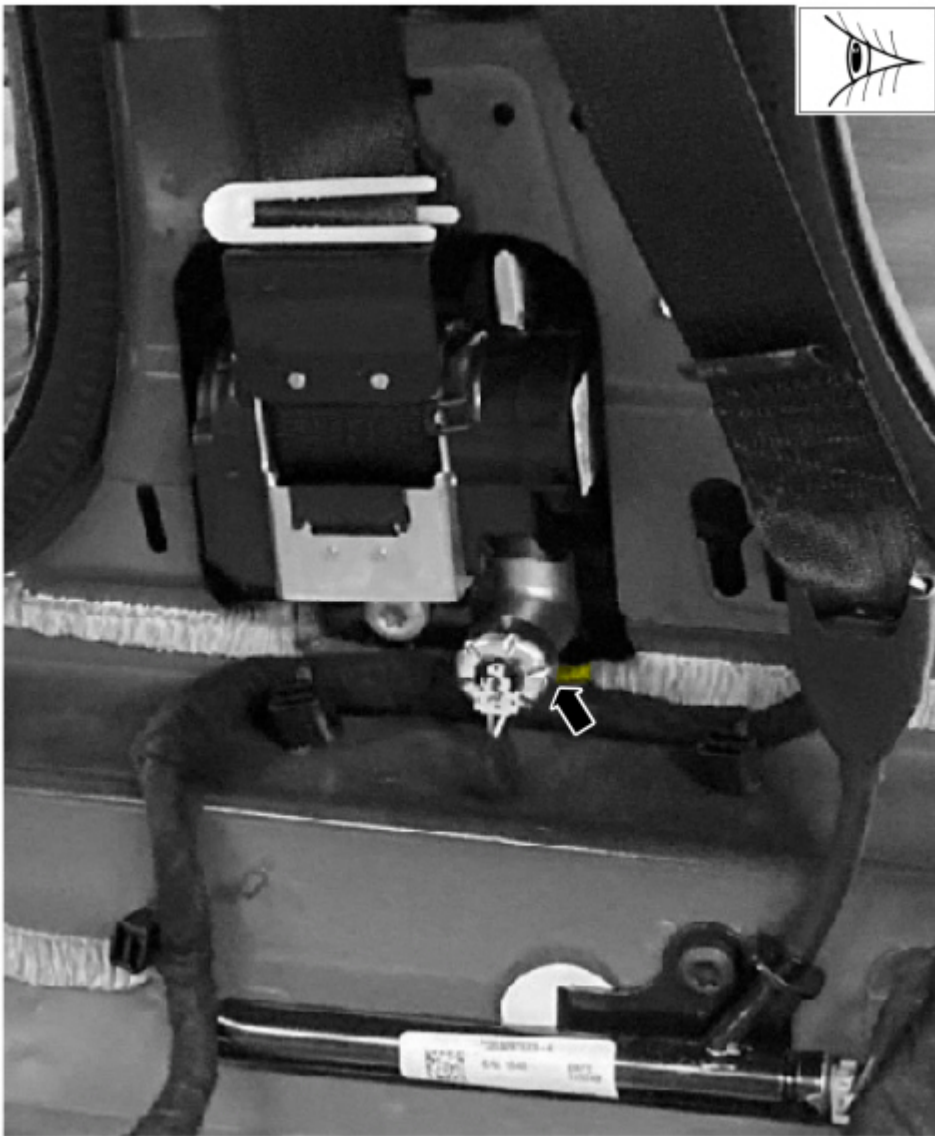
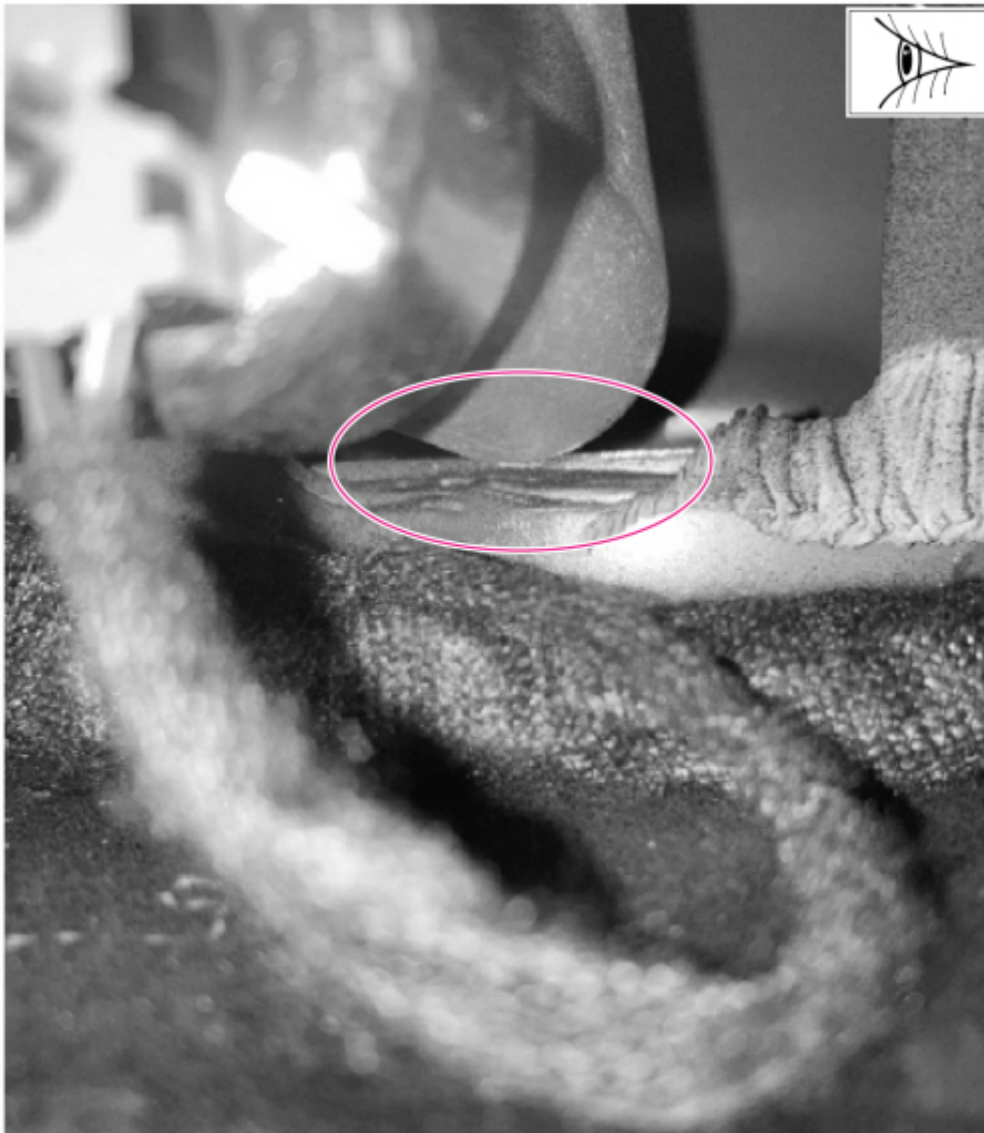
2. Inspect the lower corner of the driver seatbelt retractor, near the seatbelt pretensioner, for evidence of interference with the B-pillar metal flange. This will prevent the seatbelt retractor from fully seating into B-pillar mounting area. (Figures 1-2)

- 3.** Was interference found between the seatbelt retractor pretensioner assembly and the B-pillar sheet metal?
 - (1). Yes - proceed to Step 4.
 - (2). No - this article does not apply. Refer to WSM, Section 501-20A for normal diagnostics.
- 4.** Remove the seatbelt retractor and pretensioner assembly only. It is not necessary to remove the upper B-pillar trim, the seat belt D-ring or seatbelt anchor bolt. Refer to WSM, Section 501-20A.
- 5.** Using a suitable tool, remove approximately 2 mm (0.0787 in) of the B-pillar flange overlap to allow clearance between the seatbelt retractor and B-pillar sheet metal. (Figure 3)
