TECHNICAL SERVICE BULLETIN

10R140 Transmission - Ticking Or Scraping Noise Coming From Bellhousing

21-2100

Ford 2020-2021 F-Super Duty	Transmission/Transaxle: 10R140
--------------------------------	--------------------------------

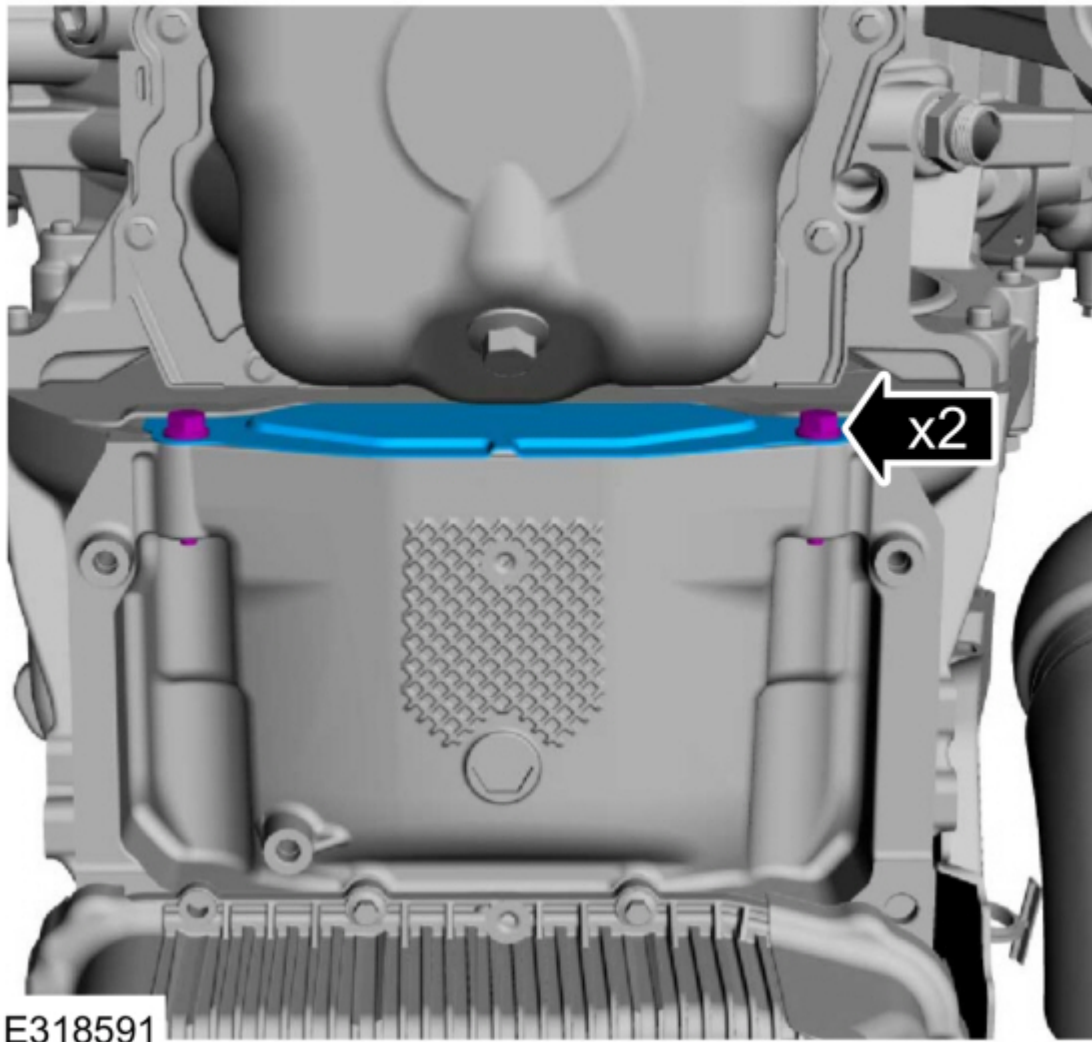
Figure 1

Issue: Some 2020-2021 F-Super Duty vehicles equipped with a 10R140 transmission may exhibit a ticking or scraping noise coming from the bellhousing. The noise may or may not go away while in PARK and/or NEUTRAL. This may be due to the torque converter studs contacting the flexplate inspection cover and/or internal torque converter damper spring contact. To correct the condition, inspect and adjust the flexplate inspection cover (gas engine only) and/or replace the torque converter (gas or diesel engine).

(1). Yes - remove and inspect the flexplate inspection cover for contact with the torque converter studs. If contact is found, adjust the cover so contact does not occur. Refer to Figure 1.
