## TECHNICAL SERVICE BULLETIN

### Slow Fill And/Or Illuminated MIL With DTCs P0171, P0174, P0451, P0455, P0456, P0496 And/Or P1450 - Built On Or Before 30-Nov-2020

**21-2106**

<b>Ford</b> 2017-2021 Transit
----------------------------------

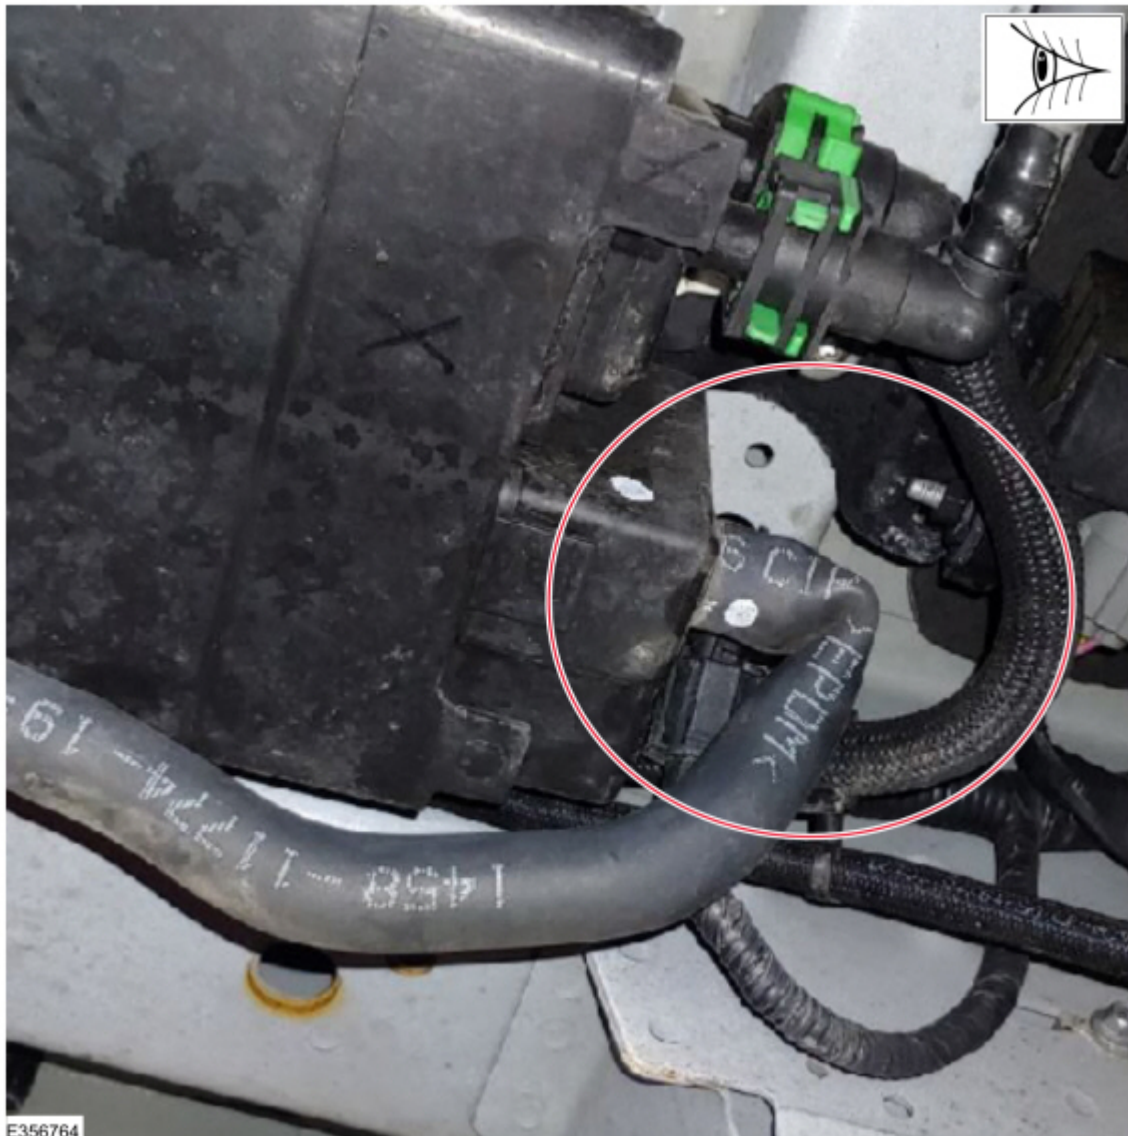
Figure 1

**Issue:** Some 2017-2021 Transit vehicles built on or before 30-Nov-2020 may experience a slow fill condition and/or illuminated malfunction indicator lamp (MIL) with diagnostic trouble codes (DTCs) P0171, P0174, P0451, P0455, P0456, P0496 and/or P1450. This may be due to a kinked evaporator emissions fresh air vent line. To correct this condition, follow the Service Procedure to attach a zip tie to the fresh air vent line.

1. Inspect the evaporative emissions fresh air vent line near the carbon canister. Is the line kinked? (Figure 1)
