# TECHNICAL SERVICE BULLETIN

## Transmission Fluid Leak From Fluid Cooler Tubes At Transmission - Improperly Seated Transmission Cooler Tube

21-2108

<b>Ford</b> 2020-2021 Mustang
----------------------------------

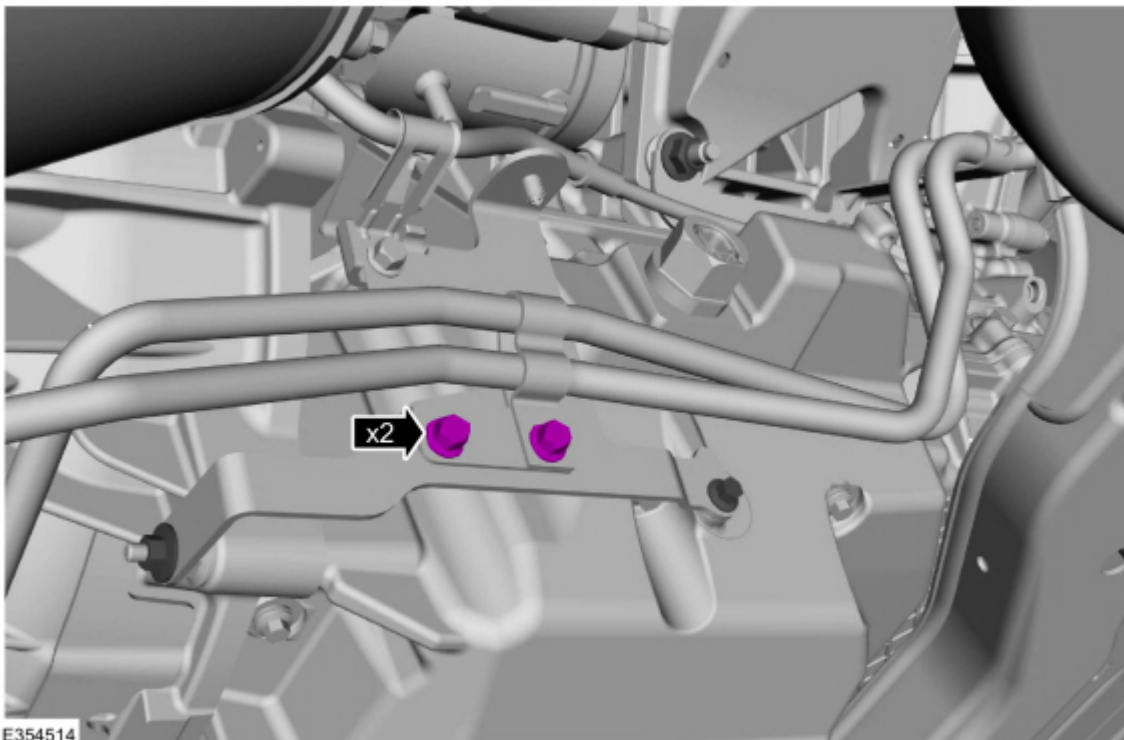
Figure 1

**Issue:** Some 2020-2021 Mustang GT500 vehicles may exhibit a transmission fluid leak caused by improperly seated transmission cooler tubes attached to the transmission case. If the threads in the transmission case that the cooler tube retaining bolts go into are damaged, it is not necessary to replace the transmission. These threads can be repaired. To correct the condition, follow the Service Procedure to repair these threads.

- Determine which cooler tube port on the transmission has damaged threads.
  - If the front port is damaged, replace the transmission oil filter cover. Refer to Workshop Manual (WSM), Section 307-01B. If only the front port is damaged, repair is complete.
  - If the rear port is damaged, proceed to Step 2.
- Disconnect and position aside the transmission cooler tubes from the bottom of the transmission. It is not necessary to completely remove the transmission cooler tubes. Refer to WSM, Section 307-02B, Removal and Installation, Transmission Fluid Cooler Tubes, Steps 9 through 11. (Figure 1)

- Cover the exposed ends of the transmission cooler tubes and the cooler tube ports in the side of the transmission to prevent any debris from entering the cooler tubes or the transmission.
- Using a M6 x 1 x 12mm thread repair insert kit, repair the damaged threads in the transmission case. Use the instructions contained with the kit to install the thread repair kit.
- Thoroughly clean the repair area.
- Reinstall the transmission cooler tubes. Refer to WSM, Section 307-02B. Replace the transmission cooler tube retaining bolt(s) as necessary.
- Verify the proper transmission fluid level. Add fluid as necessary.
- Make sure no leaks are present after making the repair. If any leaks are found, refer to WSM, Section 307-01B.
