TECHNICAL SERVICE BULLETIN Pop/Sizzle/Crack Noise From Exhaust

21-2109 09 April 2021

Ford 2020 Transit

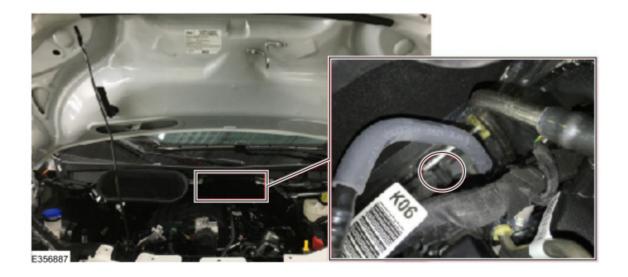
Figure 1

Issue: Some 2020 Transit vehicles may experience a pop/sizzle/crack noise from the exhaust. This may be due to water dripping on the exhaust from the evaporator drain tube. To correct the condition, follow the Service Procedure to extend the length of the evaporator drain tube.

- **1.** Apply a thin coat of Motorcraft® Seam Sealer (Black) to the inside of one end of a locally acquired vinyl tube measuring 5 cm (2 in.) long and an inner diameter of 13 mm (1/2 in.).
- 2. Install the vinyl tube from the top side of the vehicle to the evaporator drain tube. Use a set of pliers to extend reach if necessary. (Figure 1)
