Service Bulletin

Bulletin No.: 21-NA-048

Subject: Black Screen in Reverse with Red Triangle and Red Camera with A Circle and Slash Through It

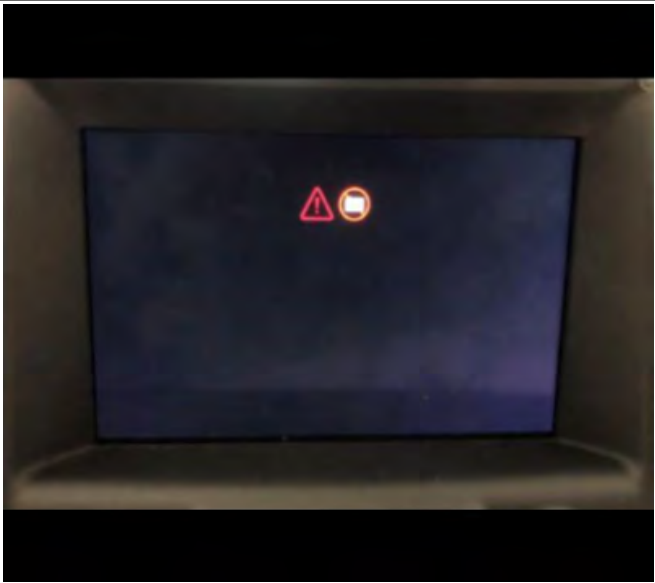
</div> <p style="text-align: right; font-size: small;">5758378</p> <p>Some customers may comment on seeing a black screen with red triangle and red camera with a circle and slash through It when vehicle is in Reverse. This condition may be intermittent.</p>
Cause	The cause of the condition may be that the crimping of the coaxial cable connectors to the cable is causing an excessive resistance that interrupts the video signal and causes the black screen.
Correction	Note: Verify the Condition, then depending on Model and Year, follow the appropriate repair in the list of Repair Procedures below.

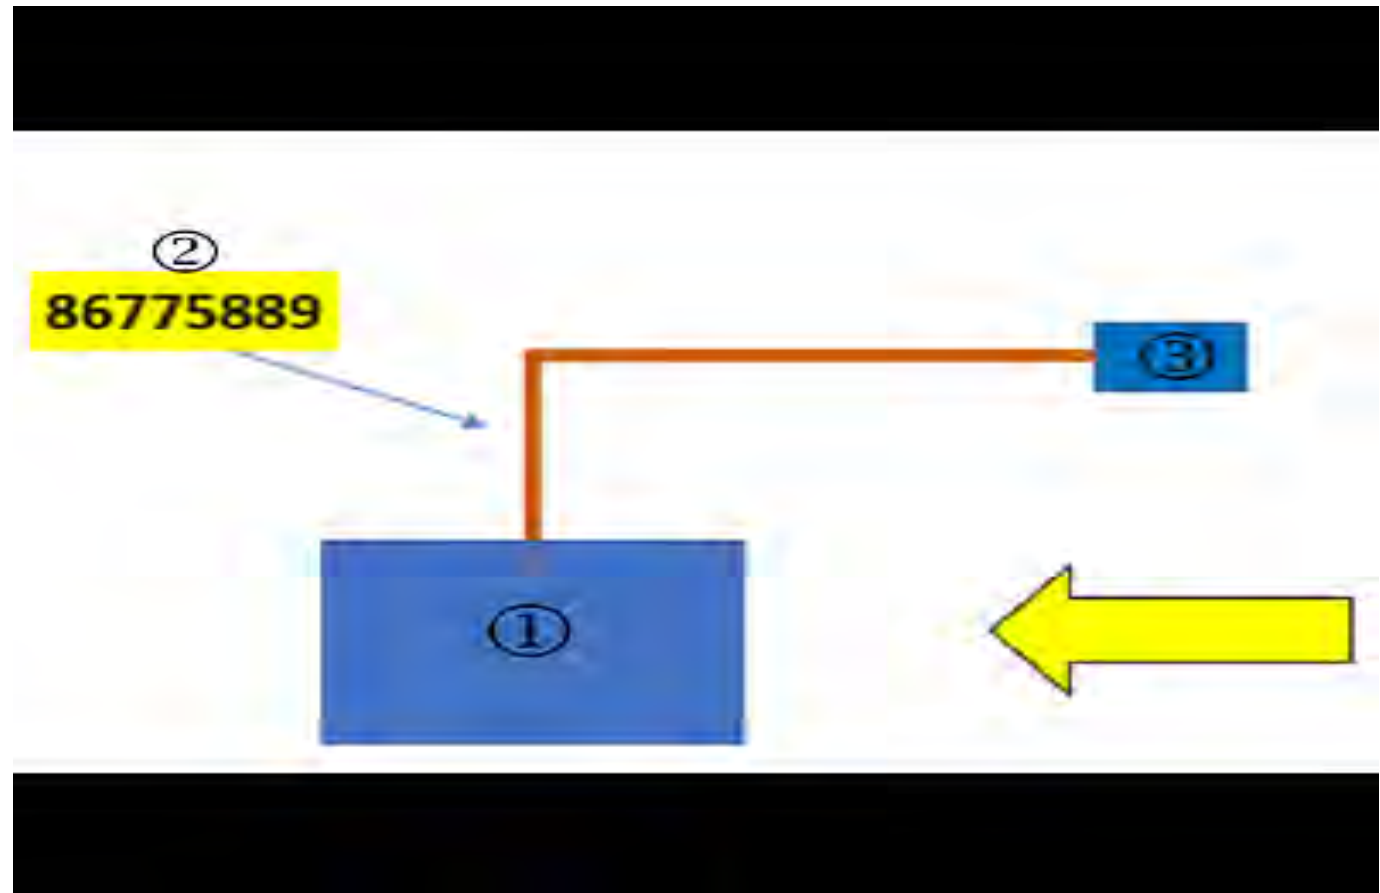
2020-2021 XT6 IP Coaxial Cable Routing (DRZ & UV2)

1. A11 Radio
2. IP Coax
3. IP to Body Coax In-line Connection

Replace the short (IP) coaxial cable from the in-line connection to the A11 Radio, located behind the right kick panel.

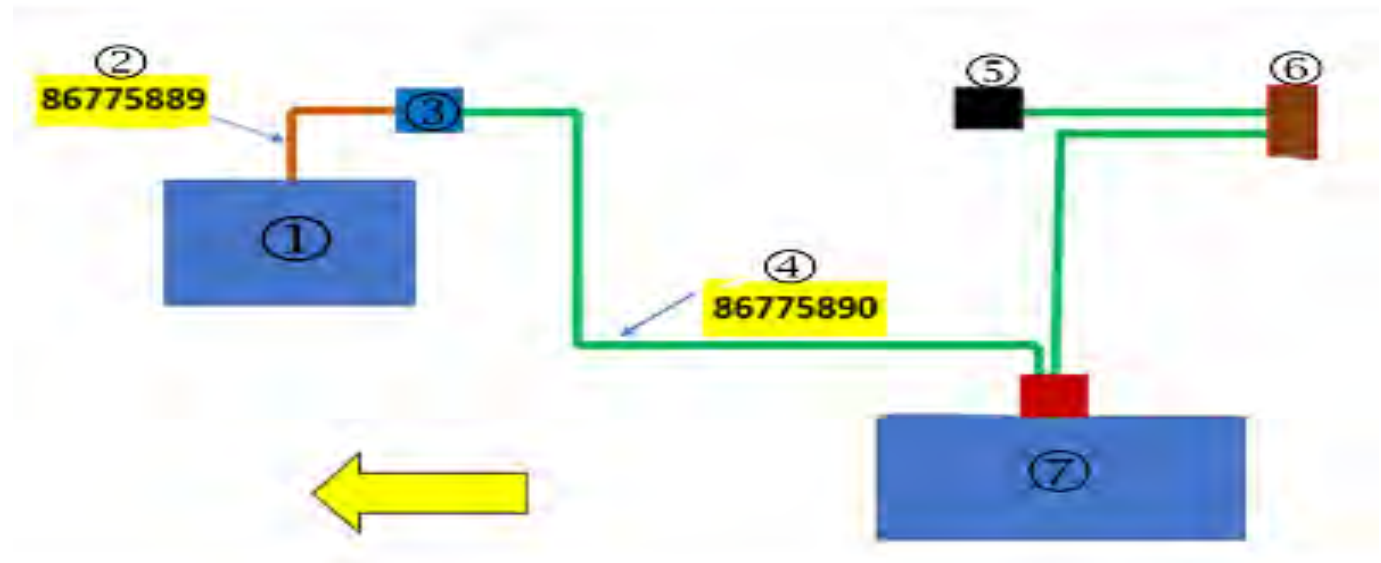
2020-2021 XT5 IP and Body Coaxial Cable Routing (DRZ & UV2)

1. A11 Radio
2. IP Coax
3. IP to Body Coax In-line Connection
4. Body Coax
5. To Headliner
6. To Liftgate Harness
7. VPM

Note: On XT5, the (Body) cable runs from the VPM to the In-line connection to the (IP) short cable behind the right kick panel. It also routes to the liftgate coaxial connector and to the coax at the top of the left "D" pillar headliner area for the rearview mirror.

1. Replace the long Coaxial cable (Body) from the VPM in the left rear of the vehicle, to the In-line connection to the (IP) short cable behind the right kick panel and to the liftgate connector and connect to the cable to the rearview mirror in the top left "D" pillar headliner area.
2. Replace the short (IP) coaxial cable from the in-line connection to the A11 Radio, located behind the right kick panel.

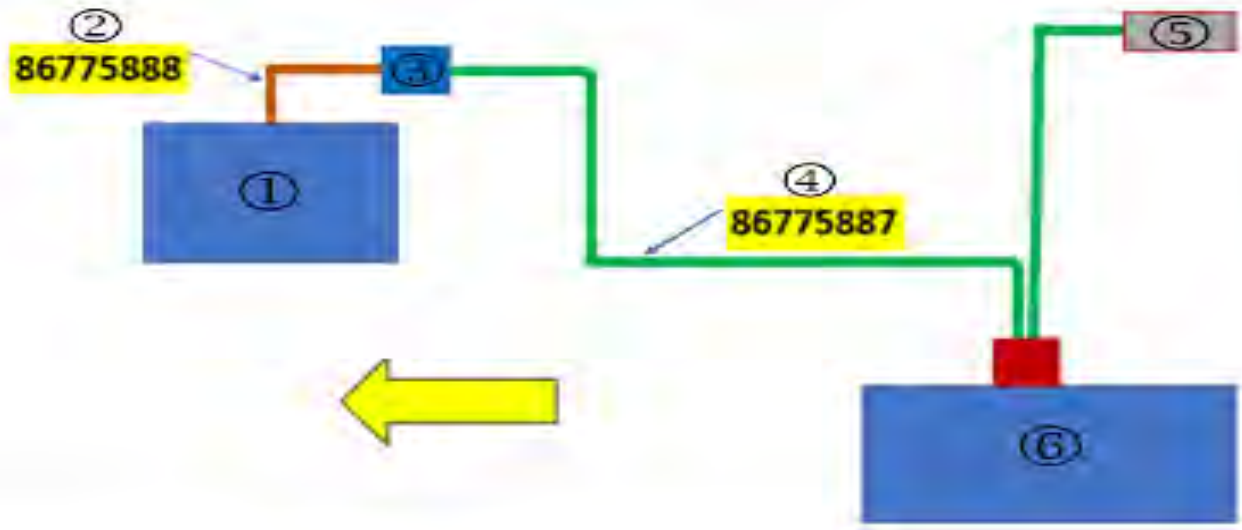
Acadia
 2020-2021 Acadia IP and Body Coaxial Cable
 Routing (UV2)

- 1. A11 Radio
- 2. IP Coax
- 3. IP to Body Coax In-line Connection
- 4. Body Coax
- 5. To Liftgate Harness
- 6. VPM

Note: On Acadia, the (Body) cable runs from the VPM to the In-line connection to the (IP) short cable behind the right kick panel and to the liftgate coaxial cable connector.

- 1. Replace the long Coaxial cable (Body) from the VPM in the left rear of the vehicle, to the In-line connection to the (IP) short cable behind the right kick panel and to the liftgate coaxial cable connector.
- 2. Replace the short (IP) coaxial cable from the in-line connection to the A11 Radio, located behind the right kick panel.
