Service Bulletin

Bulletin No.: 21-NA-071

Subject: DTC's P05AE or P059F Set Current or History

Brand:	Model:	Model Year:		VIN:		Engine:	Transmission:
		from	to	from	to		
Chevrolet	Silverado 2500HD/3500HD	2020	2021			All	All
GMC	Sierra 2500HD/3500HD

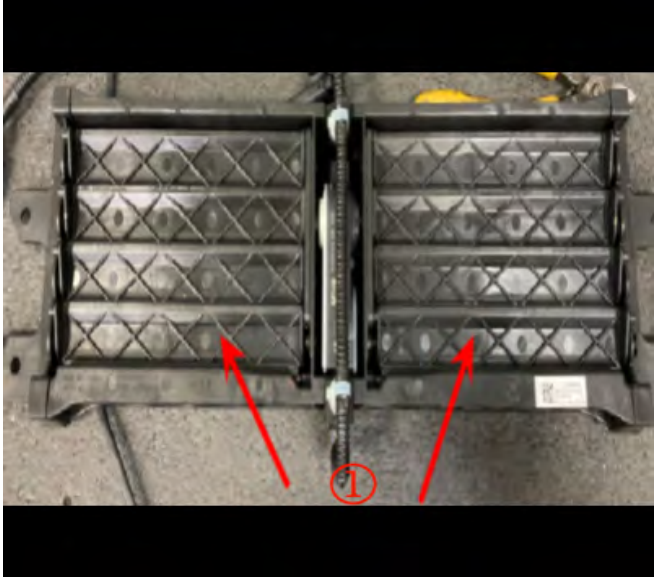
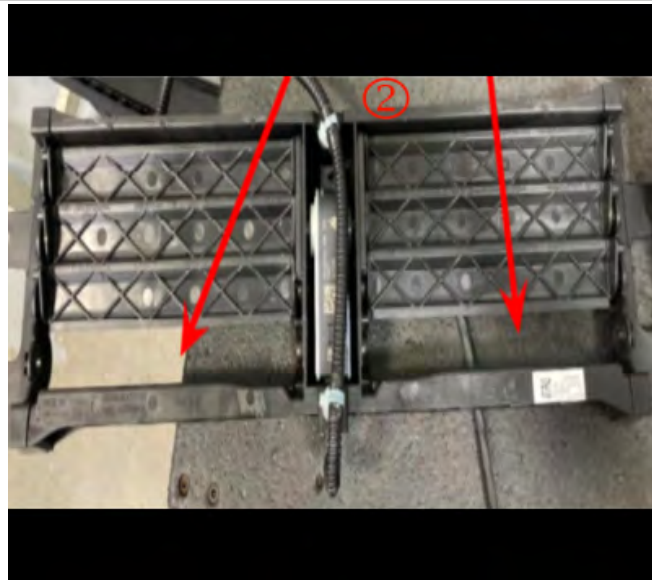
Involved Region or Country	North America, Saudi Arabia, Israel, Chile
Additional Options (RPOs)	
Condition	<p>Customers may come in for service and technician may find either of the DTC's listed below set in current, or history.</p> <ul style="list-style-type: none"> • DTC P05AE - Active Grille Air Shutter 2 Performance • DTC P059F- Active Grille Air Shutter 1 Performance
Cause	The cause of the condition may be road debris like small stones, or ice, may collect at the bottom of the front bumper lower shutter assembly and can prevent the louver from fully closing, causing the DTC's to set.
Correction

Note: The graphics above show before (1), and after (2), examples of the lower shutter modification.

Remove the front bumper lower shutter and complete the *Lower Shutter Louver Modification Procedure* below, to remove the lowest row of louvers from the shutter.
