# Preliminary Information

## PIP5348C Vibration At Idle In Gear Or Low Speeds Remove Foreign Object Material Debris From Transmission Mount

Brand:	Model:	Model Years:	VIN:		Engine:	Transmissions:
			from	to		
Chevrolet	Colorado	2015 - 2021	All	All	All	6L50 MYB
GMC	Canyon	2015 - 2021	All	All	All	6L50 MYB

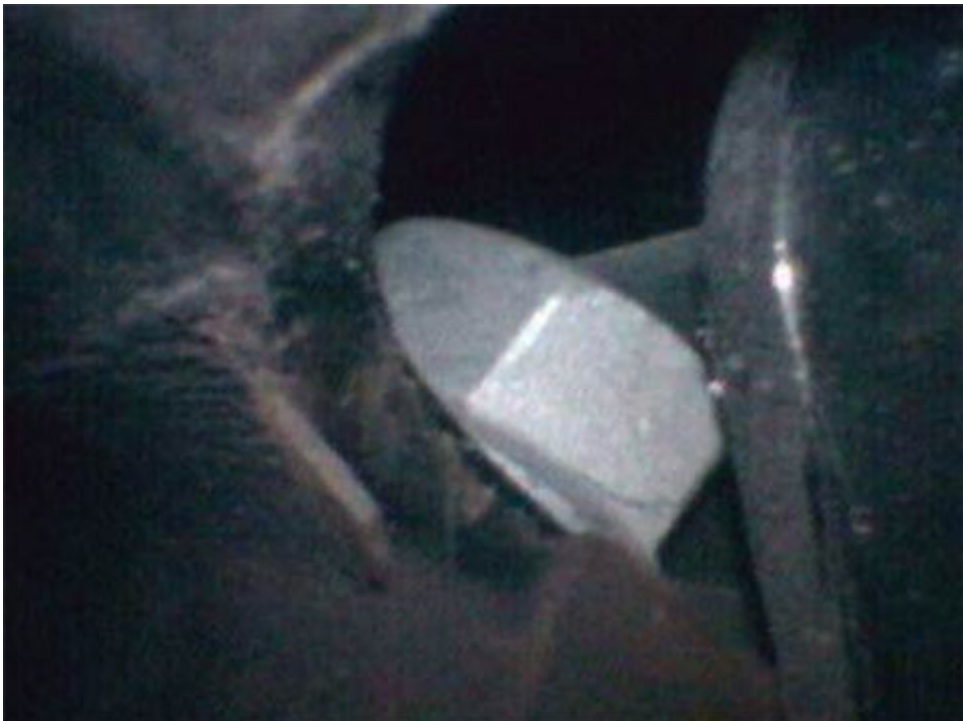
**The technician should inspect for a stray nut or debris such as a rock wedged between the rubber and metal portions of the transmission mount.**

**This debris can be very difficult to find. The technician may have to use a borescope to locate it. See pictures below.**

**Loosen the transmission mount fasteners and manipulate the mount to allow removal of the stray debris.**

**Torque all fasteners back to specification.**
