Preliminary Information

PIT5666B Squeak/Creak/Squawk/Itch Type Noise Heard From The I/P or Center Console Area

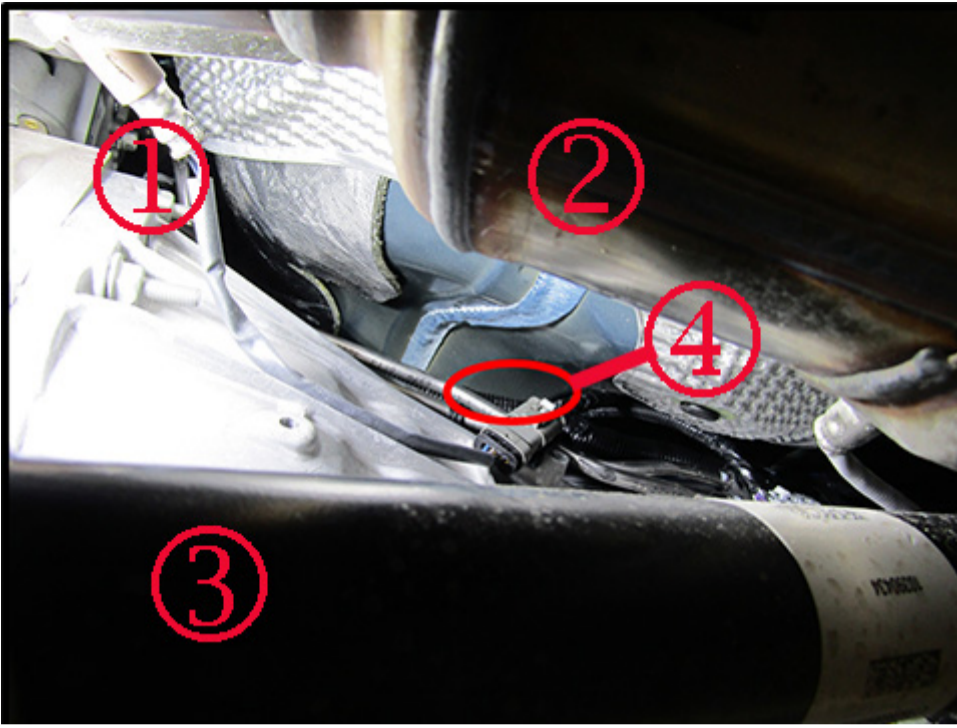
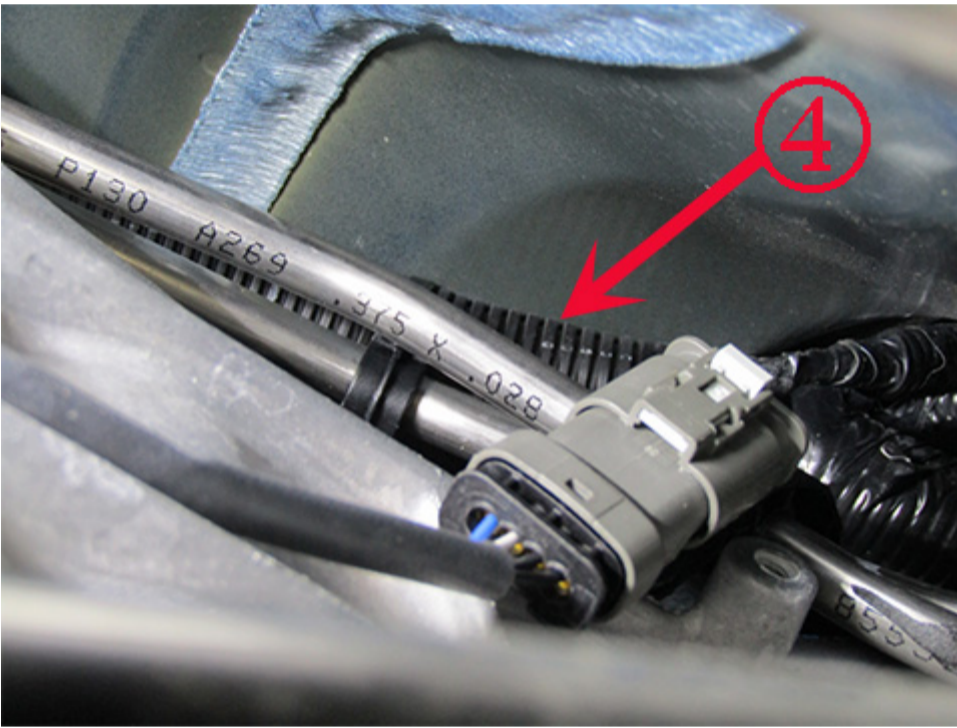
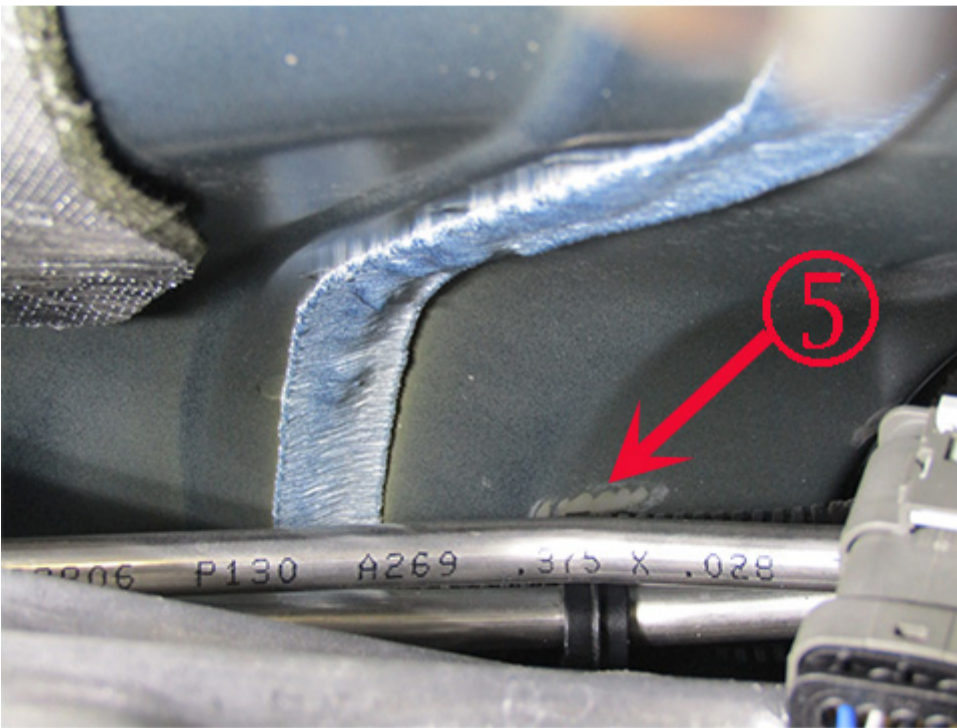
Involved Region or Country	North America
Condition	<p>Note: The Labor Code in this PI should not be used if it wasn't the root cause of the customer's complaint.</p> <p>Some customers may comment of a squeak, creak, itch, or rubber type noise heard from the IP dash or center console area. The noise may be duplicated by the following:</p> <ul style="list-style-type: none"> - Driving over bumps (noise may go away if coasting or if transmission is shifted into "N") - During acceleration - Brake torqueing in drive (noise may not occur when brake torqueing in reverse)
Cause	<p>This noise could be caused by the engine harness rubbing on the floor pan above the transmission (item numbers 4 and 5), as shown below. The photos below were taken from under the vehicle looking up along the driver's side of the transmission bell housing.</p> <p>Callout 1 - Bank 1 Sensor 1 O2 sensor Callout 2 - Bank 1 Catalytic Converter Callout 3 - Front Driveshaft (on 4WD vehicles) Callout 4 - Engine Harness rubbing on floor pan Callout 5 - Engine Harness pushed aside to show the contact on the floor pan</p>

Reposition and secure the engine harness down beside the fuel/evap lines so it no longer contacts the floor pan, as shown below. The rear transmission crossmember may need to be removed so that the transmission can be slightly lowered to gain access to the area. To allow enough slack in the engine harness to reposition it down

beside the fuel/evap lines, it needs to be moved/repositioned forward in the clips at the rear of the harness above the rear of the transmission/transfer case. First, release the rear harness clips and move/reposition the harness forward in the clips, then lock the clips closed. This will create enough slack in the harness to reposition and secure the harness down beside the fuel/evap lines, as shown below.
