Bulletin No.: PIT5834

**PIT5834 A/C Blows Warm Intermittently Or Takes A Long Time To Start Cooling. Vehicles With 11th VIN digit Is S Built Between 09-08-2020 And 09-15-2020**

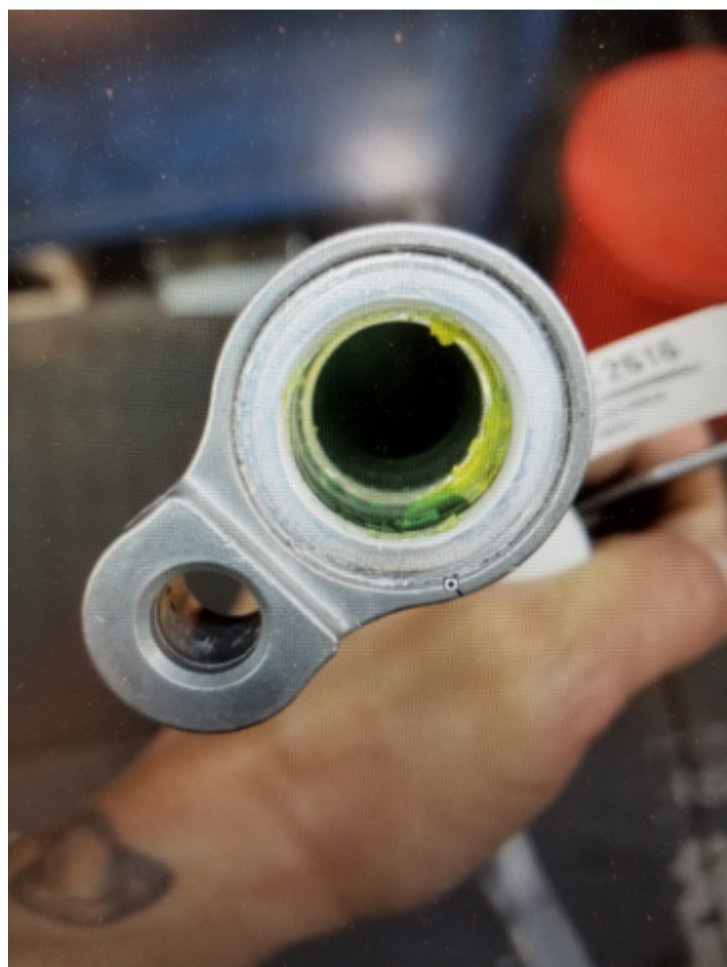
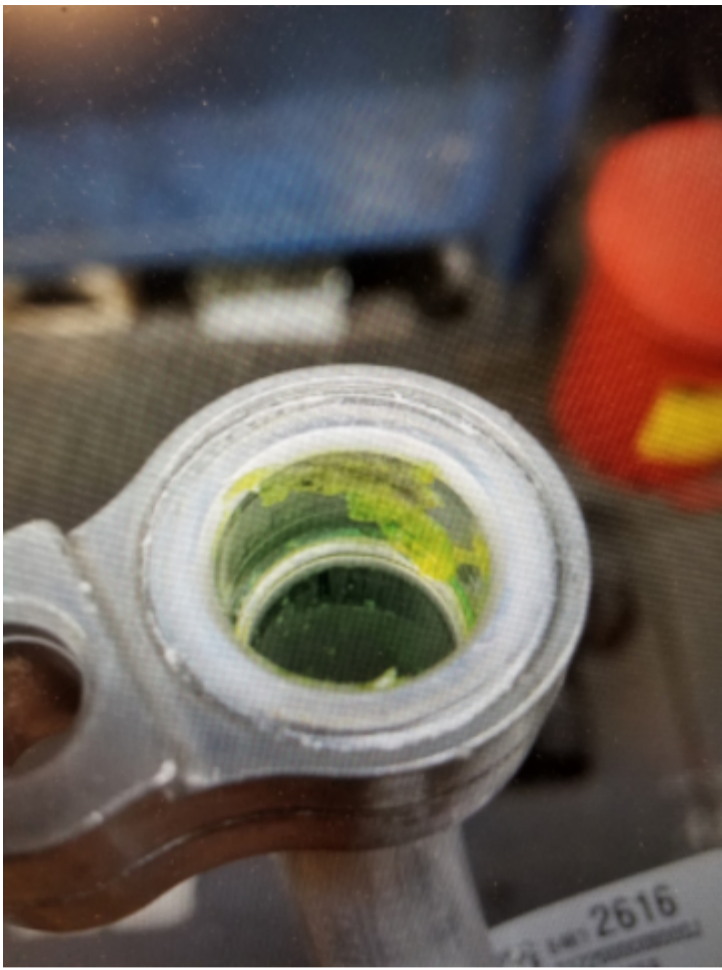
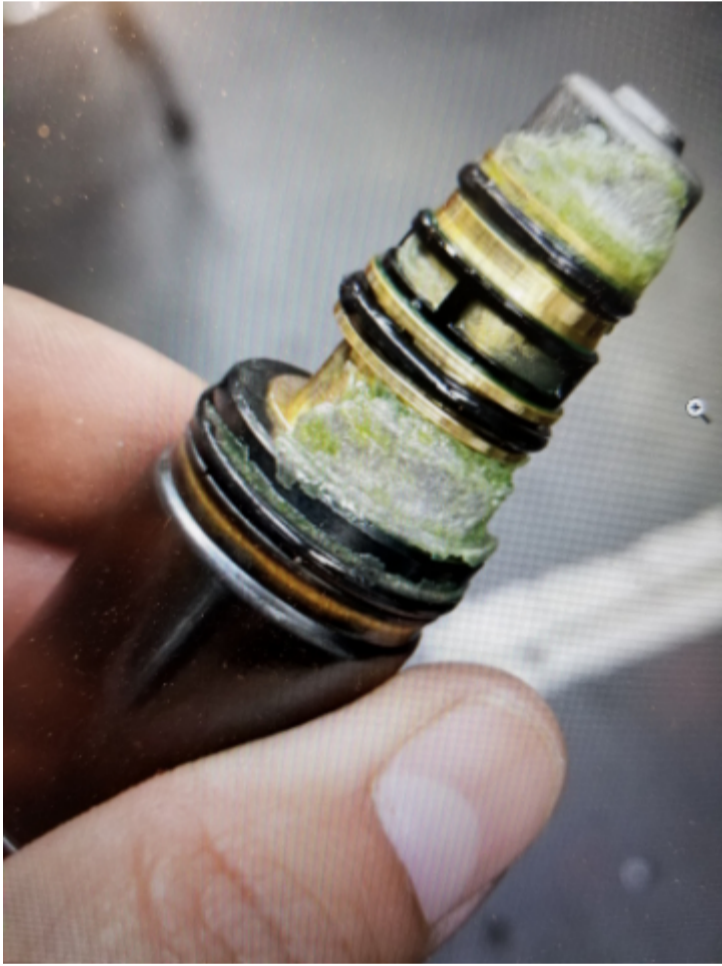
<b>Involved Region or Country:</b>	<b>North America</b>
<b>Condition:</b>	<b>A/C is slow to cool, takes longer to blow cool air when compared to like vehicle.</b>
<b>Cause:</b>	<b>Possible A/C refrigerant contamination.</b>

If you duplicate this condition and there is a noticeable performance difference when compared to another Blazer or Equinox and the vehicle was built during the above time period , recover the refrigerant using the GE-50957 Contaminated Refrigerant Recovery Machine. Remove the line from the condenser and the TXV and look for contamination like illustrated in the pictures below. If you have this contamination, take pictures of the fittings, open a TAC case and attach them to the case. Your case will be reviewed and you will be contacted directly. If you do not see visible contamination like below reinstall the lines and diagnose using the performance chart and diagnostics in Service Information.
