## PIT5835 Sill Plate Lightening Inoperative After Installing LPO Illuminated Door Sill Plates

Brand:	Model:	Model Years:	VIN:		Engine:	Transmissions:
			from	to		
Cadillac	Escalade Models	2021	All	All	All	All

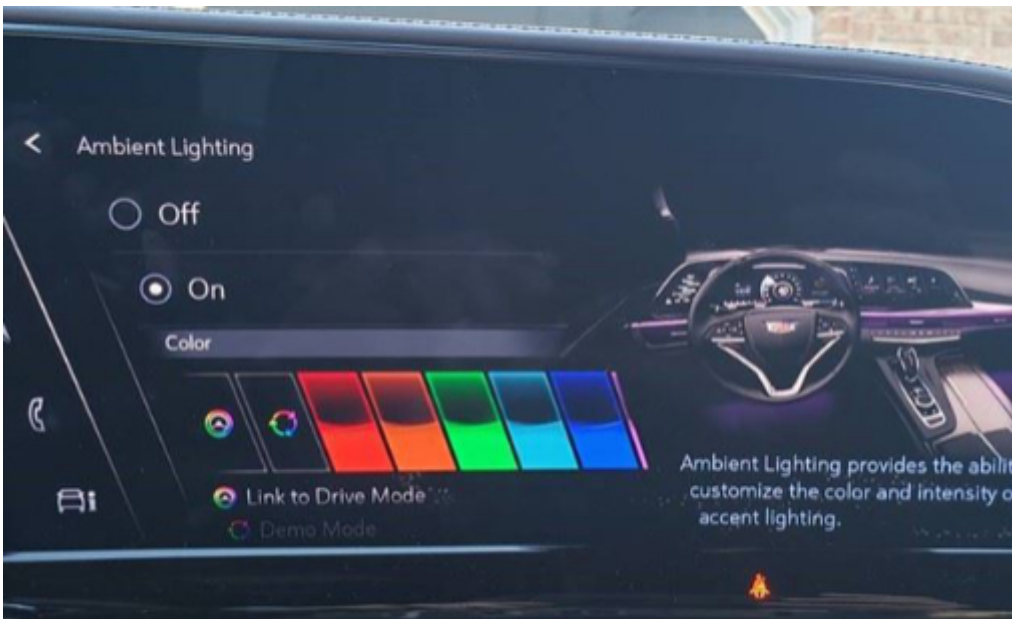
Involved Region or Country	North America
Condition	Some technicians may notice that the Sill plate lightening is inoperative after installing the LPO Illuminated Sill Plate kit as per document id: 5400715.
Cause	<p>This may be caused by one of the following reasons:</p> <p>1) The light sensor needs to see a dark condition. To insure the vehicle is in the night mode, cover the ambient light sensor, and ensure the headlights tell tale is illuminated on the IPC.</p> <p>2) The Ambient light sensor setting in personalization under the lighting tab is turned Off. Enable ambient lighting. See Below</p>

Before extensive diagnostics are performed, please check the two items listed above.
