PIP5803A Inspection Loose Upper Bolt For Timing Chain Guide Oil Leak Front Timing Cover Removal 2.0 LTG

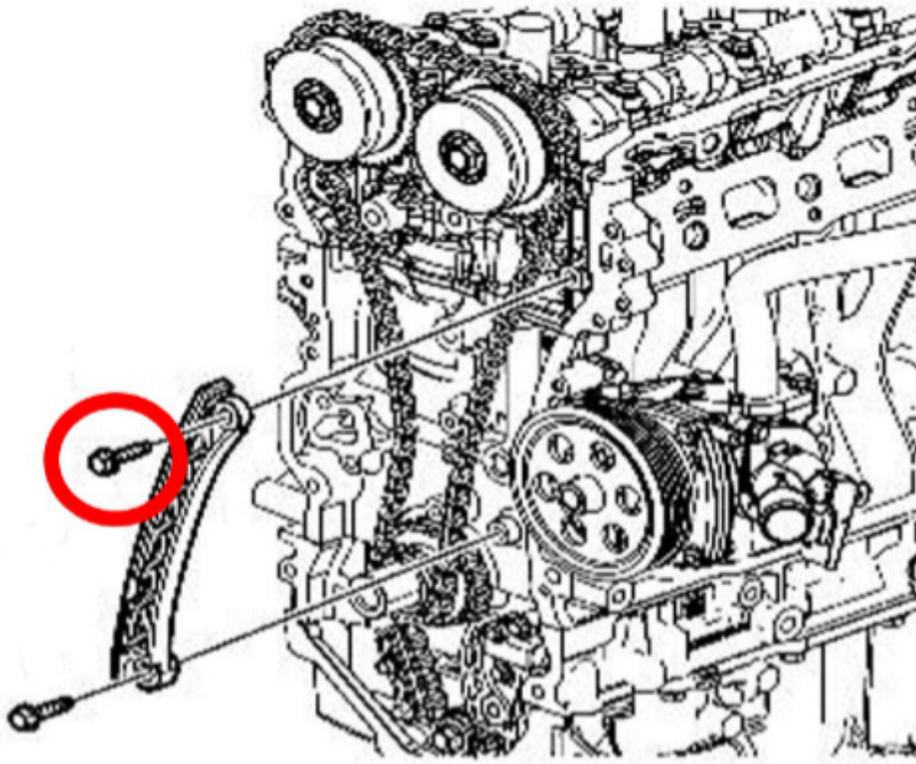
Involved Region or Country	North America
Condition	If a technician is making a repair that requires the front timing cover to be removed and finds the timing chain guide upper bolt (circled) loose enough to turn by hand, replace the timing chain guide and bolts.
Cause	The cause of this loose bolt has not been determined yet and is being investigated by engineering.

Replace the timing chain guide and bolts.
