PIP5773B DTC P0331 Knock Sensor 2 Performance Under Engineering Investigation

Brand:	Model:	Model Years:	VIN:		Engine:	Transmissions:
			from	to		
Chevrolet	Camaro	2019 - 2020	All	All	2.0 LTG	All
Chevrolet	Equinox	2019 - 2020	All	All	2.0 LTG	All
GMC	Terrain	2019 - 2020	All	All	2.0 LTG	All

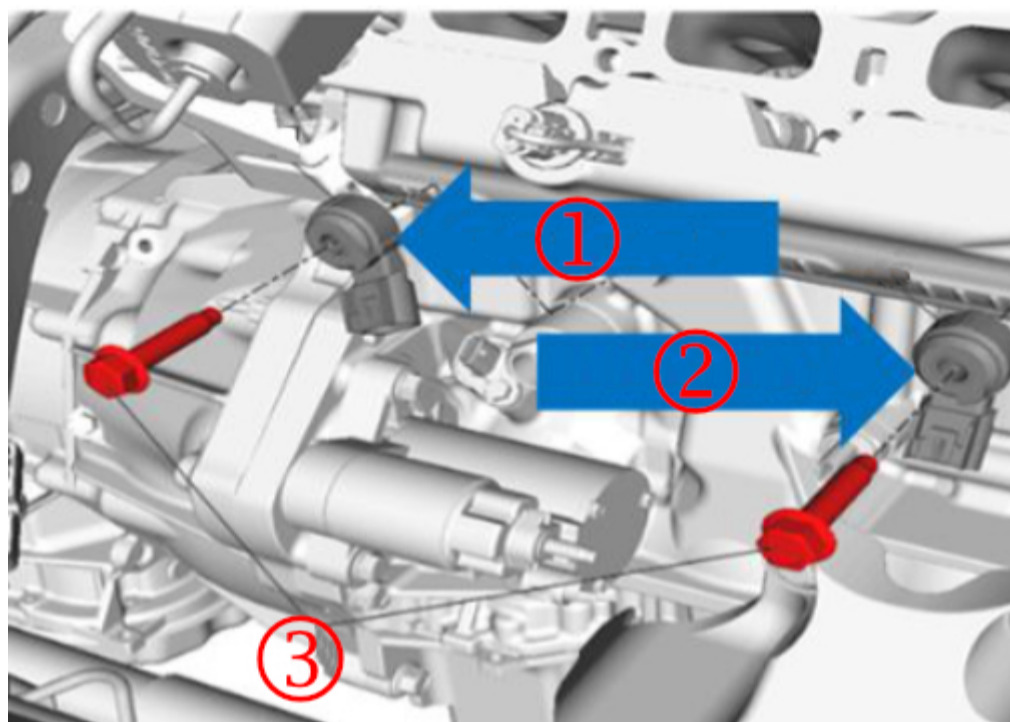
Involved Region or Country	North America
Condition	SES light on and technician may find DTC P0331 set.
Cause	The cause is unknown at this time.

1 - Knock Sensor #2

2 - Knock Sensor #1

3 - Bolts for knock sensors

Perform a visual inspection to make sure the wire harness is connected and the sensor is bolted into place.

If no trouble found, do not replace any parts, clear the code and return the vehicle back to the customer.
