PIT5836 Diagnostic Tips For Park Assist Off Message / Unwanted Or False Park Assist Alerts / No DTCs

Models

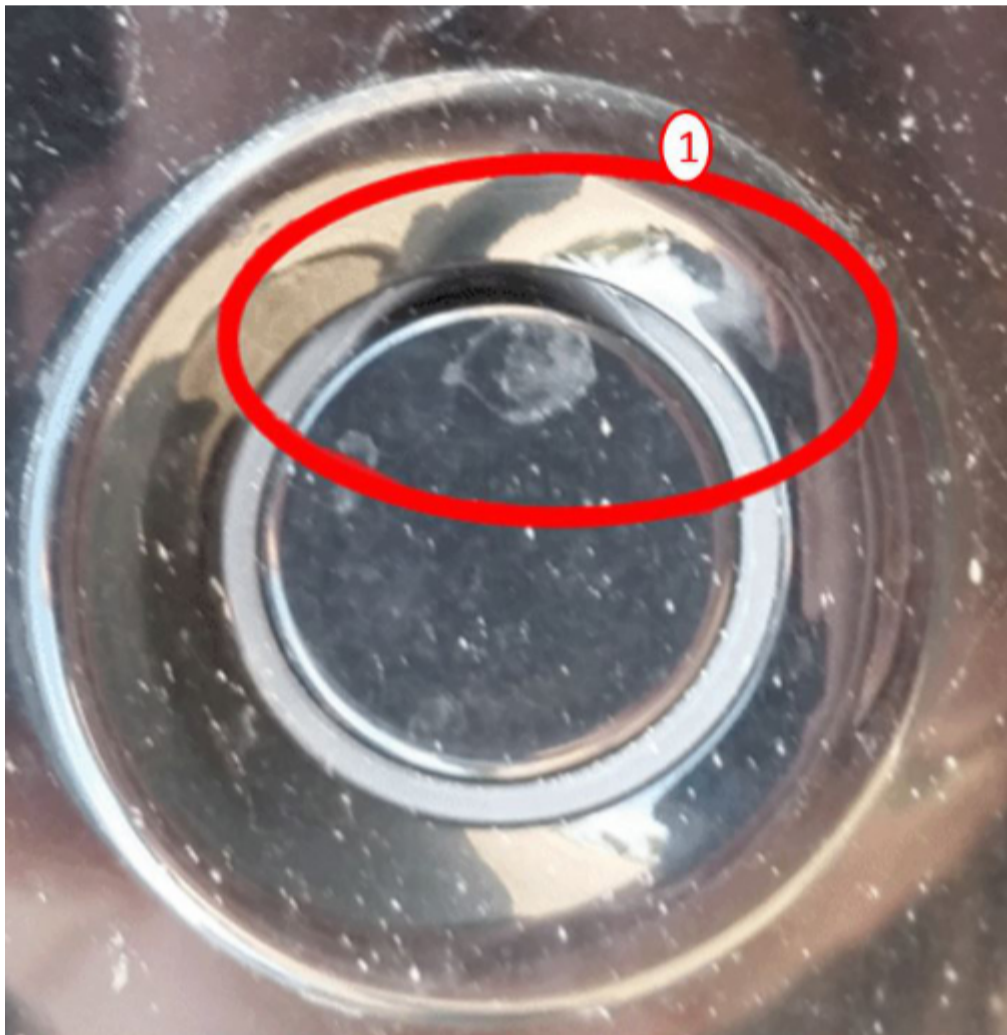
1. Perform a visual inspection of the park assist sensor(s) and bezel(s). Look for any stone chips/dents, paint chips, damage, etc., as well as, any issues with the silicone ring. See example (1) below of a silicone ring which is not properly installed. If any issues are found then repair as necessary.

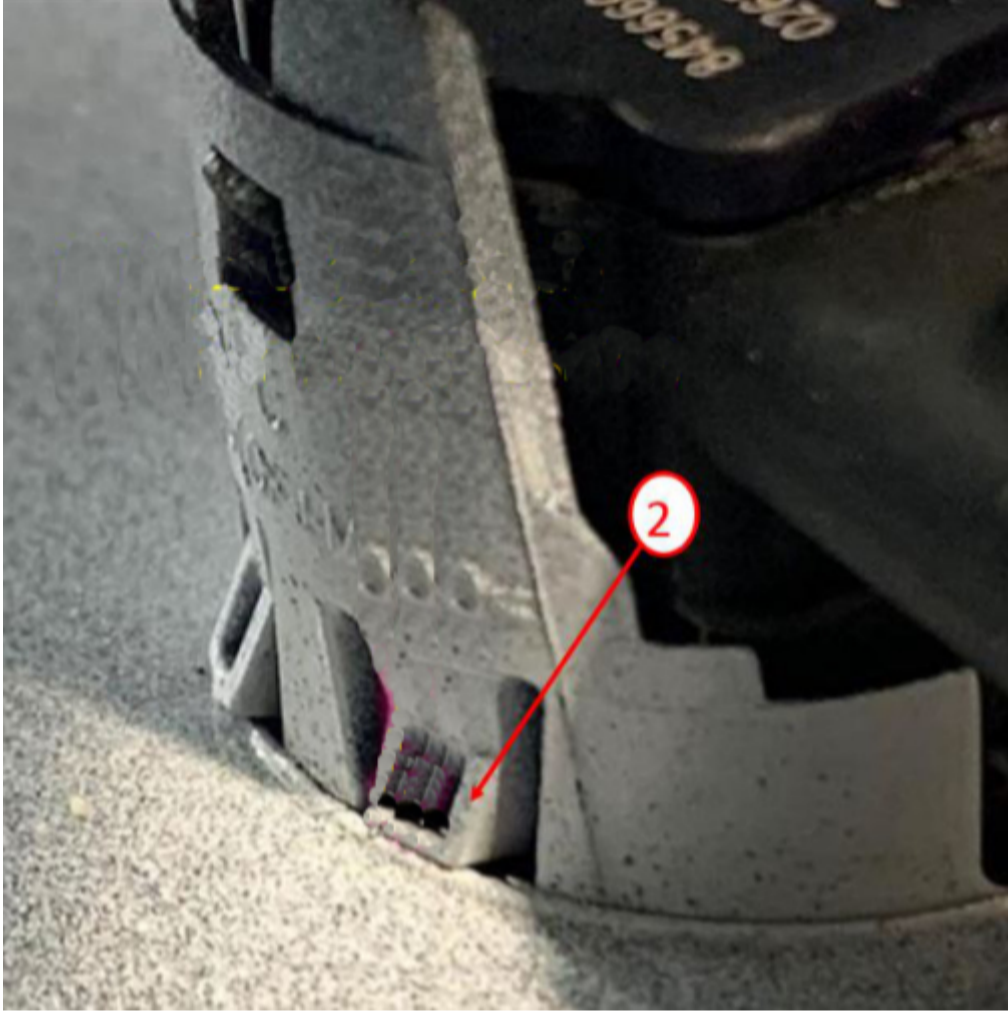
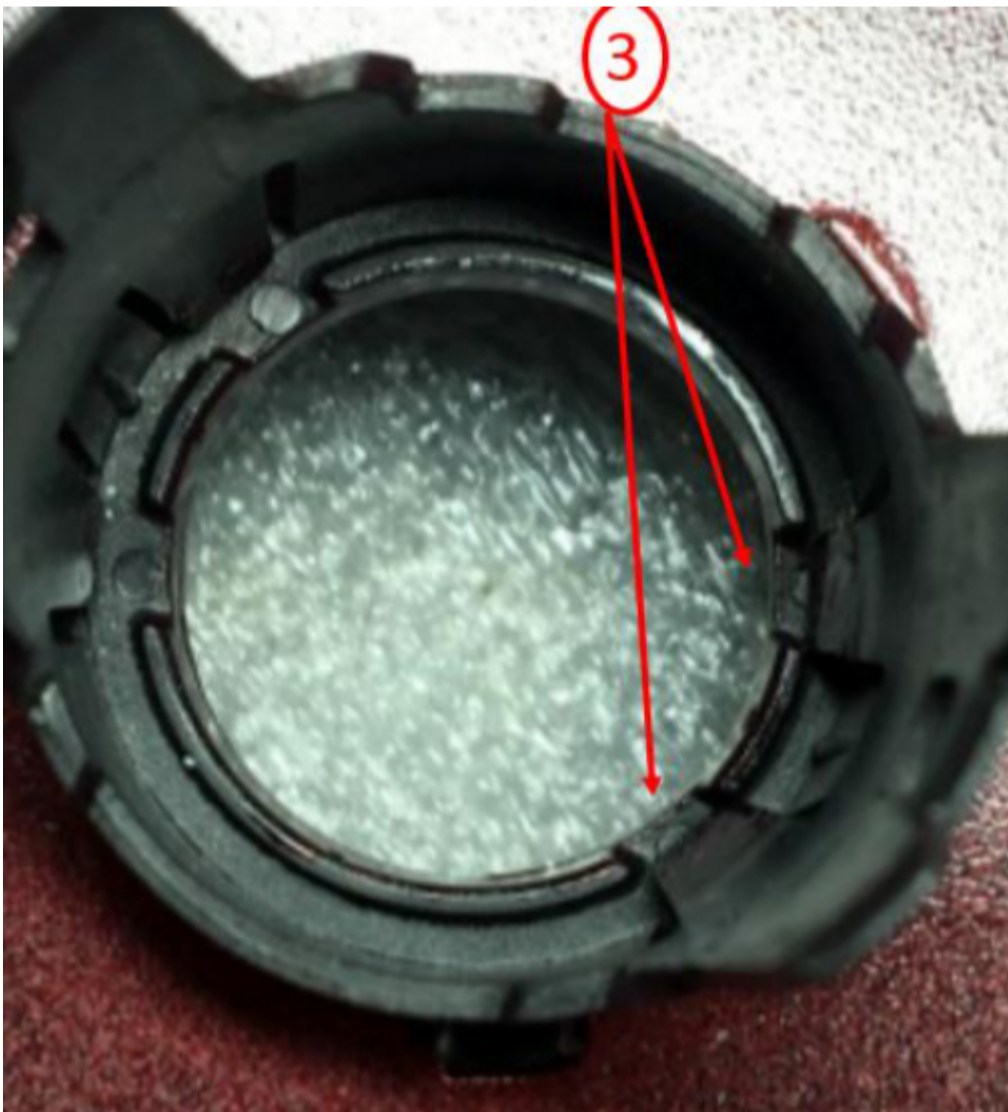
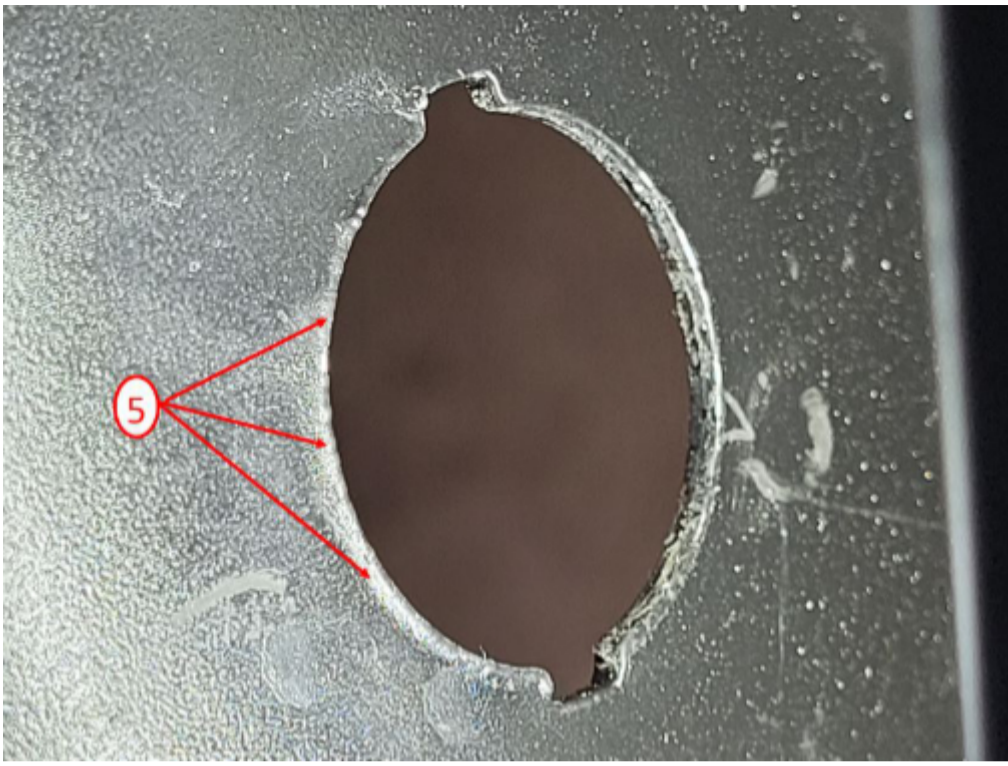
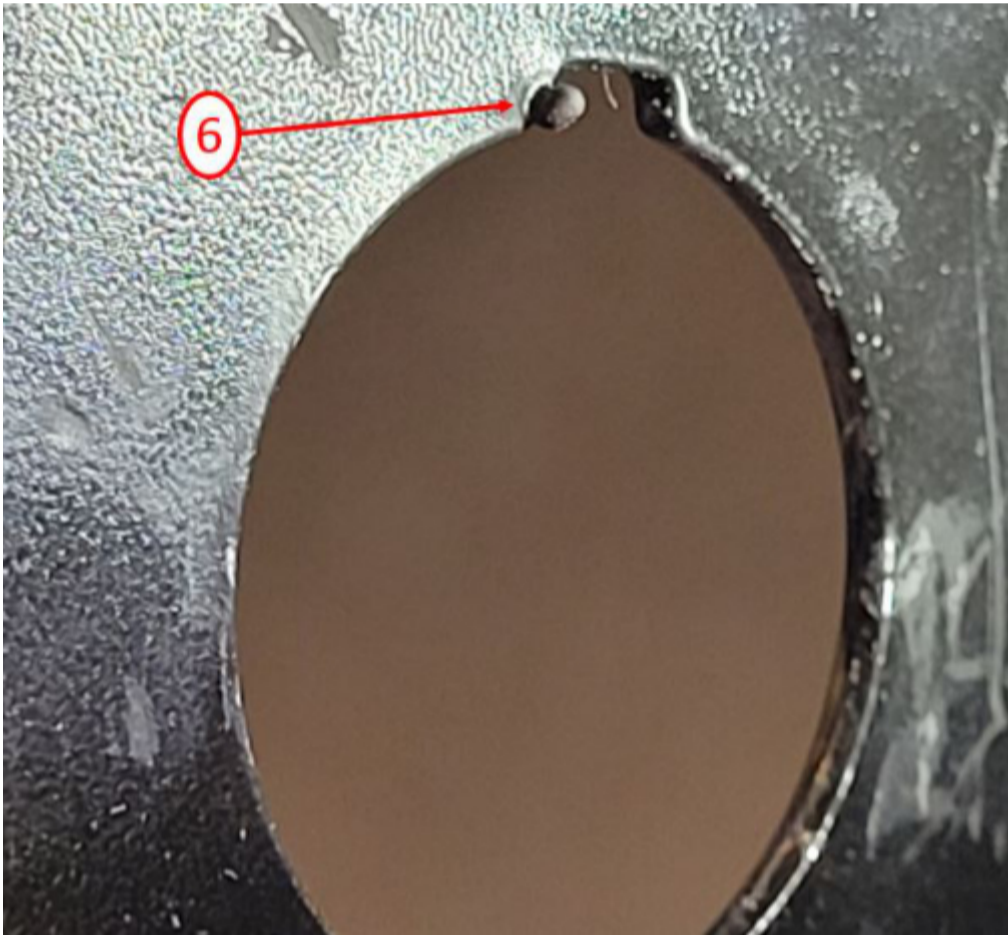
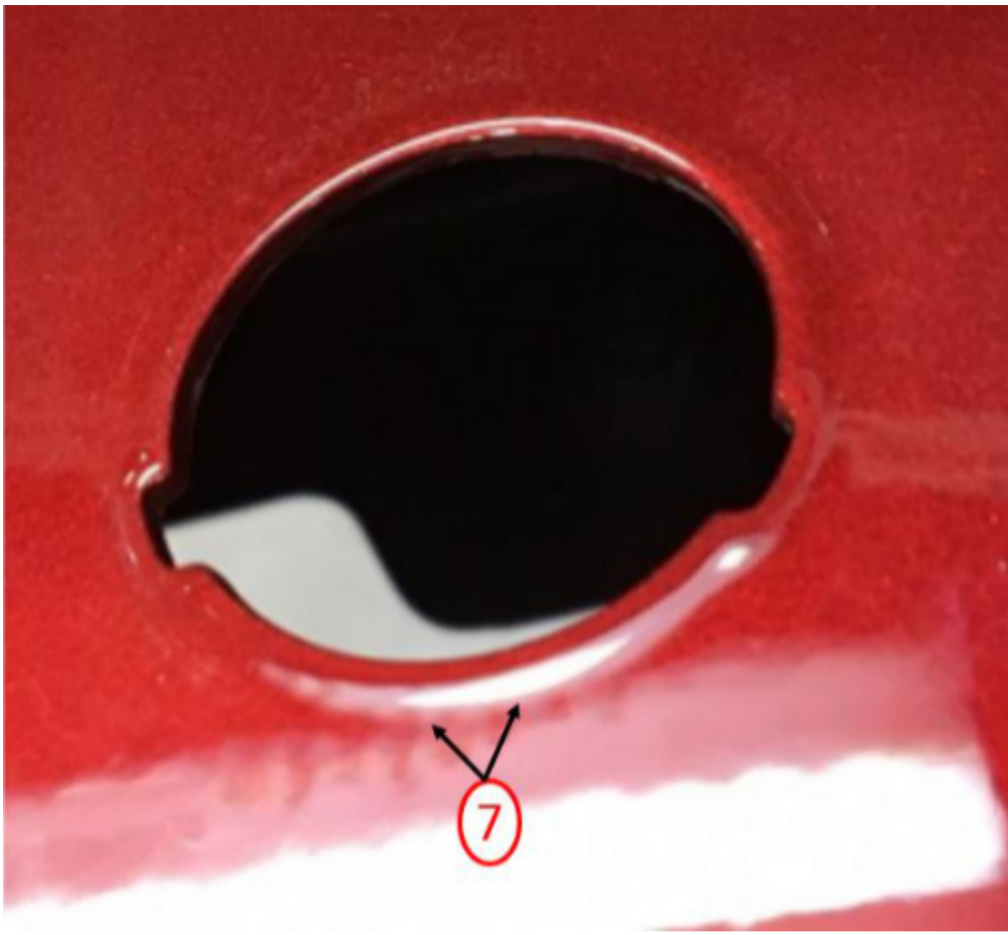
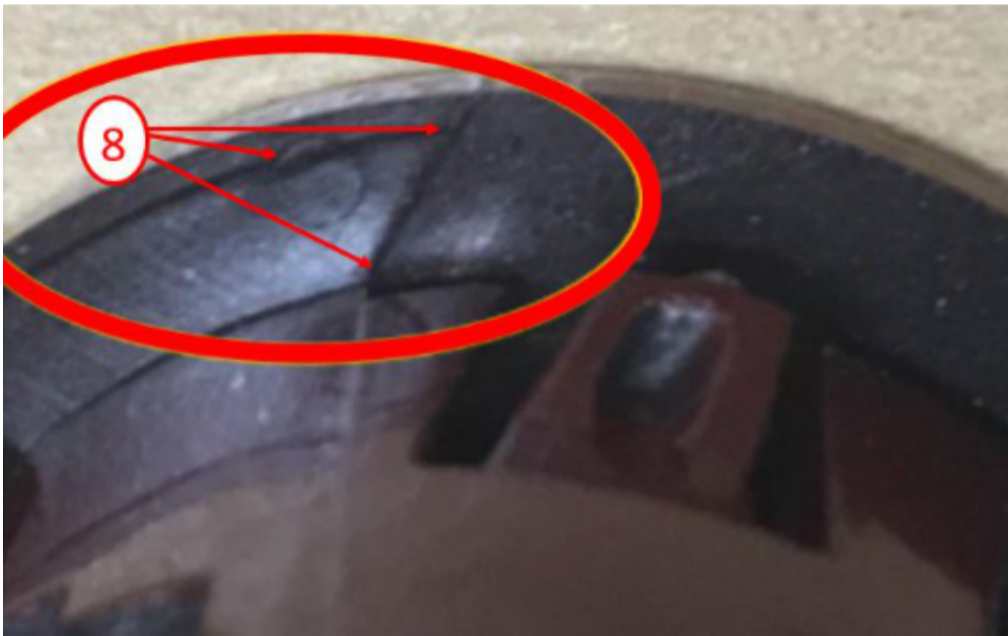
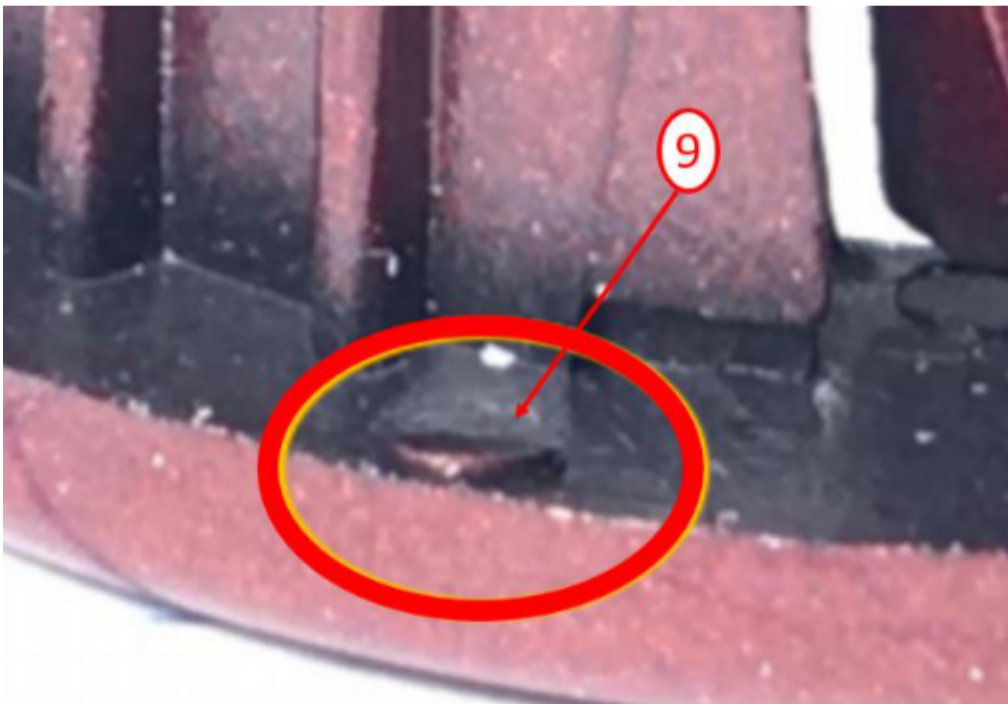
2. Inspect the park assist sensor bezel(s) for not being properly mounted in the bumper hole. If the bezel is not properly mounted into the bumper hole it can lead to a sensor grounding out or the sensor getting squeezed. The bezel has four locking tabs that secure the bezel to the bumper. Make sure all four mounting tabs are fully engaged. See example (2) for a mounting tab that is not fully engaged (view from the back side of the bumper/bezel). If any tab is not fully engaged it can protrude into the opening where the park assist sensor mounts and cause it to ground out or get squeezed. See example (3) for a tab not fully engaged and protruding into the opening for the sensor. If any of the bezel mounting tabs are not fully engaging, inspect the following:

- Burrs on the back side of the bumper hole, see example 5 and 6
- Excessive paint/clear coat on the bumper around the mounting hole, see example 7.
- Plastic flashing on the park assist sensor bezel itself, see examples 8 and 9.
- Inspect the bumper hole for being slightly too small. The bezel should easily slide into the bumper hole without force.

If any of these concerns exist, then use a file or grinding wheel to remove any burrs or flashing. If needed, enlarge the bumper hole opening. On any exposed/bare metal apply an Anti-Corrosion Treatment, see Document ID: 2096919. After repairing any bumper hole or bezel issues then reinstall the bezel and make sure the four mounting tabs are fully engaged and then reinstall the park assist sensor. There is no need to replace the bezel or sensor unless they are damaged.

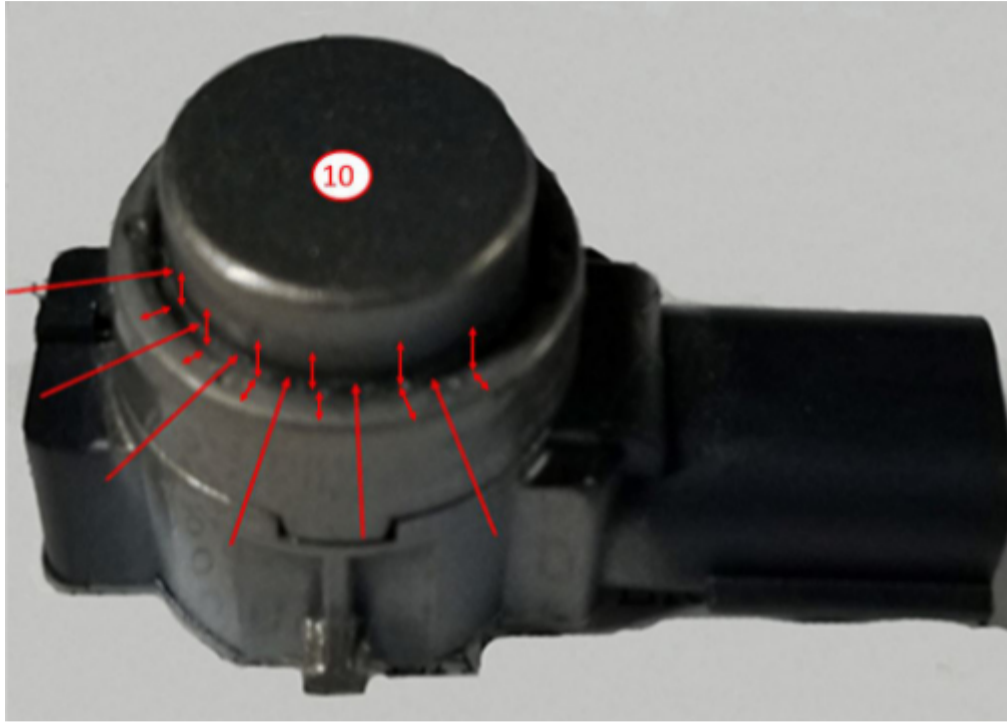
3. If the park assist sensors have been painted, it is important that only the tip of the sensor is painted and clear coated. The tip of the park assist sensor is isolated from the rest of the sensor body by an internal decoupling ring. If paint or clear coat is allowed to run or drip down the sides of the sensor's tip and/or into the gap between the body and sensor tip, as shown below, this can cause the sensor to ground out.
