Preliminary Information

PIP5598D Diagnostic Tip: Possible Crank No Start Or Extended Crank And Potential DTC P0014 P0017 P0365 P0366

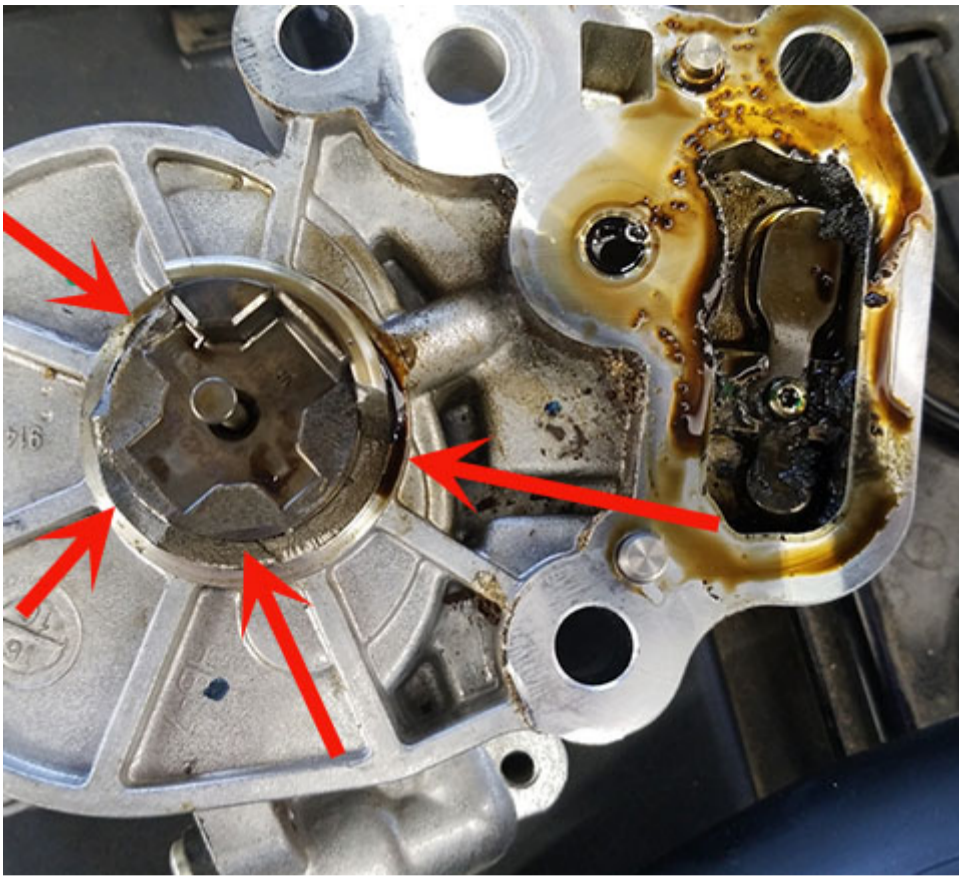
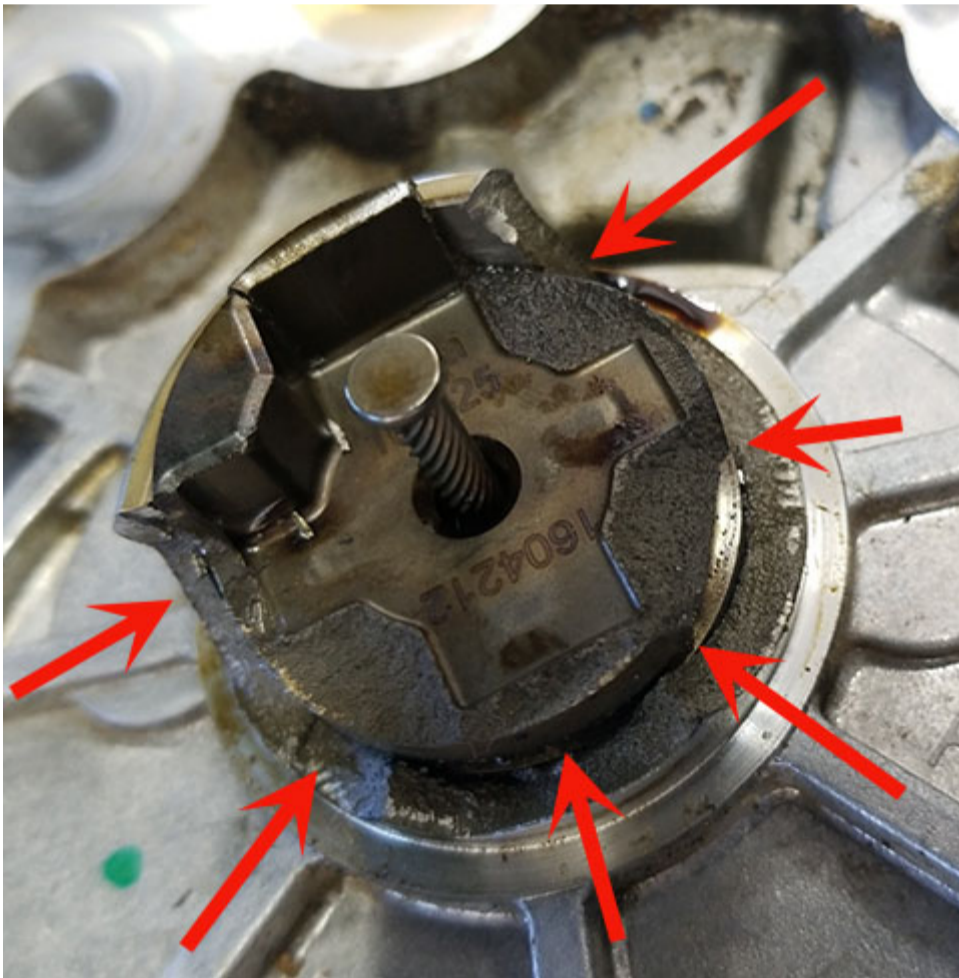
Remove cam cover assembly and perform steps below to confirm exhaust camshaft reluctor orientation. During disassembly the vacuum pump drive lugs should also be inspected for damage. (Photo below show damaged vacuum pump drive lugs)

If you find the vacuum pump drive lugs are broke and/or the exhaust camshaft retractor is out of position then replacement of the exhaust camshaft and vacuum pump will be required.

Note: If needed, It will also be necessary to locate and remove the broken vacuum pump drive lugs and other metal debris during repairs.

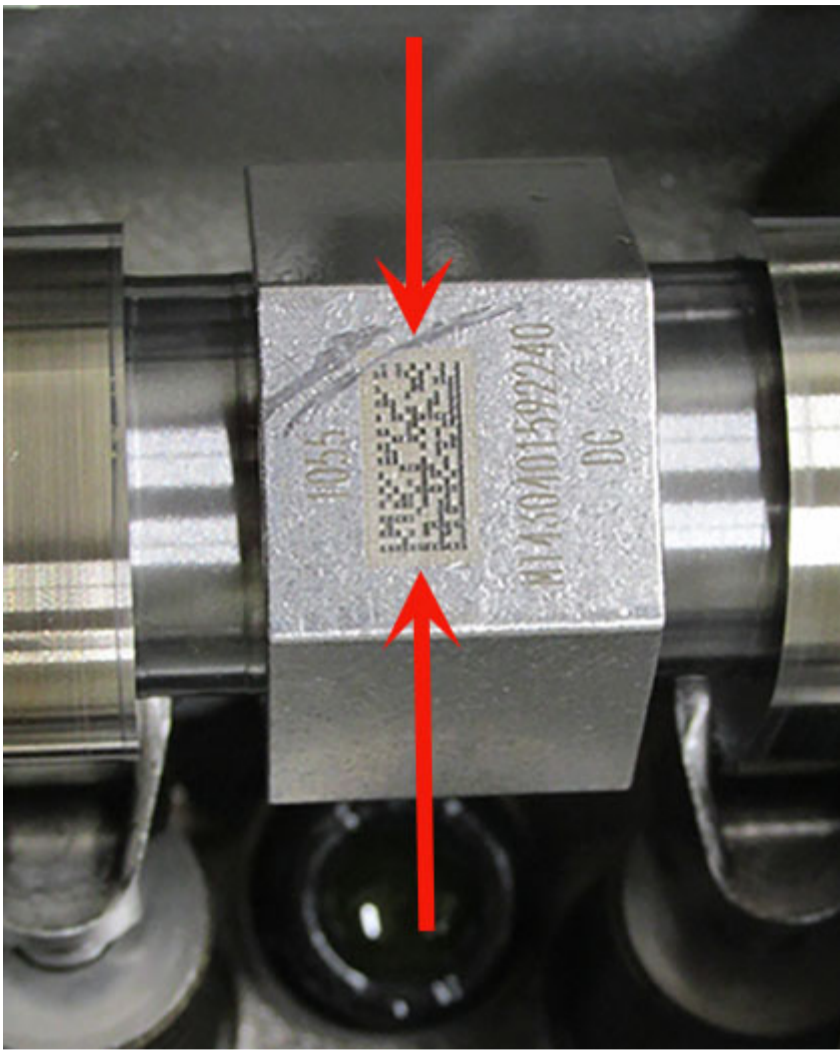
Rotate the exhaust camshaft to position the 2D matrix marking on the camshaft hex in the 12' O'clock position.
(Reference photo below for 2D marking.)

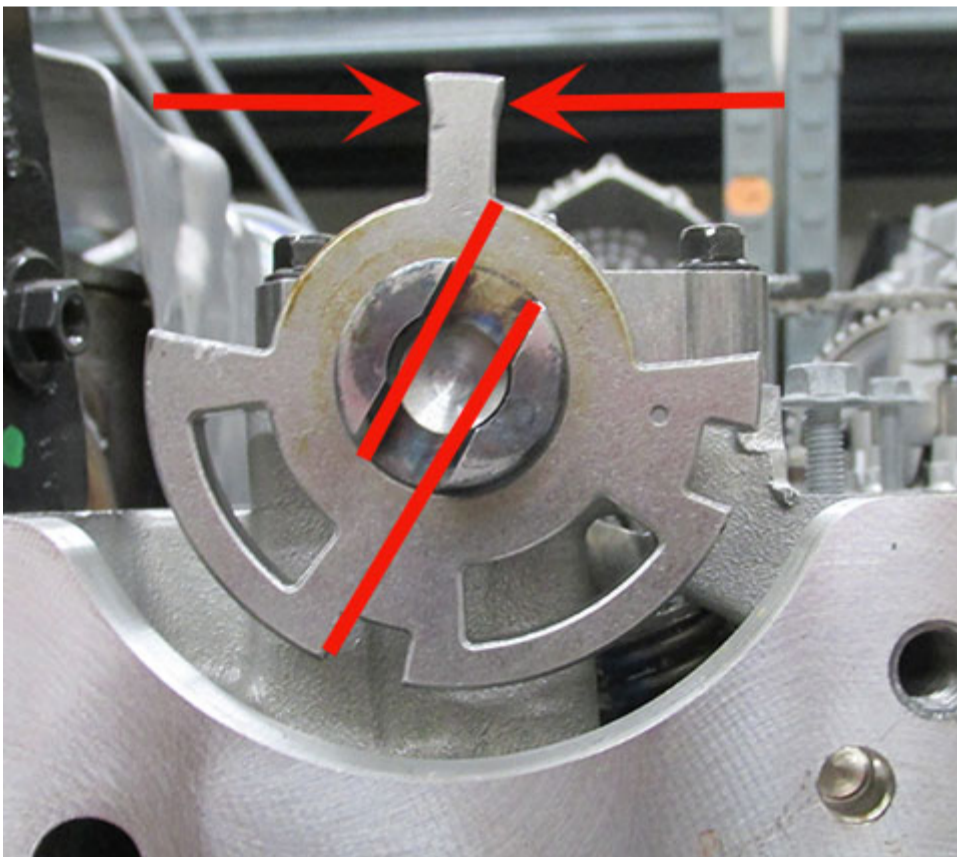
Once the exhaust camshaft 2D matrix has been positioned at 12' O'clock. Verify the small tang located on the camshaft reluctor ring (Arrows below showing tang on reluctor) is inline with the 2D matrix marking. Also shown are additional reference points used to verify exhaust cam reluctor orientation to camshaft.

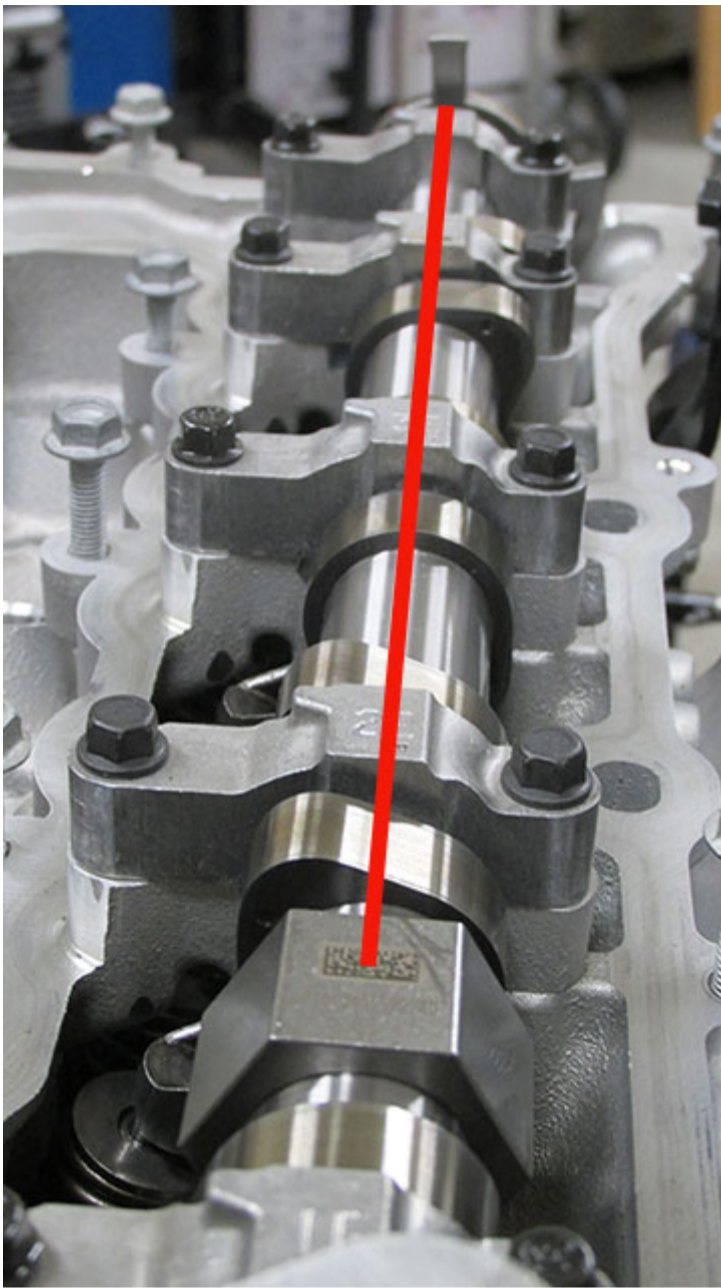
Photo below is showing the proper relationship between the 2D matrix marking and the small tang on exhaust cam reluctor wheel.
