Preliminary Information

PIP5748F Particulate Matter Sensor Protection Tube Performance Diagnostic May Set A False DTC P1488 or P24DA

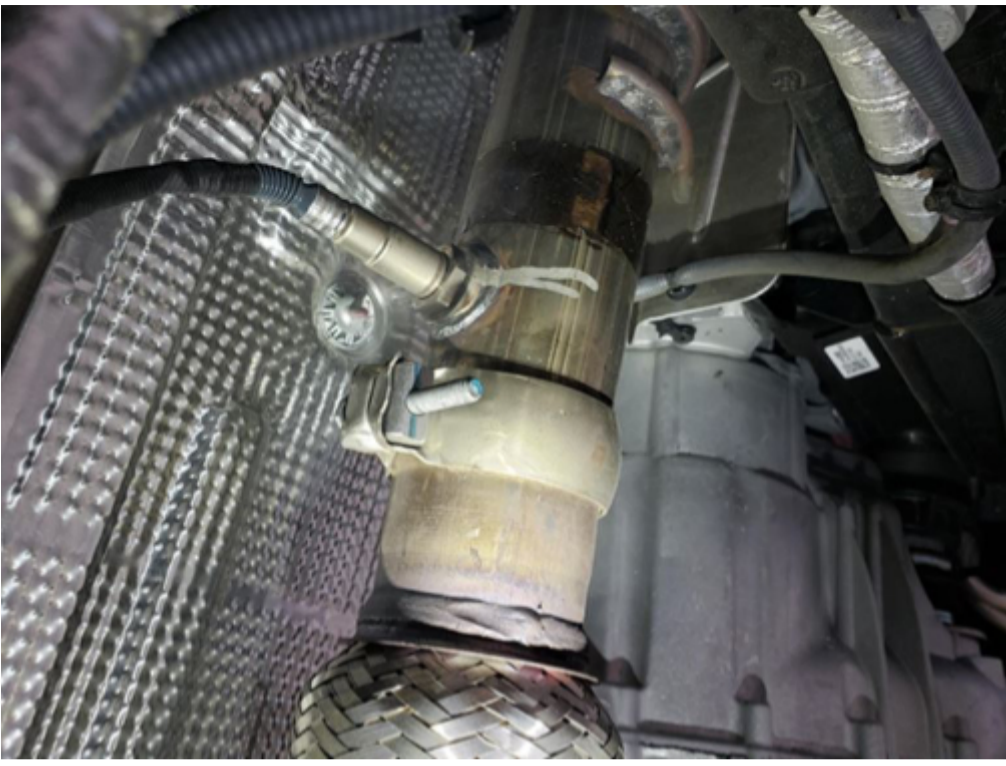
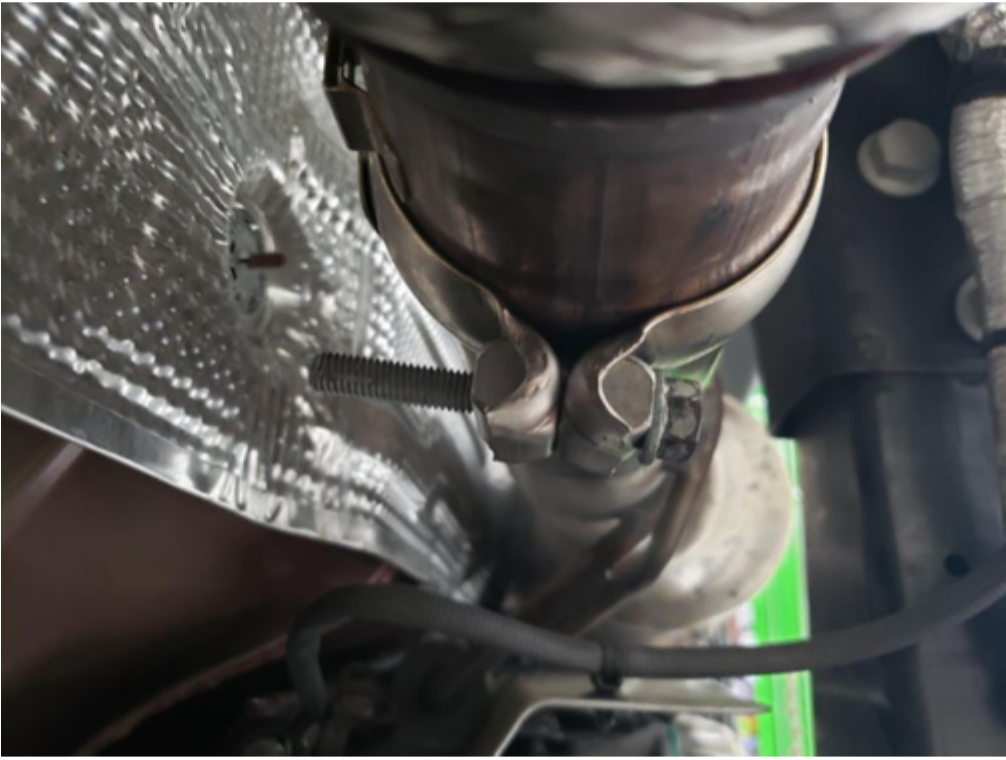
To test for leaks in the exhaust use the Power Smoke diagnostic leak detector (GE-52250 - refer to the latest version of [PIP5684](#)), but there are two important considerations. The smoke from the tester may not get through the DPF, so to test downstream of the DPF, administer the smoke downstream of the DPF. Also, the tailpipe sealing bladder doesn't reach the exhaust cooler so use duct tape around the pipe to seal the cooler holes. Repair any leaks as necessary but pay particular attention to the joint illustrated in the pictures below.

If this joint is leaking the clamp may have bottomed out before applying sufficient clamp load to the joint, or damage may have occurred from mis-alignment of the joint. Also, misalignment of the joint may contribute to the P1488/P24DA setting, even if the joint does not leak.

Separate the joint and check the witness marks for proper alignment. If the joint was found to be leaking, also inspect for deformations to either half of the joint and replace the components as necessary. If the clamp was found to be bottomed out, replace the clamp.

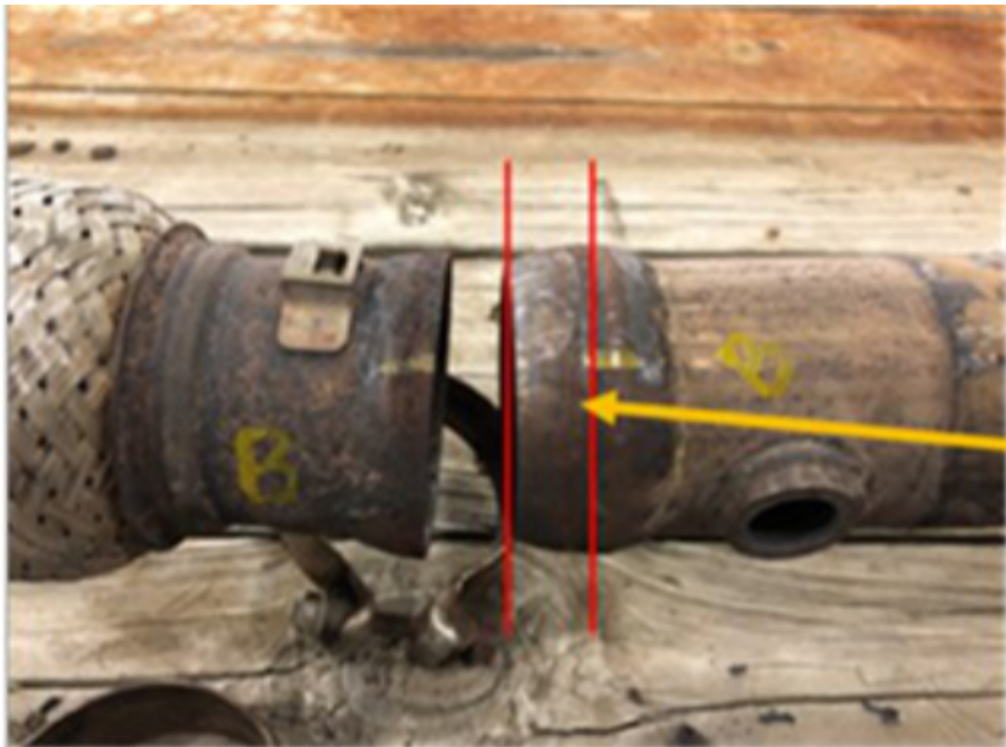
These witness marks indicate proper alignment

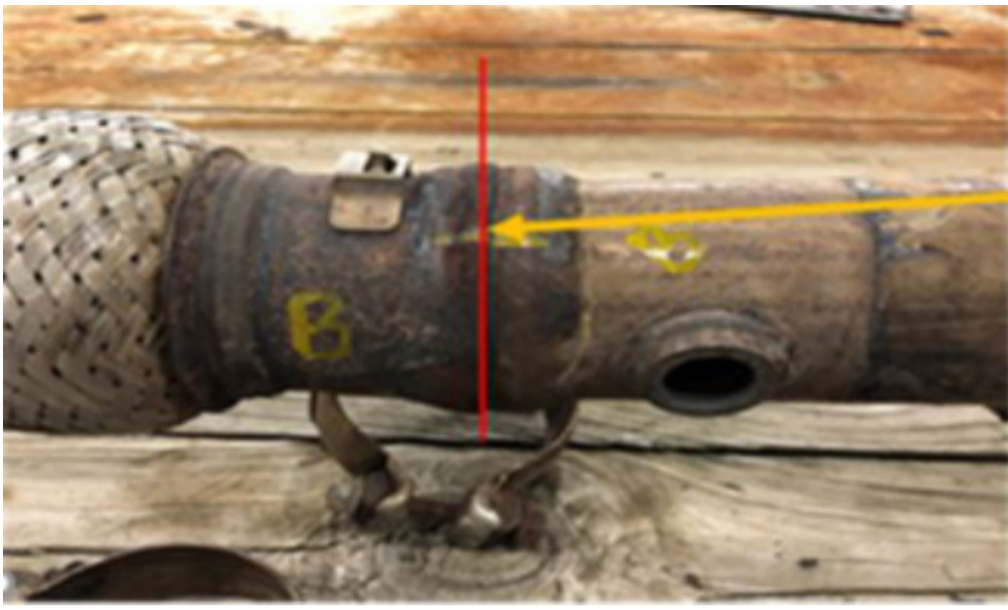
These witness marks indicate improper alignment
