TECHNICAL SERVICE BULLETIN

2020-2021 Mustang Shelby GT500 - Hood Inner Panel Cracks

21-2155

Ford 2020-2021 Mustang Shelby GT500

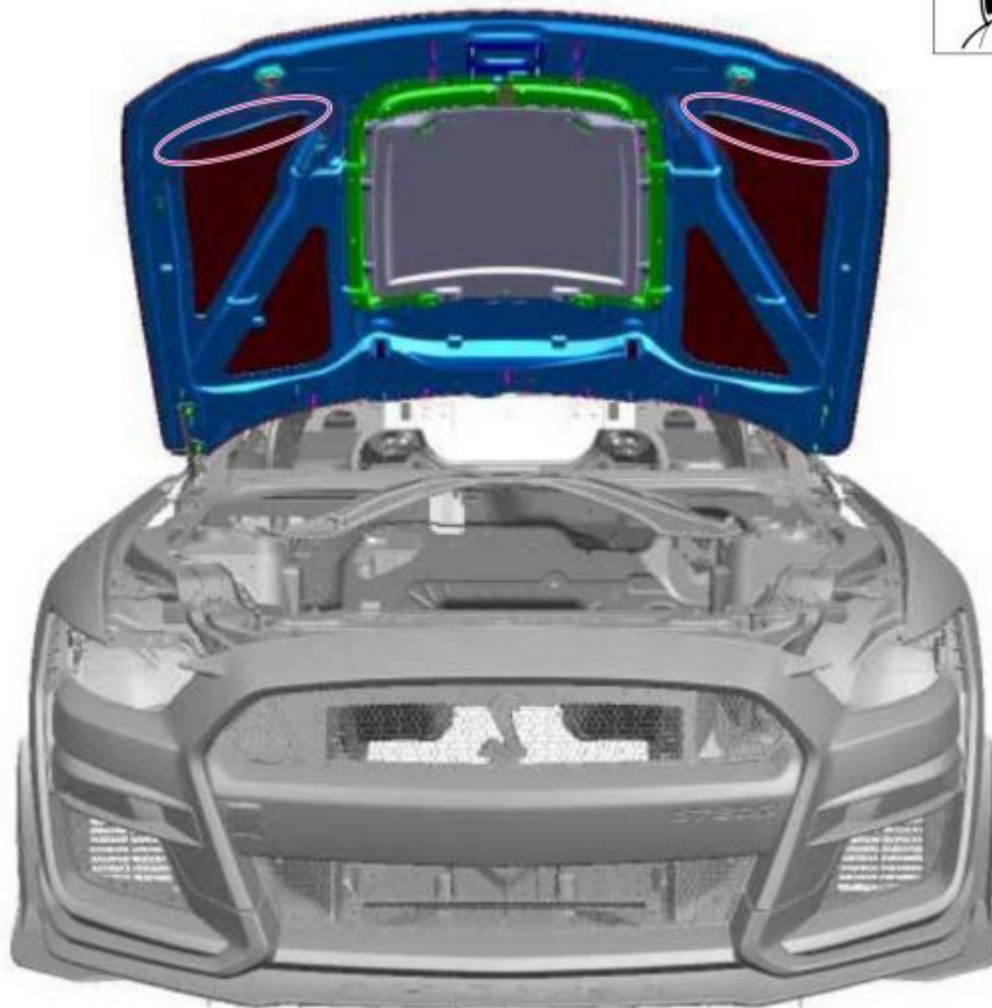
Figure 1

Issue: Some 2020-2021 Mustang Shelby GT500 vehicles may exhibit a cracking on the hood inner panel. The crack is a cosmetic condition, not a structural concern. This may be due to a variation in production of the hood. To correct the condition, follow the Service Procedure to repair the hood crack.

1. Lightly sand the affected area using 400-600 grit sandpaper.
2. Prepare the cracked surface by spraying an alcohol/water mixture on a microfiber cloth and using it to clean the surface.
3. Create typical body filler by mixing resin and hardener following manufacturer specifications. Mix enough to last 2 minutes.
4. Using a plastic blade, apply thin layers to fill the void. Use a front, back, and side to side motion. Make sure the material is bordered on all sides.
5. Allow the body filler to dry for a minimum of 15 minutes or as specified by manufacturer.
