05/31/2019
CAL WS 49-001

Subject: ATD Inlet Pipe Bellows Assembly

**Models Affected: Specific Western Star 4900 Low Max Car Hauler
Model Year 2017 through 2020 vehicles manufactured from January 1, 2016 to June 31, 2019.**

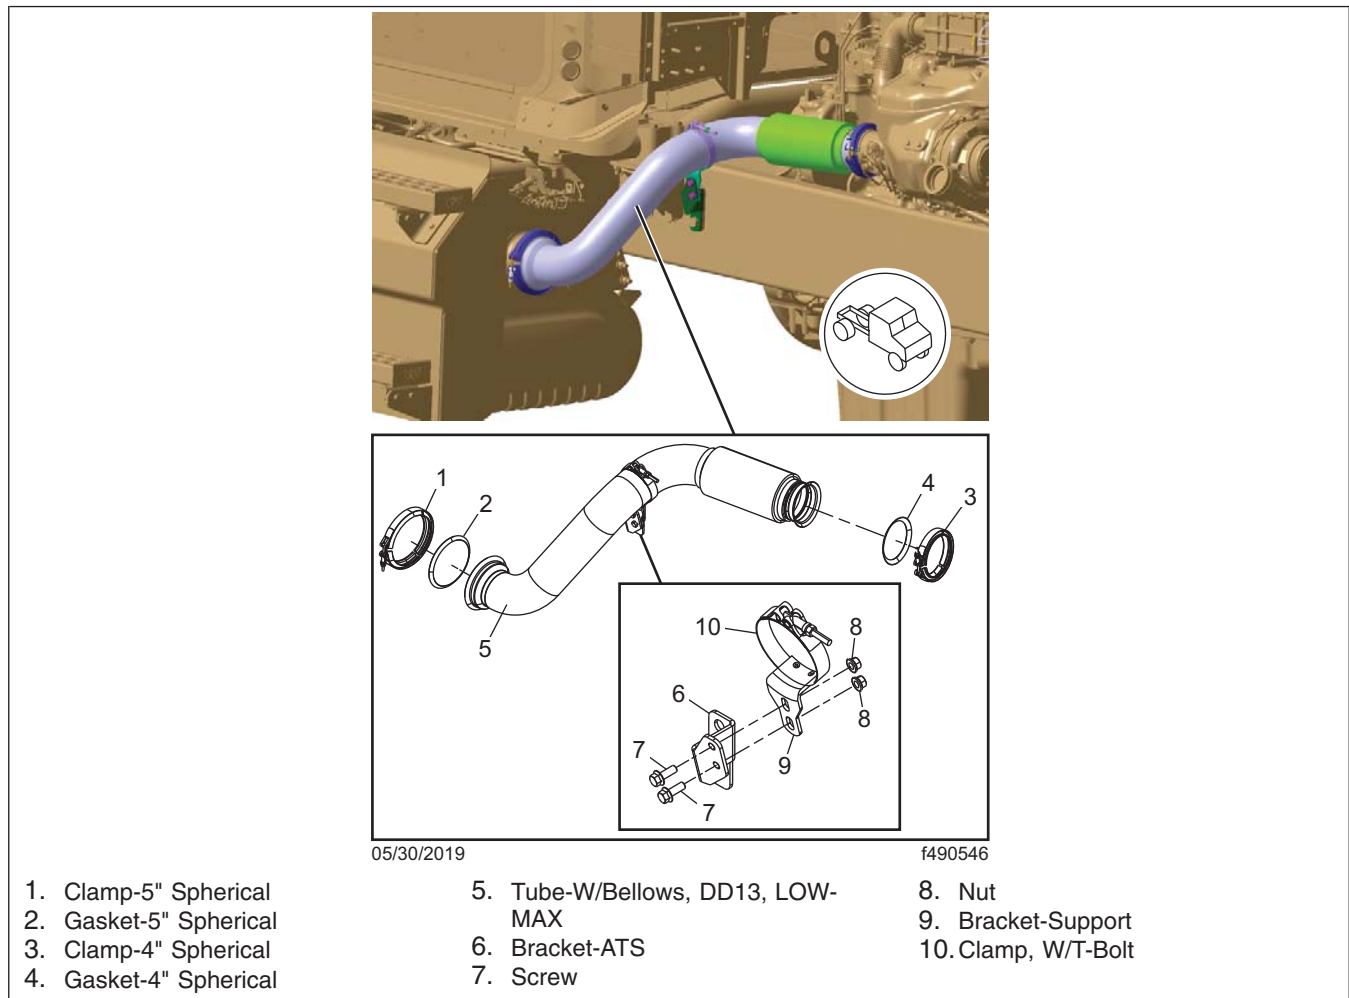
Fig. 1, Bellows Assembly

Some Western Star Low Max 4900 Car Hauler applications with DD13 GHG17 engines containing bellows pipe part number 04-32700-000, may experience high failure rates due to cracking at the ATD flange. Western Star will be providing a modified pipe to mitigate the cracking issue. This pipe modification will be done locally under the supervision of Transwest Truck, an authorized dealer for Western Star, and/or Western Star Management.

10. Remove the bellows and ATD inlet pipe as an assembly. See [Fig. 1](#).
