3/8/2019  
CAL 26-001

## **Subject: Missing Transmission Cooler Line Bracket and Clamp**

**Models Affected: Business Class M2 vehicles built between Au-  
gust 1, 2018 and August 30, 2018**

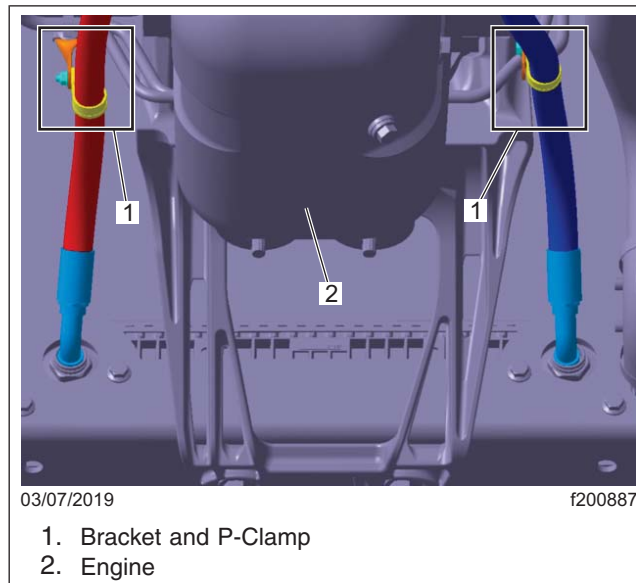
Fig. 1, Transmission Cooler Lines

Some Business Class M2 vehicles built between August 1, 2018 and August 30, 2018 do not have a bracket and P-clamp installed for the transmission cooler lines. See [Fig. 1](#) and [Fig. 2](#). The bracket and clamp prevent the transmission cooler line from rubbing on the frame rail. If the line is rubbing on the frame rail, it could lead to transmission fluid leaking at the rubbed spot, and could result in transmission failure.

If necessary, provide a copy of this letter to a service staff member at a local authorized Freightliner repair facility and have vehicles from the applicable build dates inspected for the missing bracket and clamp, and for progressive damage to the transmission cooler line. The transmission fluid should be checked if the transmission cooler line is found to be leaking. If the transmission fluid is low, but normal in appearance and smell, the transmission fluid should be topped off. If the transmission fluid is dark or smells burnt, the fluid should be drained and inspected for large metallic debris. If there is no debris in the transmission fluid, the transmission should be topped off with the new fluid. The transmission will have to be replaced if there is large metallic debris. The dealer should refer to the transmission manufacturer's literature for inspection procedures for the transmission and fluid.

If the bracket and clamp is missing on any Business Class M2 vehicle, the parts should be ordered critical by the dealer. The part number for the bracket is 23-13516-001 (BRKT-STDF,.344X.344X4.0,TWIST). The part number for the P-clamp is 23-09528-060 (CLAMP-SUPPORT,1.062 ID). The dealer will advise you when the parts have been received, so you can make arrangements to have the parts installed. The repairs should be covered under the vehicle base warranty.
