01/18/2019
CAL WS 32-001

Subject: Transverse Track Rod Tower Bracket

Models Affected: Specific Western Star 4700SF Model Year 2014 through 2017 vehicles manufactured from April 29 to September 16, 2016.

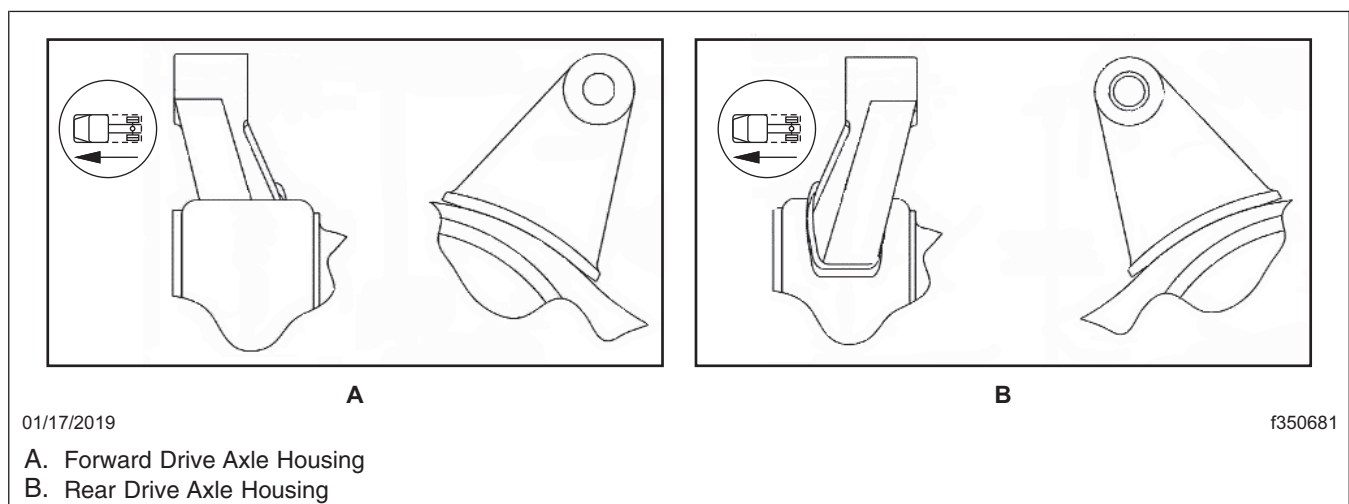
Fig. 1, Track Rod Tower Bracket Orientation

Trucks equipped with Meritor MT axles and Hendrickson Haulmax suspensions may use an incorrect track rod axle tower. Certain 4700SF trucks were shipped from the Portland or Cleveland truck manufacturing plant possibly without correct track rod axle tower brackets.

8. Install the transverse track rod to the frame bracket. Tighten the fasteners only enough to remove play.
9. Attach the tower bracket to the transverse track rod. Tighten the fasteners only enough to remove play. Do not apply the final torque at this time. See [Fig. 1](#) for the bracket orientation.

10. Using the tower bracket attached to the track rod, establish the position of the tower bracket on the axle housing in preparation for welding. Make sure the transverse track rod is as perpendicular to the frame rail as possible.
11. Press the bracket tight against the axle housing to reduce gaps, tack-weld the tower bracket into place.
12. Remove the track rod from the tower bracket.

13. Weld the tower bracket onto the axle housing. Lay a full-length 3/8 to 1/2 inch (9.5 to 12.7 mm) fillet in a single pass on each side.
