TECHNICAL SERVICE BULLETIN

XL/XLT - Instrument Panel Warped/Separated At Defrost Vents

20-2268
18 May 2021

Ford 2015-2020 F-150

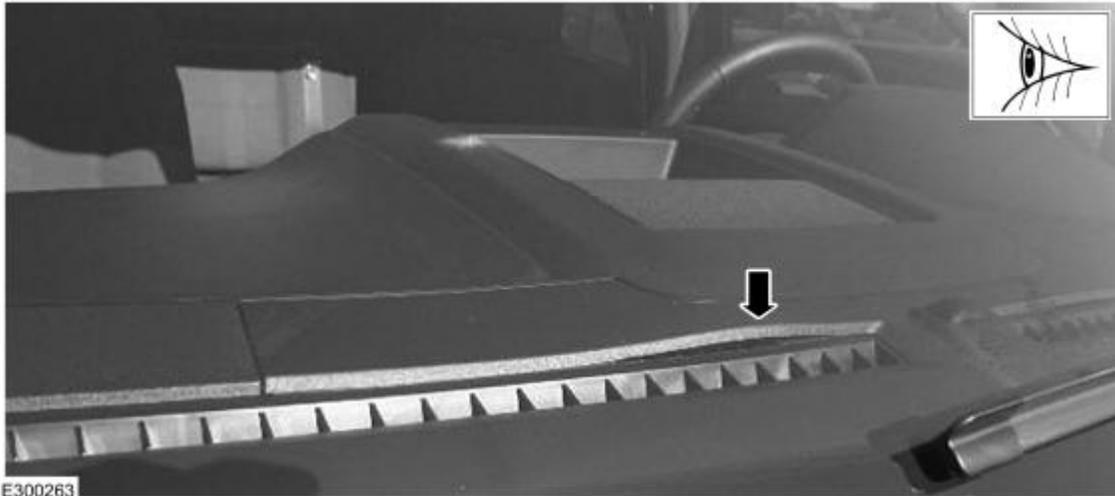
Figure 1

1. Inspect the instrument panel. Does the instrument panel exhibit a warp/separation at the defrost vent as shown in Figures 1-2?

2. Replace the instrument panel upper section. Refer to WSM, Section 501-12.
