SERVICE BULLETIN

APPLICABILITY: Manual Transmission Vehicles with Push Button Start ONLY

NUMBER: 15-279-21R

SUBJECT: Gen1 Telematics DCM Replacement for 3G Sunset

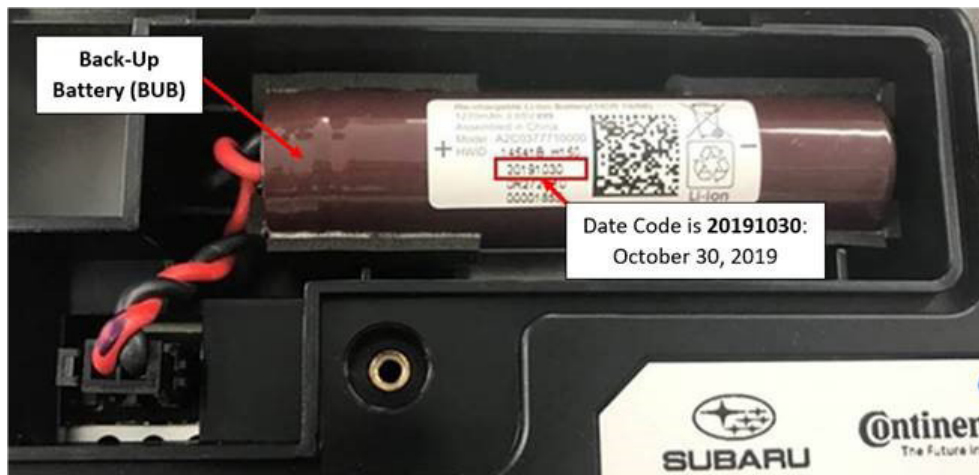
8. Disconnect the connector and remove the BUB.
9. Visually inspect the date code on the outside of the BUB as shown below.
 - a. If the date code is over five (5) years old, the BUB has passed its life cycle and should be replaced before installing the new DCM. The customer must be informed of the expired date code and the need for a replacement since the BUB is a maintenance item. The replacement cost is not covered by this no-charge DCM replacement service.
 - b. If the BUB is less than four (4) years old and no related DTCs are present, no action is required.

NOTE: The photo above illustrates where the BUB production date is located.

10. Transfer the existing BUB (or new replacement BUB) into the new DCM.
11. Reinstall the battery cover.
12. Install the new DCM. (Refer to STIS: ENTERTAINMENT & MONITORING > Data Communication Module > INSTALLATION.)
13. Reinstall all remaining components and interior trim in the reverse order of removal.
14. Reconnect the ground (-) terminal at the battery sensor. (Refer to STIS: REPAIR CONTENTS > NOTE > BATTERY.) **Always support the sensor and DO NOT OVER-TIGHTEN.**
