Warranty Extension: 2018-21 Clarity Plug-In Hybrid A/C Condenser

Year	Model	Trim Level	VIN Range
2018-21	Clarity Plug-In Hybrid	ALL	Check the iN VIN status for eligibility.

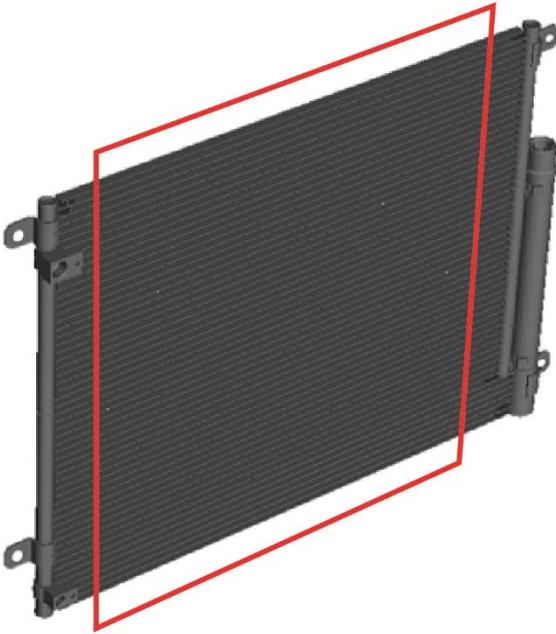
This warranty extension only covers vehicles that have a defective A/C condenser from the factory. The A/C condenser was not manufactured to specification. As a result, corrosion may develop in the form of tiny holes in the condenser tube walls that allow the refrigerant to leak out.

16. Check for leaks in the central condenser area.

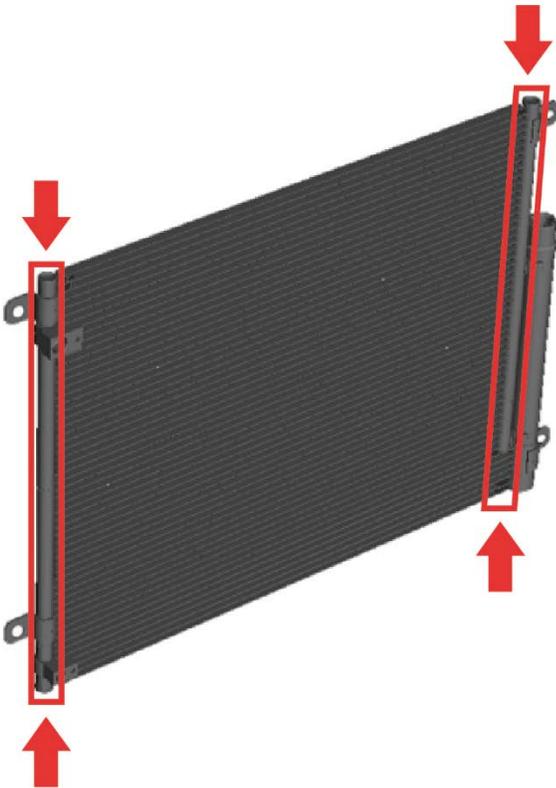
17. Check the joints between the horizontal tubes and the vertical pipes.

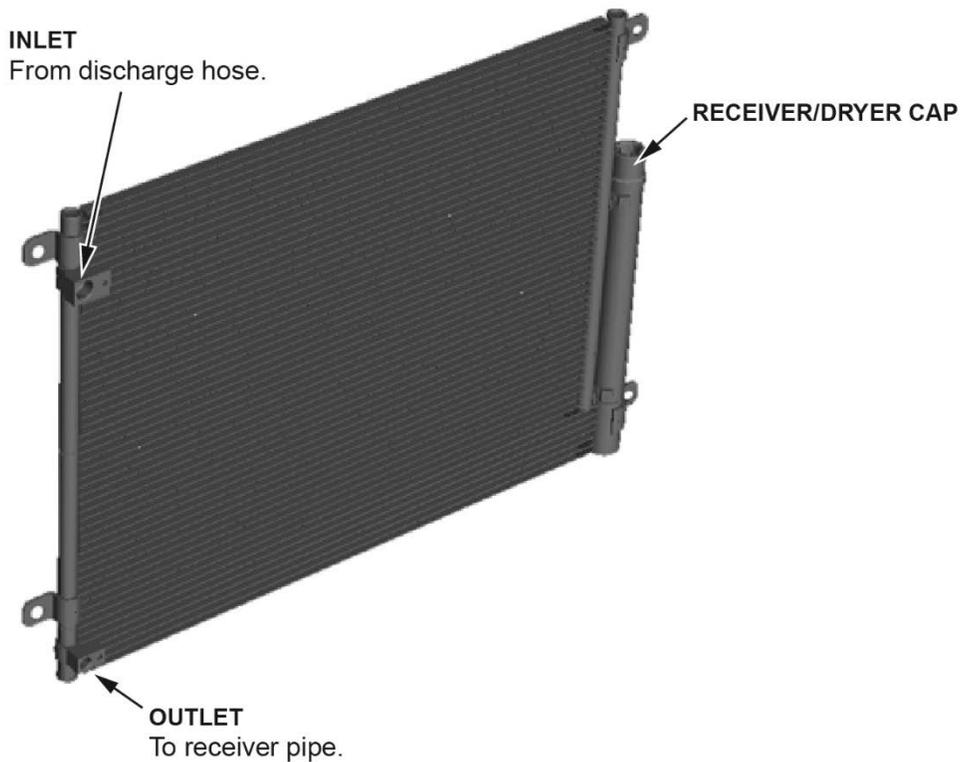
18. Check the inlet and outlet joints and the receiver/dryer cap for leaks.

NOTE: Leaks from the O-rings or the receiver/dryer cap are not covered by this bulletin.

- If the condenser is leaking, go to the next step.
- If the condenser is not leaking, this bulletin does not apply. Continue with normal troubleshooting.

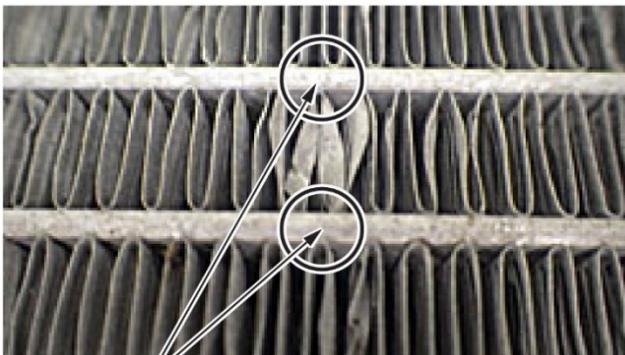
**Foreign Object Did Not Damage Tube Face
Covered Under Warranty Extension**

Fin damage without impact damage to the tube face.

- Tube face damaged by foreign object - This bulletin does not apply, continue with normal system troubleshooting.
- Foreign object damage but tube face is not damaged, or the tube face is corroded - Go to REPAIR PROCEDURE.
- No damage or corrosion found but the condenser is leaking - Go to REPAIR PROCEDURE.

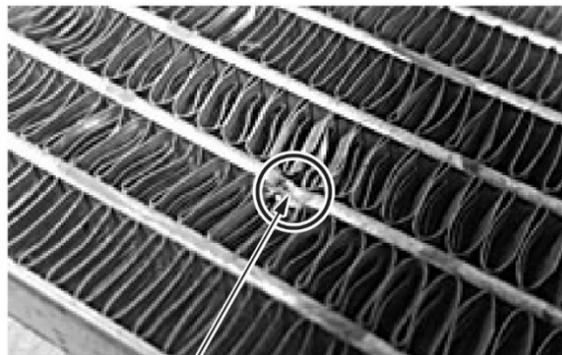
**Foreign Object Damaged Tube Face
Not Covered Under Warranty Extension**

Impact damage on the tube face.
