## Service Bulletin

Bulletin No.: 00-06-01-026N

Subject: Engine Replacement After Severe Internal Engine Damage – Replace Intake Manifold

Models: 2021 and Prior GM Passenger Cars and Trucks (including Medium Duty)

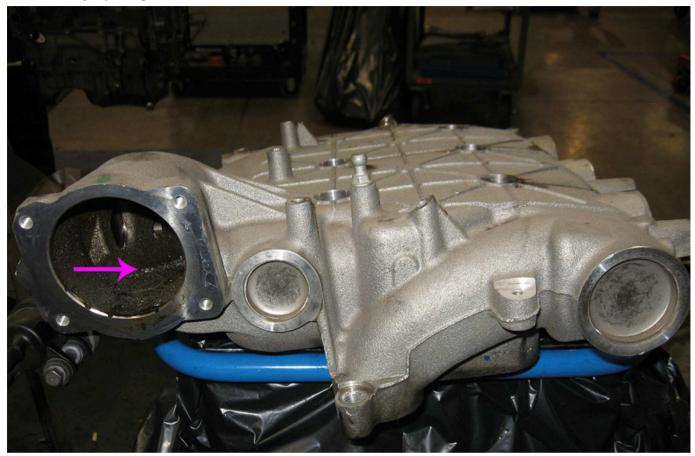
4246245

View of Debris in Aluminum Intake Manifold – Throttle Body Opening

⇒ If ANY of the above were to occur, the intake manifold MUST be replaced and the catalytic converters must be inspected or subsequent severe engine damage will occur. This replacement is required due to the complex inlet runner and plenum configuration of most of the intake manifolds, making thorough and complete component cleaning difficult and impossible to verify the complete removal of all debris.

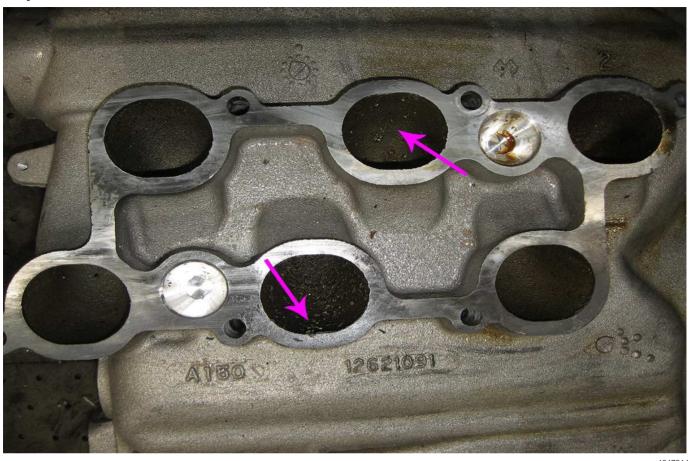
View of Debris in Aluminum Intake Manifold – Ports to Cylinder Heads

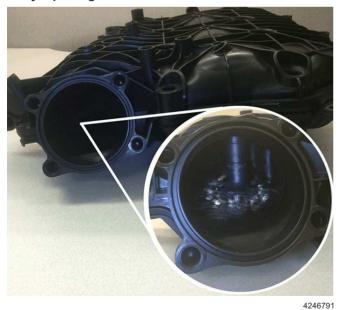
View of Debris in Plastic Intake Manifold – Throttle Body Opening

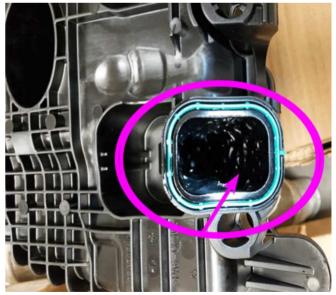
4565447

View of Broken Valve that Blew Debris Back into the Intake from the Combustion Chamber

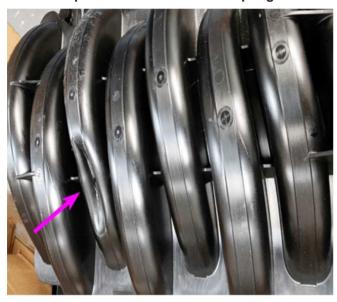
4565440

View of Intake from GEN 5 V8 that Experienced Lifter Collapse and/or Broken Valve Spring

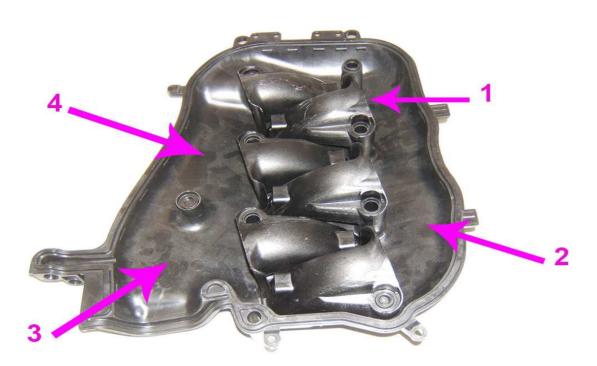
4247259

This internal view shows the plenum and runner complexity and is the reason why the intake manifold CANNOT be completely cleaned of debris.

- 1. Intake port to cylinder head opening.
- 2. Areas where debris can collect.
- 3. Areas where debris can collect.
- 4. Areas where debris can collect.

Notice: The plastic intake manifold CANNOT be disassembled.
