Service Bulletin

Bulletin No.: 09-08-64-014D

Subject: Information on Side Window Glass Not Clearing Molding When Indexing Down During Door Opening

Models: 2010-2021 Chevrolet Camaro

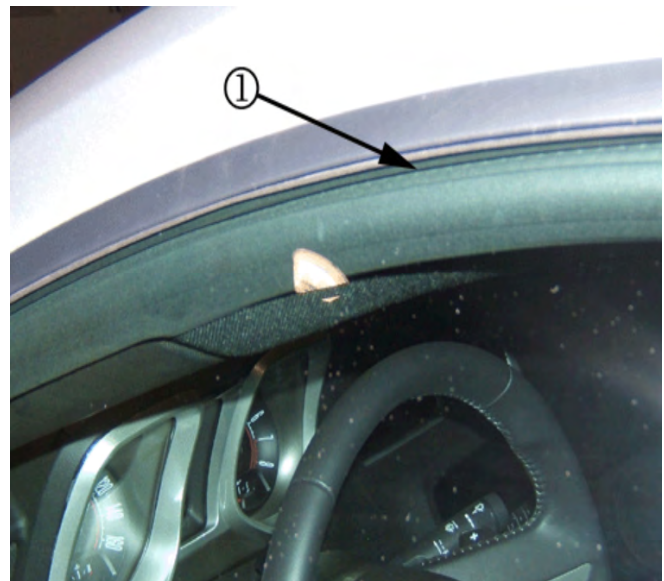
2261663

Window in "Up" Position (1) (Door Window Fully Seated in Weatherstrip)

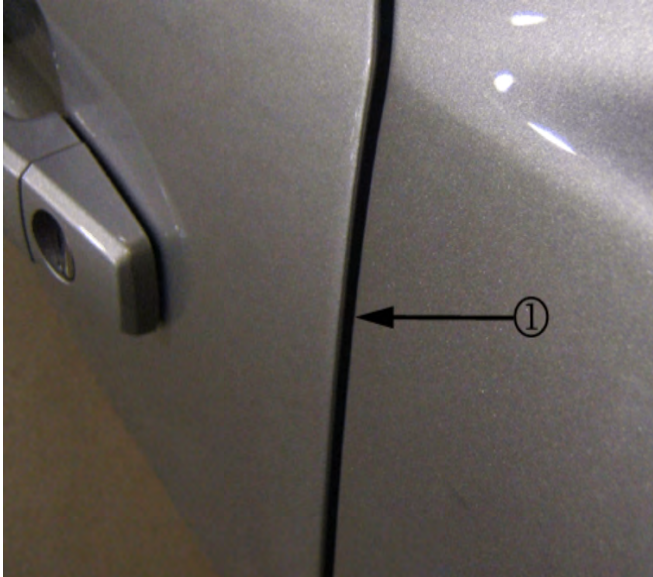
2263892

Door in "Closed" Position (1)

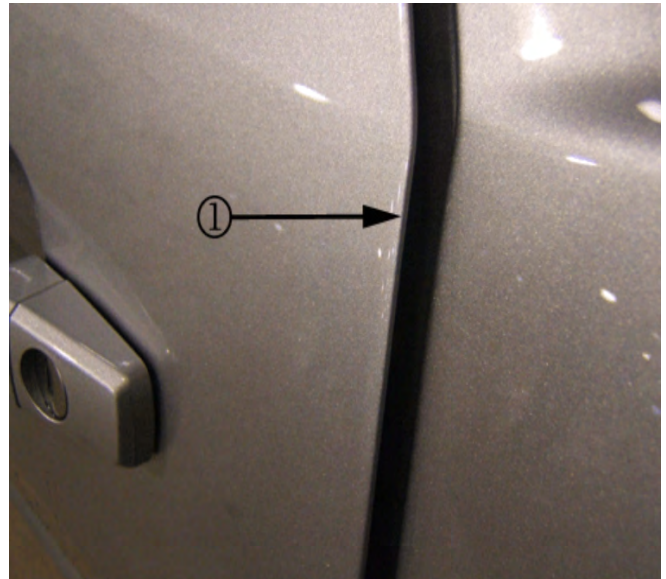
2263896

Door in "Open" Position From 1 mm (0.039 in) to 7.5 mm (0.295 in) (1)

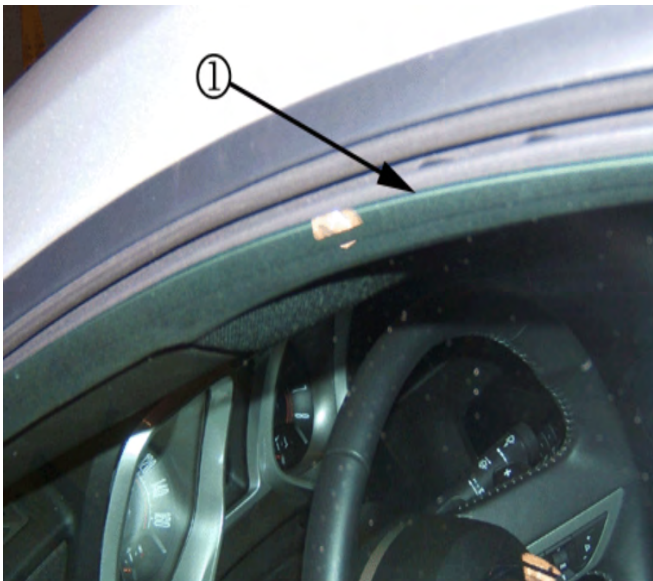
2261664

Window in "Indexed" Position (1)
(When Door Latch is Opened)
