June 17, 2021

Version 7

Popping/Crackling from the Speakers; Display Blank

Year	Model	Trim Level	VIN Range
2021	RDX	ALL	ALL

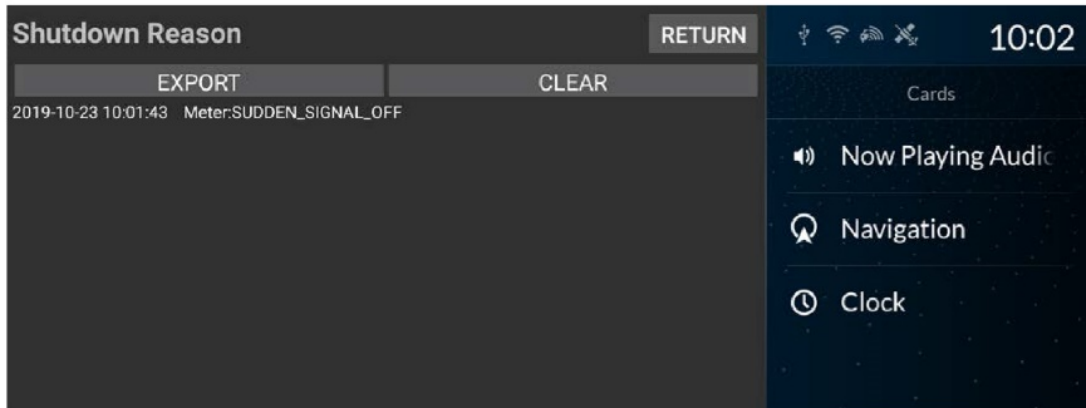
In this example, the cause of the failure can be identified as **Meter:SUDDEN_SIGNAL_OFF**.

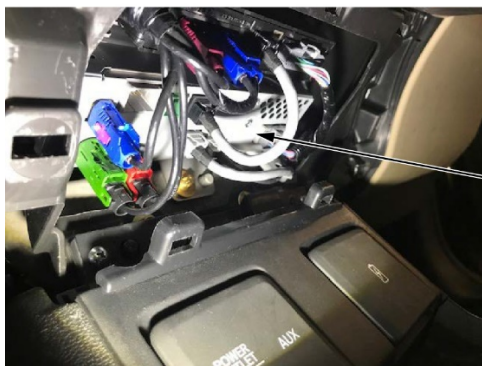
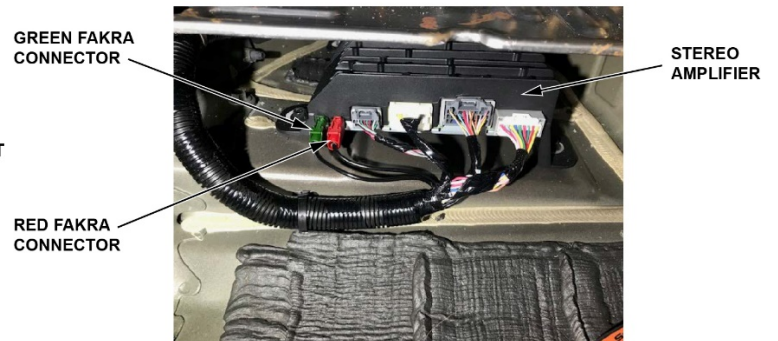
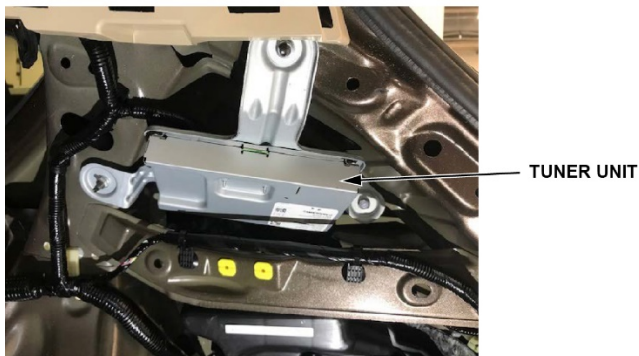
There is a loose connection in the MOST bus network.

19. Disconnect the red and green MOST connectors at the infotainment, stereo amplifier, and tuner units using the straight FAKRA puller.

NOTE: To avoid mixing up the wires, remove only one FAKRA connector at a time.
