SERVICE BULLETIN

APPLICABILITY: 2020MY Legacy and Outback

SUBJECT: Denso Gen 4 Cockpit One (CP1)
Infotainment System Operating TIPS

NUMBER: 15-259-20R

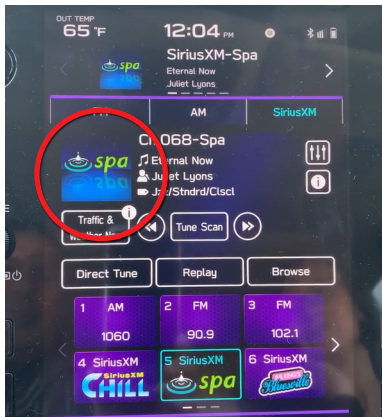
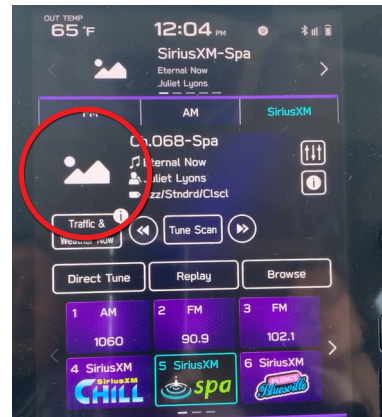
It is a normal operating characteristic for the SXM station artwork to disappear from the CP1 / Gen 4 Infotainment system display whenever the vehicle is in motion. Artwork is restored when the vehicle stops.

Artwork is displayed when stopped or parked.

Artwork is NOT displayed when moving.

Explain to customers questioning this condition that it is a normal operating characteristic intended to reduce distraction. Replacing the head unit will not change this characteristic.

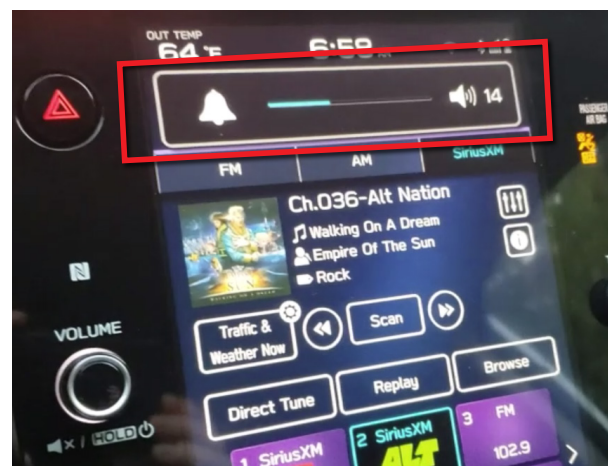
There are instances when using Android Auto, the audio volume cannot be adjusted intermittently even though notification of the adjustment by turning the volume control knob occurs as shown below on the display as shown here.

This condition occurs because Android Auto operation is being prioritized over the CP1 / Gen 4 Infotainment system.

This condition is temporary and will clear eventually. To expedite clearing and regain faster volume control for the audio source, there are some work arounds. One option is to relaunch Android Auto by disconnecting and reconnecting the phone to the CP1 / Gen 4 Infotainment system or, a short press of the Talk button on the steering wheel to start the native VR followed by saying “cancel” after the beep is heard. The procedure shown below copied from the Owner’s Manual regarding sound output can also be used.

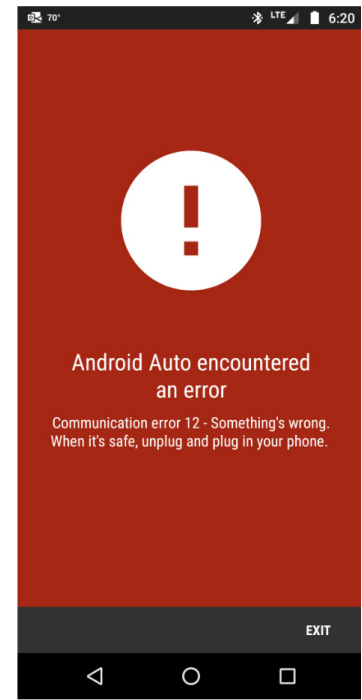
When this message is displayed on the phone after connection to the CP1 / Gen 4 Infotainment system, the Android Auto application fails to launch. Investigation has shown the source of this error is on the phone side and can be resolved by re-synching communication by disconnecting and reconnecting the phone. The communication error number (12 shown in the example) is irrelevant.

When reviewing a similar issue, explain to the customer that replacing the head unit will not resolve this condition as it is not the root cause of the error. It is a good practice to confirm an undamaged, genuine cable is used to connect the phone as well as making sure the phone is set to accept connection with a new vehicle.

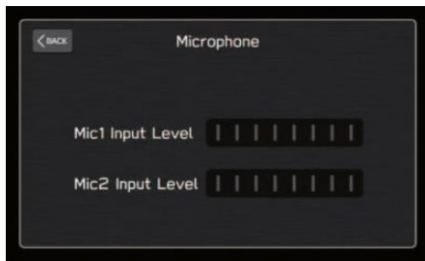
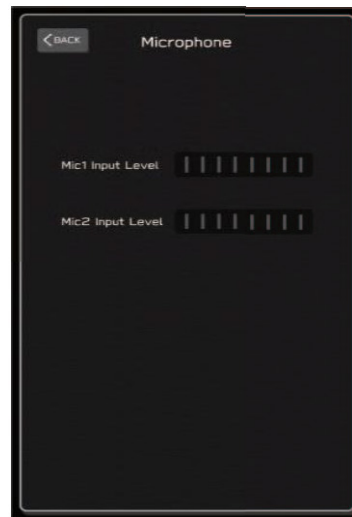
Lower Display Screen on
"Base" Models

Display Screen on "Mid"
and "High" Models

There is a known bug with the RC2003 software update released in June 2020. See Appendix B in TSB **15-261-20R** to confirm if the software of the unit being repaired is impacted by this bug. This bug affects only the display of the microphone test and in no way impacts actual microphone operation.

With the microphone display being impacted, it is recommended to use other diagnostic methods. Alternatively, troubleshoot the microphone operation using the Voice Recognition feature to confirm the unit receives voice input correctly or, make a voice call. If concerns remain, perform continuity and voltage drop testing to confirm if a poor contact or connection may exist. Reference the applicable Service Manual for related wiring diagrams for the Cockpit Control Module and microphone wiring diagrams, with or without Telematics depending upon the vehicle.

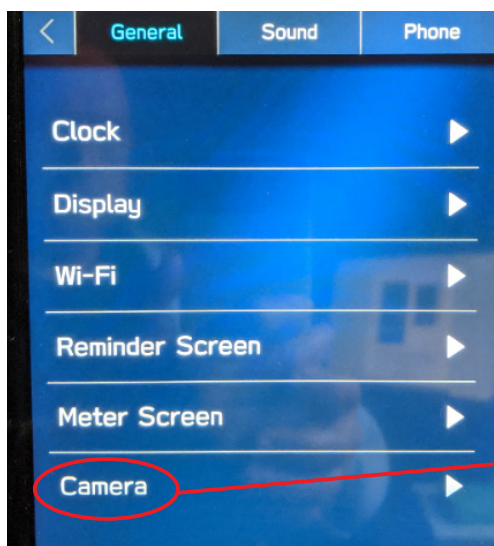
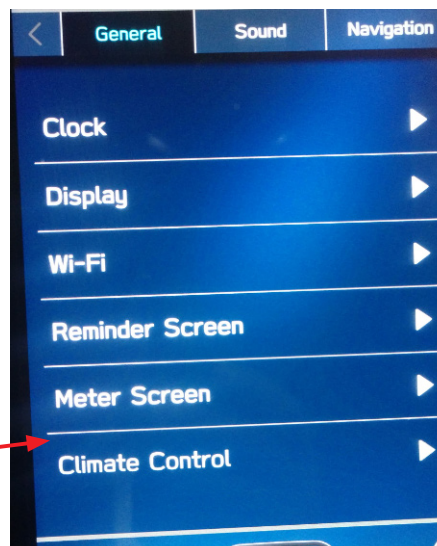
A report was received describing a missing “Camera” setting in Settings/General menu:

Camera setting PRESENT

Camera setting MISSING

After further investigation, it was determined to be a result of a needed process not being followed during replacement of the combination meter. The new combination meter was installed but not programmed properly by completing the required Variant Work. Always follow the applicable Service Manual instructions on STIS and confirm completion of all the necessary steps before condemning a possibly related system or hardware component. The Service Manual image below is an *example* of the VARIANT WORK procedure required for Combination Meter System replacement. Always follow the applicable procedure for the vehicle being repaired.

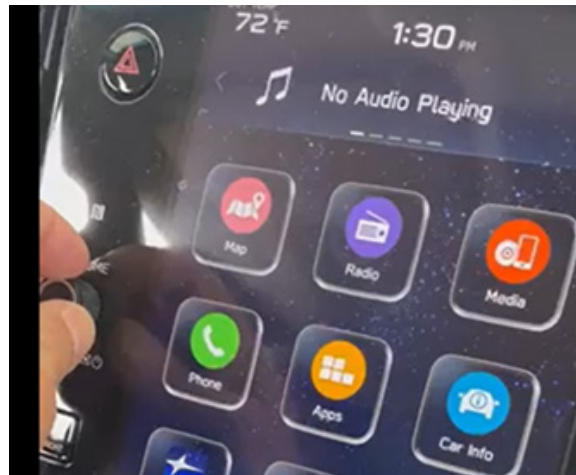
CAUSE: There have been many reports for audio playback and volume adjustment issue following CP1 reboot. Please keep in mind it might be a normal operation, if you see a message “**No Audio**

Playing” in the status bar area.

The message “No Audio Playing” in the status bar area indicates no audio source was selected for CP1 following reboot. Likely resulted from CP1 running projection application or streaming audio prior its shutdown. This is not a failure and the customer should not be alarmed.

RECOMMENDATIONS: please select the audio source (SXM, AM, FM, Media etc.) to enable playback (audio output)
