SERVICE INFORMATION BULLETIN

APPLICABILITY: 2020-21MY Outback **NUMBER:** 12-320-21

SUBJECT: Front Outer Door Garnish -Design Change

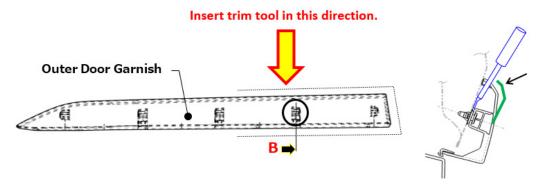
This Service Information Bulletin announces a design change made to the front door outer garnish trim. The change involves use of high strength clips added to improve retention of the garnishes and prevent any unintentional loosening / removal caused by the user's feet when entering and exiting the vehicle.

STEP 1) Start garnish removal by releasing **CLIP A** first.

STEP 2) Release CLIP B second.

STEP 3) CAREFULLY pull the garnish away from door.
