**SERVICE BULLETIN**

**APPLICABILITY:** 2017-18MY Impreza  
 2018MY Crosstrek  
 2018MY Legacy and Outback  
 2018MY BRZ\*

**NUMBER:** 15-211-17R  
**DATE:** 06/13/17  
**REVISED:** 06/08/21

**SUBJECT:** Reprogramming File Availability for Additional Optimization of Harman Gen 3 Audio and Navigation Head Units

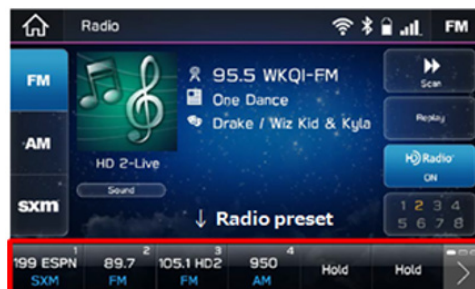
- Update to address some or all AM/FM station presets becoming lost and replaced by “Hold”

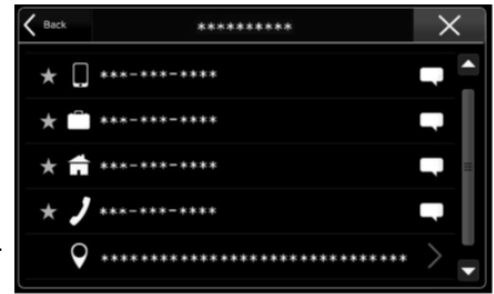
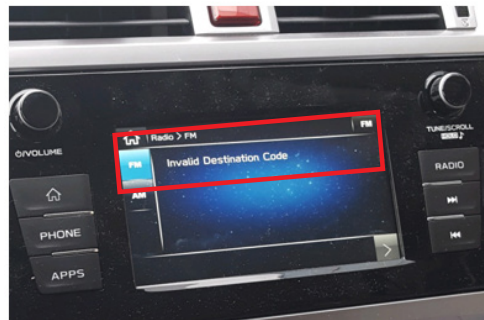
- Update to address display of “Invalid Destination Code” message

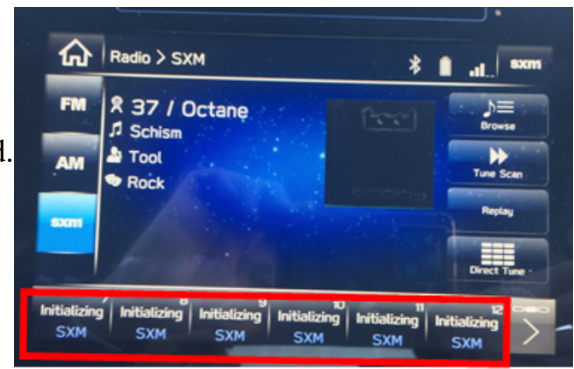
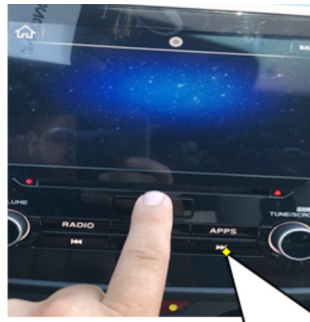
Background shown, but no icons

- On 2018MY Legacy / Outback models with Navigation (High) head units, the update corrects a condition where the head unit remains powered even after the ignition is OFF and the driver door is opened.
- Update for a condition where the SXM presets become lost and only “Initializing” appears as shown below.
- Update for condition where only the star field background is displayed (without icons) after the HOME button is pressed.

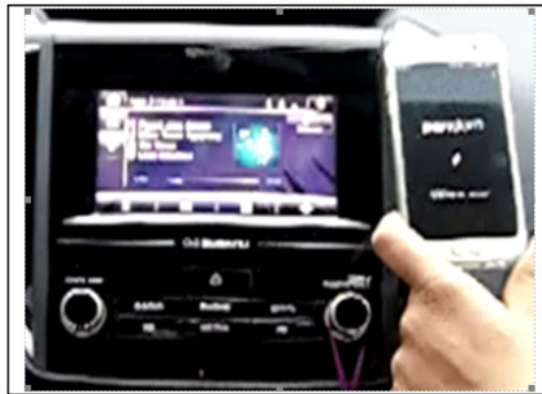
- 1- No streaming audio; when using the Pandora® app, there is no audio output.

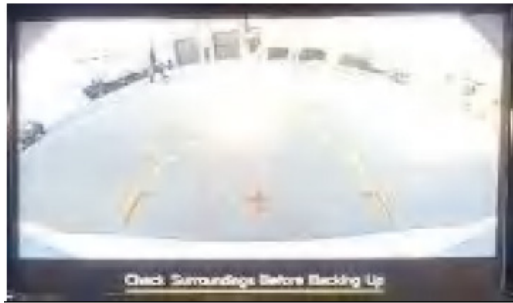
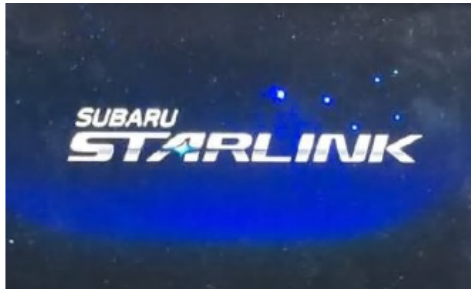
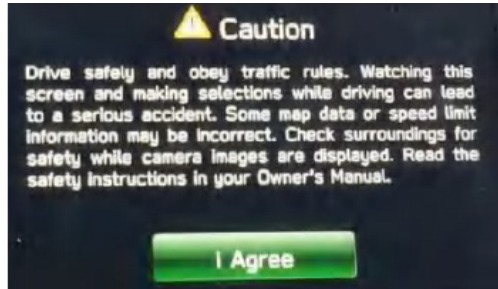
For reference, the previously released WTN-74R symptoms are also provided below. The main purpose of WTN-74R was to address display screen freeze-up during Back-Up Camera display (when the shifter is in “R”). In addition, the screen may also freeze when either the Subaru STARLINK or Disclaimer Caution / I Agree screen is displayed.

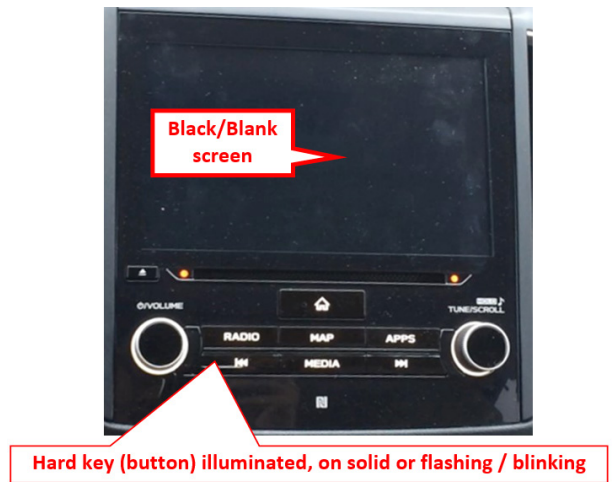
- 1) After switching the vehicle (ACC or IGN) on, the display screen goes black with no audio output and the hard key buttons are illuminated (on solid, or flashing / blinking).

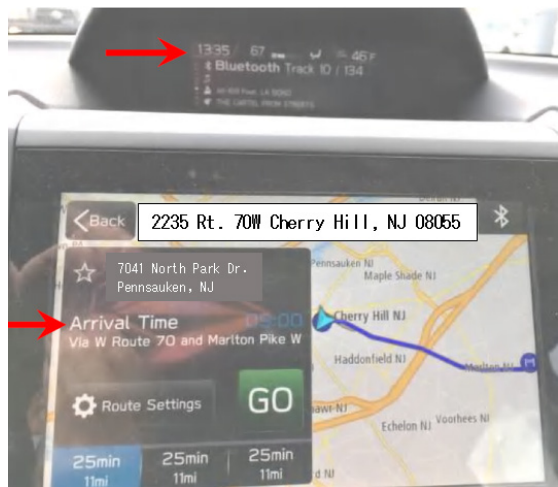
- 2) Time of day displayed in the MFD is incorrect and the arrival time displayed in Navigation unit is also incorrect.
