## SERVICE BULLETIN

**APPLICABILITY:** 2019-21MY Impreza  
 2019-21MY Crosstrek (Including Hybrid Model)  
 2019-21MY Forester  
 2019MY Legacy/ Outback  
 2019-21MY WRX  
 2019-20MY BRZ- Navigation -equipped ONLY  
 2019-21MY Ascent

**NUMBER:** 15-236-18R

**SUBJECT:** Reprogramming File Availability for Optimization of Harman Gen 3.1 and Gen 3.1α Audio and Navigation Head Units

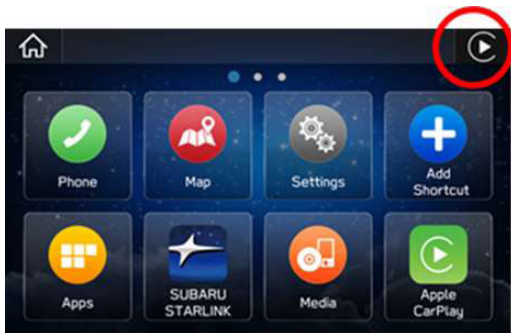
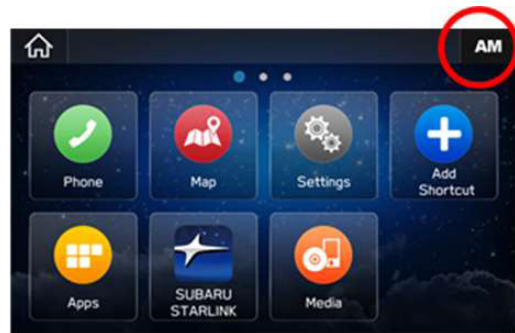
**On Ver. 6.0 and before:**

**Music playing via iPhone in CarPlay.**

**After disconnecting, the music source changes to Radio automatically.**

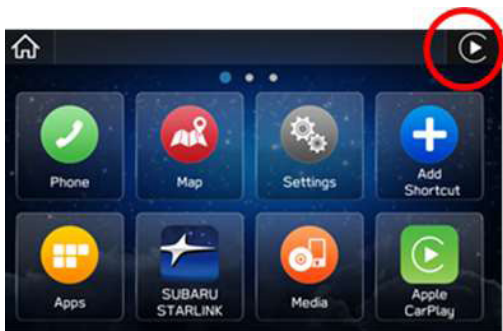
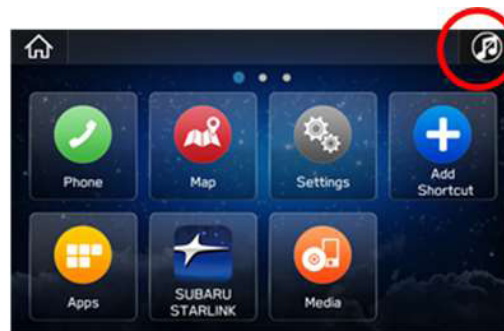
**Music playing via iPhone in CarPlay.**

**After disconnecting, no music source is selected automatically.**

If a source of music other than CarPlay has been playing when the iPhone is disconnected, the music source remains same (it is not turned off.)

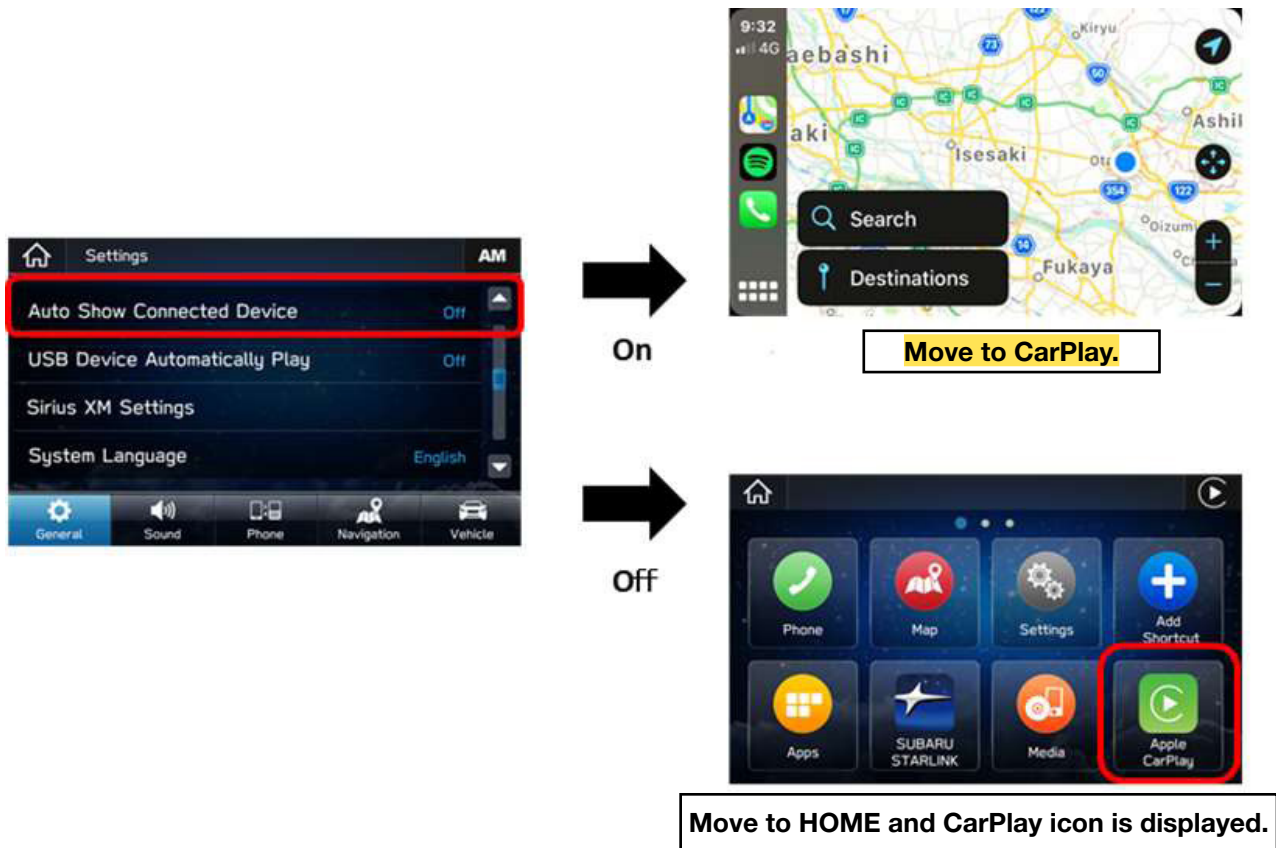
**NOTE 3:** When using a USB connection with iPhone (CarPlay active), move to CarPlay screen.

In a case where the iPhone was disconnected while playing music then reconnected while it is playing music, the system moves to CarPlay screen no matter what is set in <Auto Show Connected Device> in Setting (depending on iOS version of the iPhone.)

The <Auto Show Connected Device> is no longer available for CarPlay. The Setting menu shows only <Android Auto> to access the <Auto Show Connected Device> selection menu. If an iPhone with active CarPlay is connected, the Head Unit always moves to the CarPlay screen.

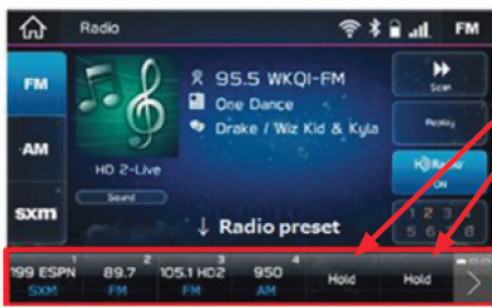
- 1) Station presets are lost. Touch buttons read “Hold”. (Applicable for software versions Rel\_4.18.25.50 (or before)). Included in software version Rel\_U1.18.38.50.
