Service Bulletin

Bulletin No.: 19-NA-076

Subject: Blue or Black Screen and Service Rear Vision System Message on Radio Display Shifting into Reverse

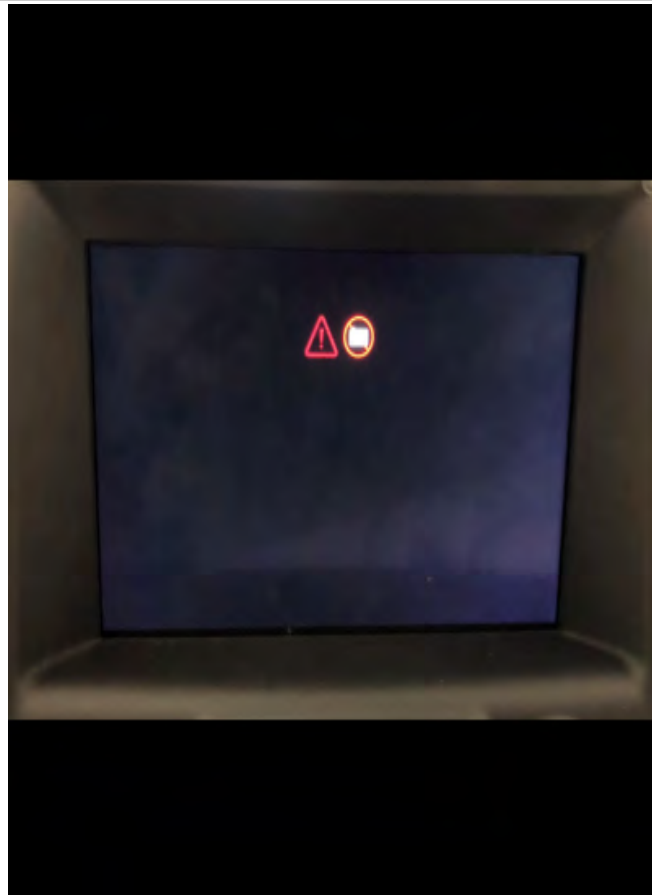
5733400

Some customers with select vehicles may notice that after having vehicle in idle for an extended period of time (length of time for black screen to occur depends on ambient temperature), a black screen with a red triangle and no camera icon will appear when the vehicle is put in Reverse and the camera icon will be crossed out on the radio center screen.

If the **blue** or **black** screen condition exists, it will occur every time the rear view is displayed to the customer within the same power cycle and may return to normal functionality on the next power cycle after the A11 radio enters and exits a sleep cycle. A DTC of B395A Symptom Byte 08, 72 and 3A will be stored as history together in the A11 Radio.

Cause	The cause of the condition may be software anomalies in the Video Processing Module (VPM) or rear camera.
Correction	<ul style="list-style-type: none"> • For vehicles with UV2/UVI/UVS, reprogram the Video Processing Module (VPM). • For vehicles with UVB – replace the rearview camera.

- 2.1. If the Video Processing Module (VPM) stores a history B101D symptom byte 3C and/or 39; or the A11 radio stores a history B395A symptom byte 08, 72 and/or 3A, do NOT replace the VPM. Reprogramming the VPM software may reduce sensitivity of the B101D setting. Refer to *K157 Video Processing Control Module: Programming and Setup* in SI. This software does not resolve non-camera related system issues. If a condition exists that is NOT related to the camera system, then follow published diagnostics for the condition reported by the customer.

3. For UV2 or UVI equipped systems:
 - 3.1. If the A11 Radio has stored DTC B395A Symptom Bytes 08, 72, and may also set 3A, then reprogram the VPM software. Refer to *K157 Video Processing Control Module: Programming and Setup* in SI.

- 3.2. If concern(s) persist, refer to published diagnostics in SI.
4. For UVB equipped systems (excluding Holden Acadia):
 - 4.1. If the A11 Radio has stored all three history DTC B395A Symptom Bytes 08, 72, and 3A, and the blue screen with service rear vision system with guidelines (if enabled) is persistent throughout a power cycle, then replace the rearview camera. Refer to *Rearview Driver Information Camera Replacement* for the appropriate model in SI.
