Service Bulletin

Bulletin No.: 19-NA-129

Subject: Squeak and/or Clunking Noise from Rear of Vehicle

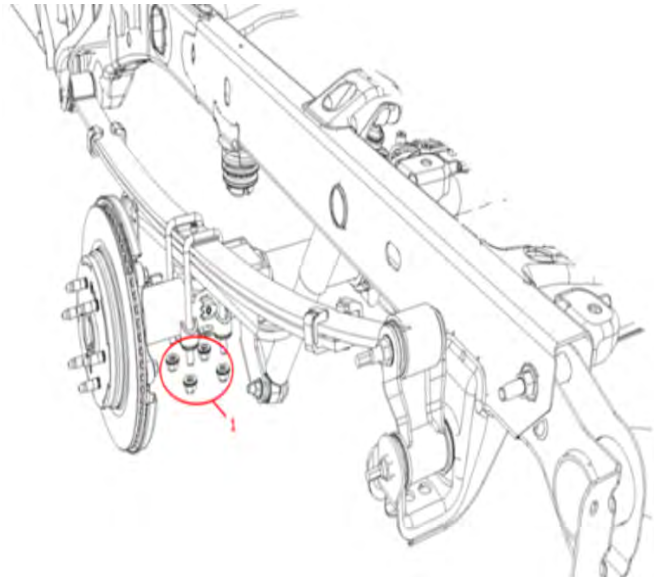
5357922

Warning: Ensure that the proper torque procedure for the U-Bolts is followed in SI. Excessive fastener torque will extrude, and damage, the spring isolators making the condition worse.

2. Loosen the anchor plate U-bolts (1).

3. Re-torque the anchor plate U-bolts (1). Refer to Fastener Specifications in SI.
4. Repeat steps # 2 and 3 for the opposite side leaf spring.
5. Re-test the vehicle for the same clunking noise. If the issue remains, follow the regular repair procedure.
