Service Bulletin

Bulletin No.: 19-NA-153

Date: May, 2021

Subject: Malfunction Indicator Lamp (MIL) Illuminated - DTC P0741 Set

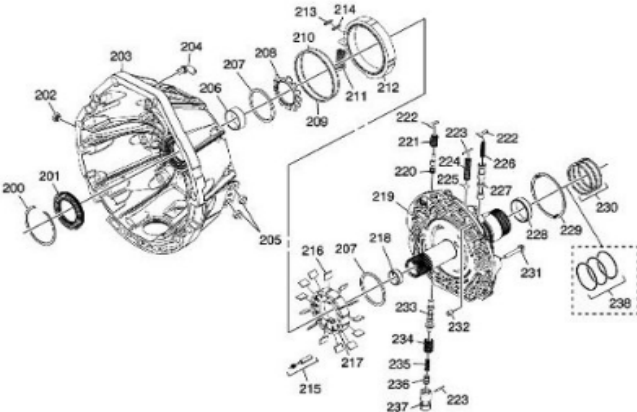
<div style="background-color: black; width: 100%; height: 20px; margin-top: 10px;"></div> <p style="text-align: right; font-size: small;">5448383</p> <p>This condition may be caused by a damaged turbine shaft front bushing (218) in vehicles with mileage less than 10,000 miles (approx. 16,000 km).</p> <p>⇒ The turbine shaft may also be damaged in the journal area that is in contact with this bushing.</p>

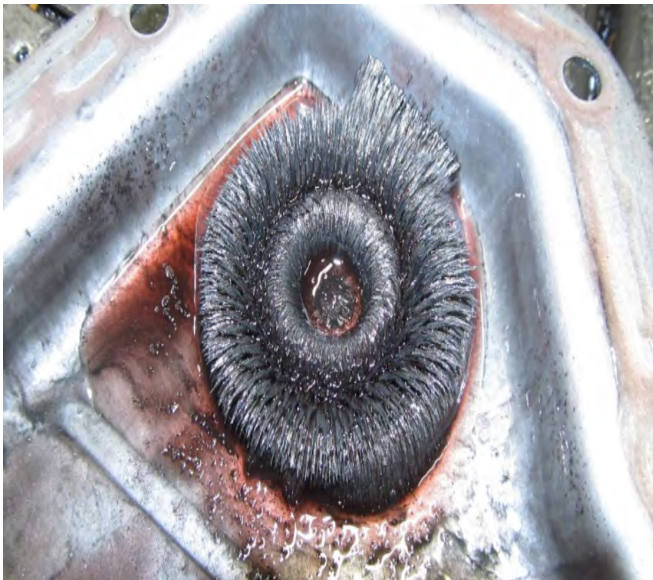
5360216

2. Remove the transmission oil pan.
3. Inspect the magnet in the pan for excessive metal accumulation.
 - If there was no signs of metal in the oil pan, install the pan and no further work is required.
 - If there was excessive metal shaving in the oil pan magnet, Install new filter when reassembling and continue to step 4.

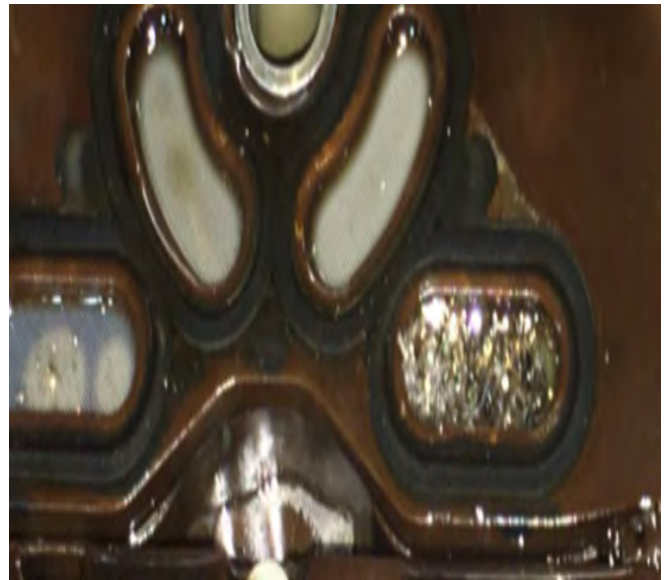
5360222

4. Remove the upper and lower valve body and clean thoroughly.
5. Inspect the TEHCM solenoid screen for debris:
 - If there was no signs of metal in the TEHCM, install the pan and no further work is required.
 - If there was excessive debris in the TEHCM, replace the TEHCM/solenoid valve body **Only** if there is debris on the screen as shown above and continue

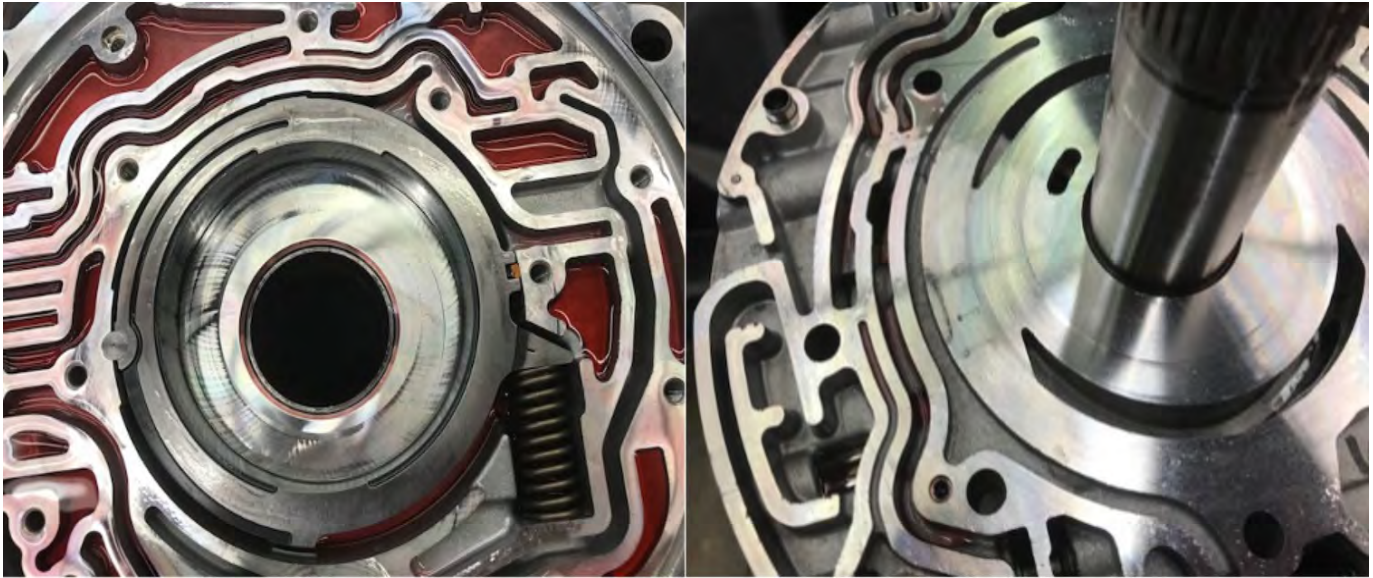
5360776

Do Not replace the pump if no signs of damage or excessive wear was not validated during inspection as shown above.

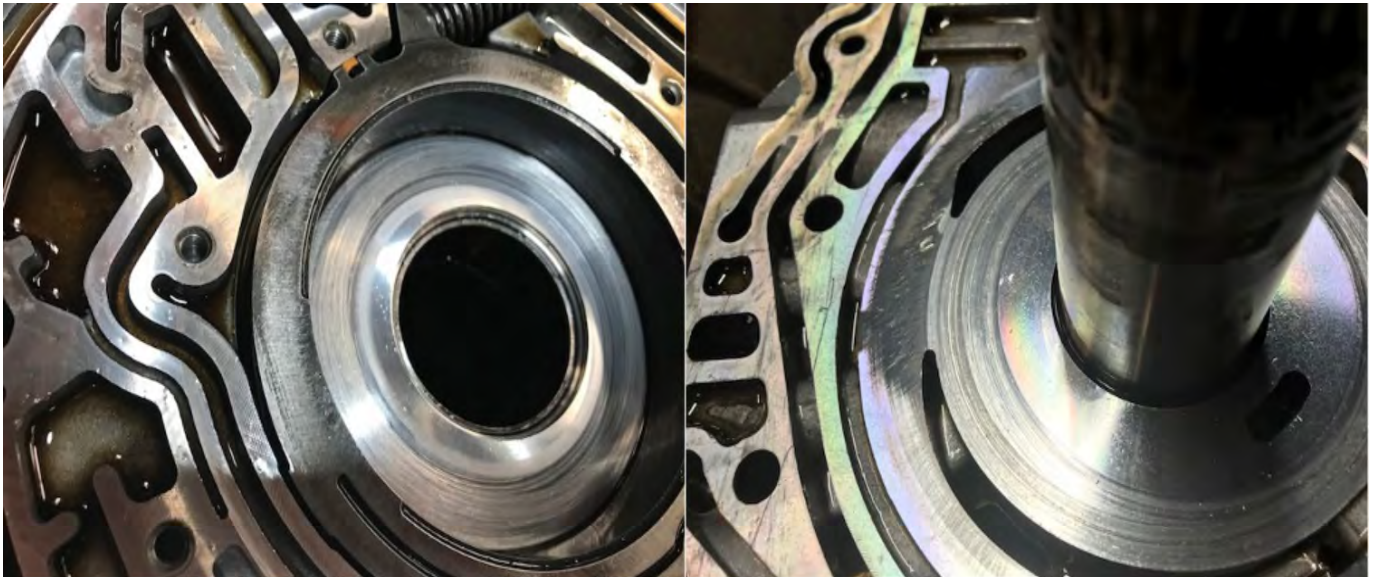
5360218

Perform an inspection of the transmission pump for signs of excessive wear as shown above.

Replace pump components as necessary.
