Service Bulletin

Bulletin No.: 19-NA-167

Subject: Water Leak into Interior and/or Various Electrical Concerns, Liftgate Actuator Noisy or Inoperative

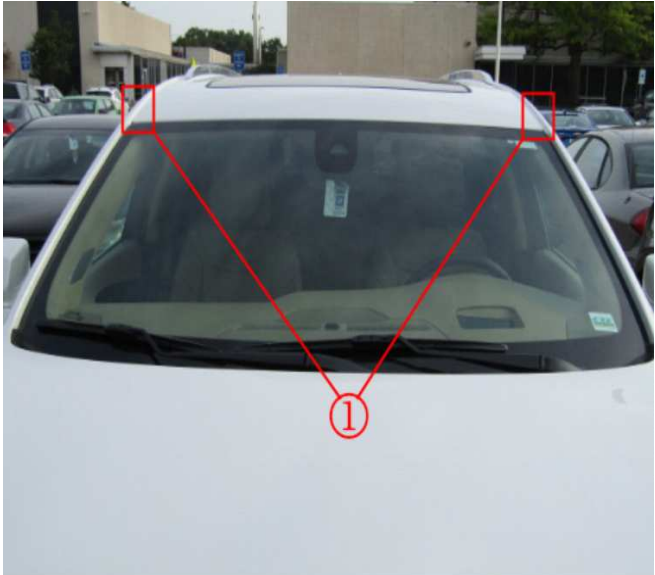
5379776

Involved Region or Country	North America, Russia, Israel, Palestine, Japan, Cadillac Korea (South Korea), Europe, Middle East
Condition	Some customers may comment on seeing water leak into the interior, or wet carpet. This condition could occur at either the front and/or rear, and on the right and/or left side. Some electrical concerns or issues may occur such as power locks cycle or are inoperative after a car wash or rain in the XT5 and Acadia, or the liftgate actuator may be noisy or inoperative in an XT6.
Cause	<p>The cause of the condition may be possible "pin hole" voids in the roof panel to outer ring laser braze and seam sealer. The pin holes are most commonly found near the top of the windshield at the A-pillars, or the top of liftgate near the D-pillars. Examples of the leak areas are shown below.</p> <p>Possible Front Laser Braze Water Leak Areas (1)</p>

Following the Service Procedure below, inspect the forward and rear laser braze corners of the roof ditch, at the upper windshield and rear liftgate areas.

1. Visually inspect the front right and left roof laser braze, then the rear right and left roof laser braze, for pin holes or a crack.
2. Seal the holes/crack in any laser braze area following the steps below:
 - 2.1. Mix a small amount of Kent® High-Tech Seam Sealer Clear P10200, or Wurth Euroseal Gel Clear 18920104, or equivalent WITH the proper touch-up paint color.
 - 2.2. Avoiding excess sealer build up within the ditch, work a small amount of the sealer into the hole with a gloved finger.
 - 2.3. Wipe away any excess sealer with a light amount of solvent on a rag or paper towel. The solvent will help the sealer flow into the hole/crack.
3. Clean and dry any wet trim. Refer to *Floor Carpet Drying* in SI.
4. Address and repair any electrical concerns as necessary.

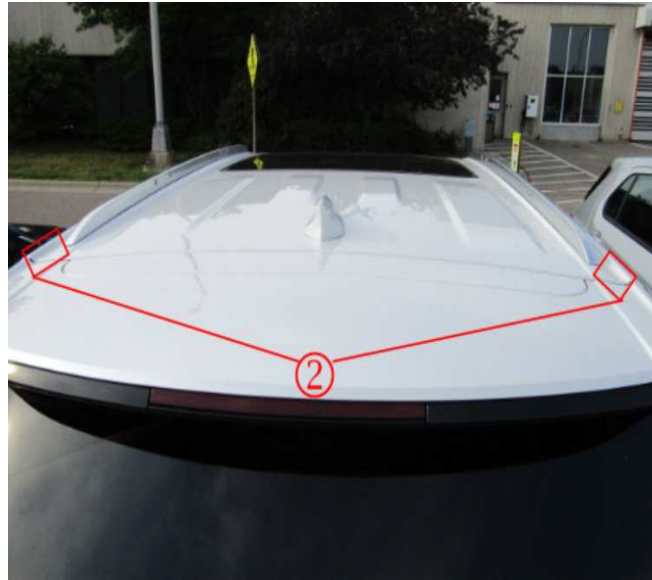
5379781

Possible Rear Laser Braze Water Leak Areas (2)

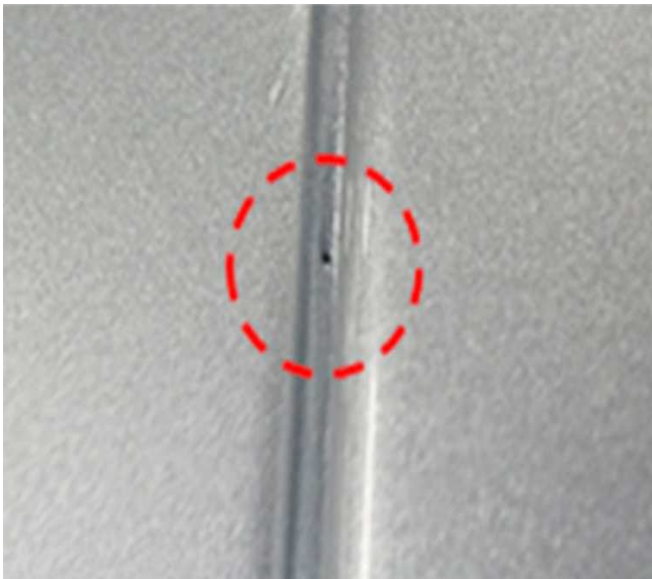
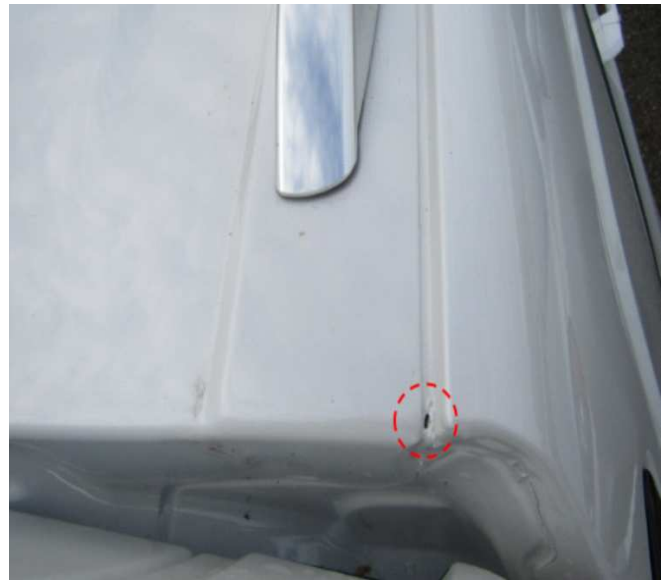
Note: The pin holes/cracks may be more difficult to see on darker color finishes. A front and rear example of a visible pin hole are shown in the graphics above.
