# Service Bulletin

Bulletin No.: 20-NA-121

**Subject:** Water Leak at Roof Area, Various Electrical Issues, No Start, Stall, Brake Lamp Not Off, Radio Inoperative, Remote Key Inoperative, TPM Light Illuminated, Malfunction Indicator Lamp (MIL) Illuminated with Possible DTCs C0750 SYM29, C0755 SYM29, C0760 SYM29, C0765 SYM29

Brand:	Model:	Model Year:		VIN:		Engine:	Transmission:
		from	to	from	to		
Buick	Encore GX	2020	2021	—	—	All	All
Chevrolet	Trailblazer (VIN M)	2021	2021			All	All

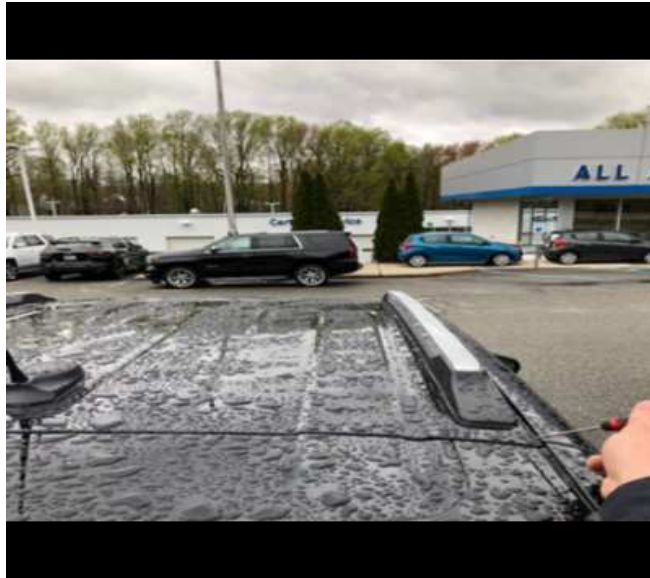
5613596

The cause of the condition may be a pin hole in the roof body seam welding/sealing.

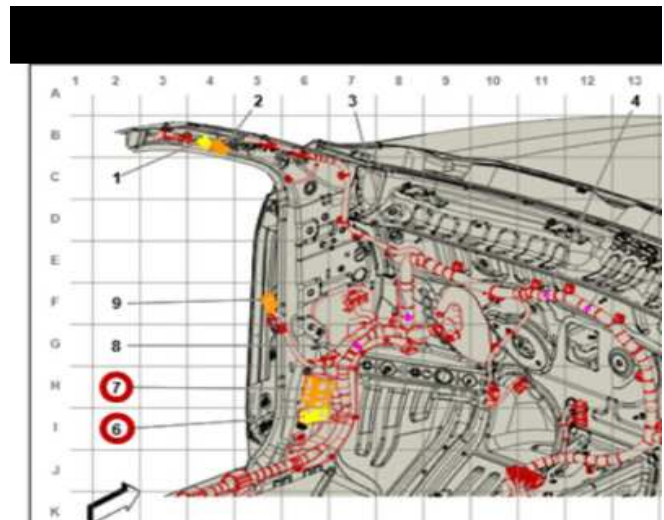
5703541

**(#8) — X204 Instrument Panel Harness to Body Harness, 76-way connector right side**

**(#6) — X202 Instrument Panel Harness to Body Harness, 2-way connector left side**

**(#7) — X200 Instrument Panel Harness to Body Harness, 76-way connector left side**

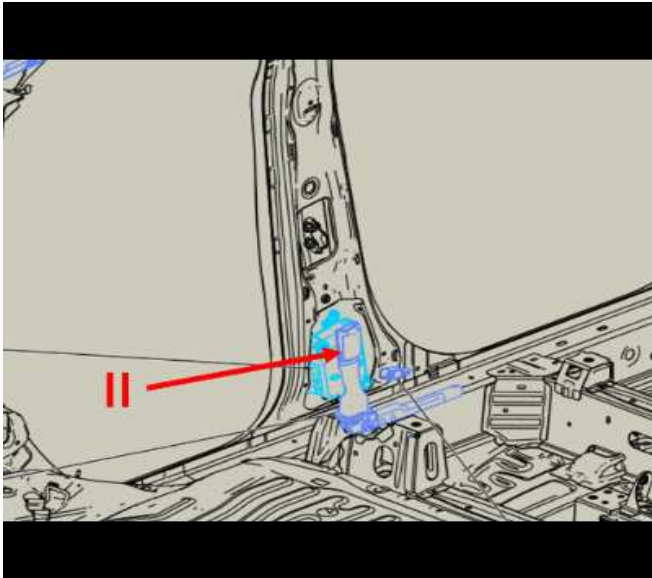
5752327

**(#11) — F112D Seat Belt Retractor Pretensioner  
- Driver****(#4) — F112P Seat Belt Retractor Pretensioner  
– Passenger (not shown)**

Clean the water inside of the connector and apply NYOGEL on terminals for waterproofing.
