Service Bulletin

Bulletin No.: 21-NA-040

Subject: Squeak, Rattle or Creak Noise Originating from Second Row Seat Area

Brand:	Model:	Model Year:		VIN:		Engine:	Transmission:
		from	to	from	to		
Buick	Enclave	2019	2021			All	All
Chevrolet	Traverse

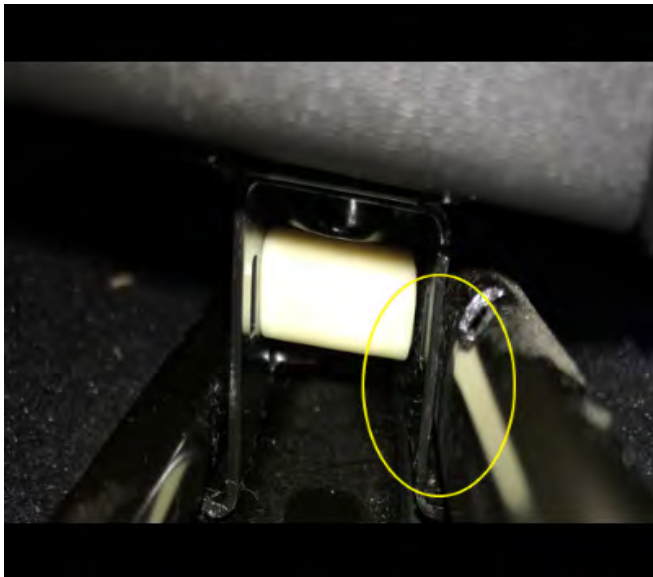
5744713

1. Verify which rear seat exhibits the condition. In the Repair Order, document which seat, along with the seat track position for/aft, where the noise occurred. Also verify whether both seat tracks are locked in by wiggling/pushing/pulling the seat back. Observe and document in the Repair Order whether the seat jumps/skips when releasing the towel bar to slide the seat for/aft. Pictures above are examples of areas to evaluate. You may find other affected areas as well.
