# Service Bulletin

Bulletin No.: 18-NA-275

**Subject:** Information on Grease Seepage from Strut Assemblies

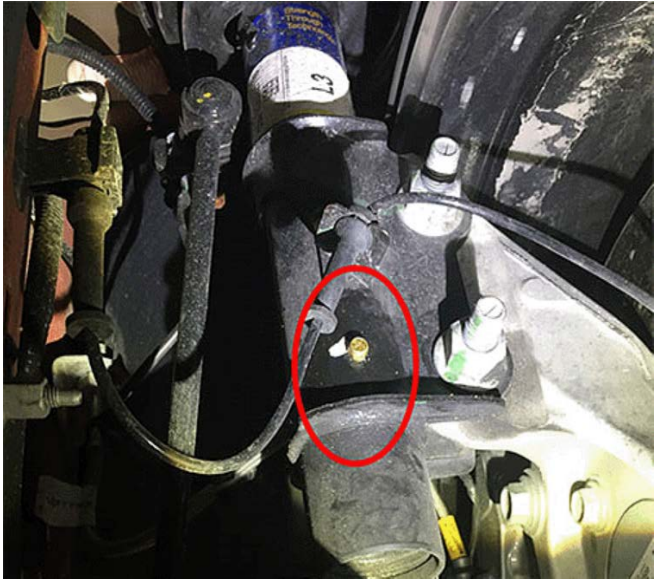
5141833

<p style="text-align: right;">5141823</p> <p>Some customers and/or technicians may comment on a small amount of grease seepage from a brass or gold colored fitting located at the bottom of the strut assemblies.</p> <p><b>Note:</b> At first glance, this may appear to be a fluid leak.</p> <p>The 5th generation Camaro Z/28, as well as the 6th generation Camaro ZL1 1LE, employ a different type of strut than other traditional car and truck lines. These struts are specifically designed and tuned for the precise vehicle handling that these vehicles are capable of.</p>
<p><b>Cause</b></p>	<p>This condition may be caused by a vent allowing breathing within the damper body. There is no oil within this chamber but there is some grease on the inner walls of the housing that keeps the insert tubing lubricated against the component's bushings. As air enters and exits this vent, it is normal to have small amounts of this grease exit the strut. This is actually part of the natural operation of these struts.</p>

<p><b>Correction</b></p>	<p>No strut replacement is required for this condition listed above.</p>
