Service Bulletin

Bulletin No.: 18-NA-307

Subject: Lack of Power, Reduce Power Displayed on Drivers Information Center (DIC), Rough Idle, Stabilitrak Light On, Malfunction Indicator Light (MIL) Illuminated - DTC P0014 , P0365, P0366, P06A3, P16A1 and/or P016A2 Set

Brand:	Model:	Model Year:		VIN:		Engine:	Transmission:
		from	to	from	to		
Chevrolet	Colorado	2015	2021			LCV	
GMC	Canyon

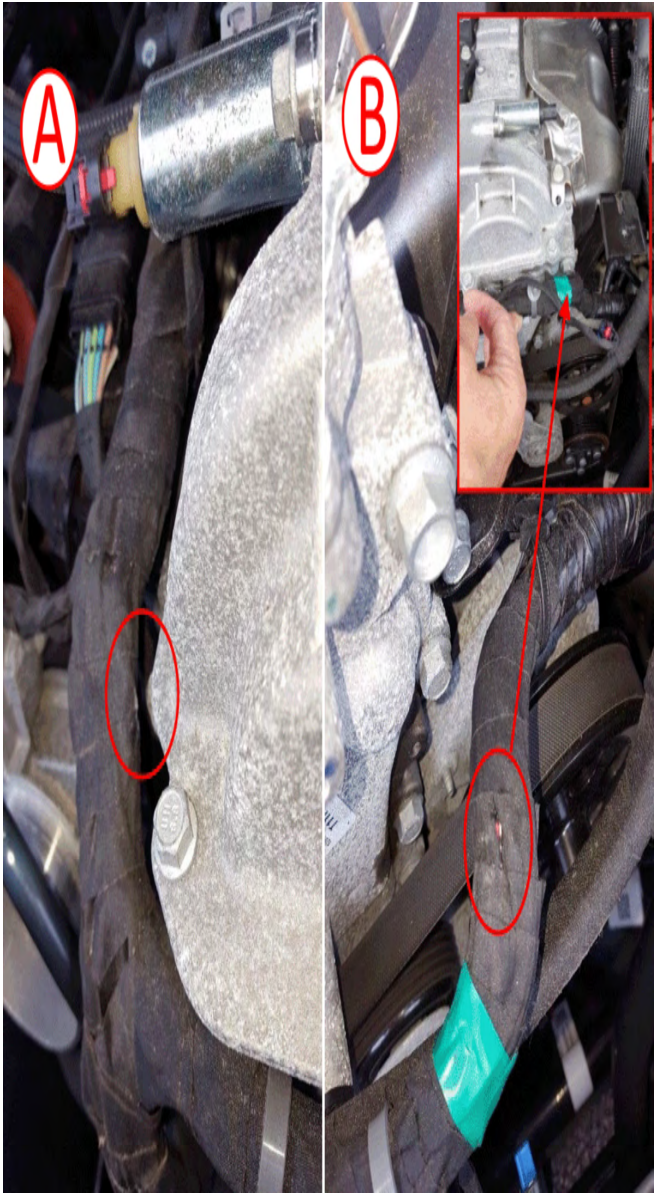
<p>5153274</p> <p>This may be caused by the engine wiring harness chaffing on the edge of the camshaft cover (A) and/or the cylinder head (B).</p>
Correction	<p>Note: Possible multiple effects or driver notifications may be experienced by one of the wires in the engine harness being chafed or cut in different circuits. Due to the cause of the condition, and the positions of the wires in the engine harness, it is unlikely that more than one circuit and/or fuse will be affected by the condition.</p> <ol style="list-style-type: none">1. Inspect the engine wiring harness conduit and wires for chaffing.2. Repair the wires per the <i>Wiring Repairs</i> procedure in SI.3. Using Woven Polyester Electrical Tape (PET), tape all the contact points of the engine harness ensuring that the tape is applied in a double layer extending along the engine harness past the camshaft cover or cylinder head.4. Utilizing tie straps, position the engine wiring harness away from the camshaft cover or cylinder head.
