Service Bulletin

Bulletin No.: 19-NA-256

Subject: Diagnostic Tips for Knocking, Rattle, Squeak and/or Squeal Type Noise from Engine – Engine Replacement Recommendations for HFV6 Gen 1 and Gen 2

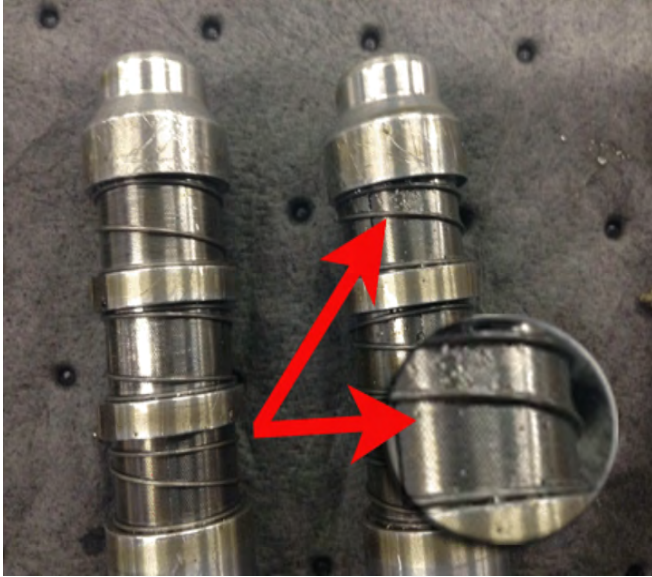
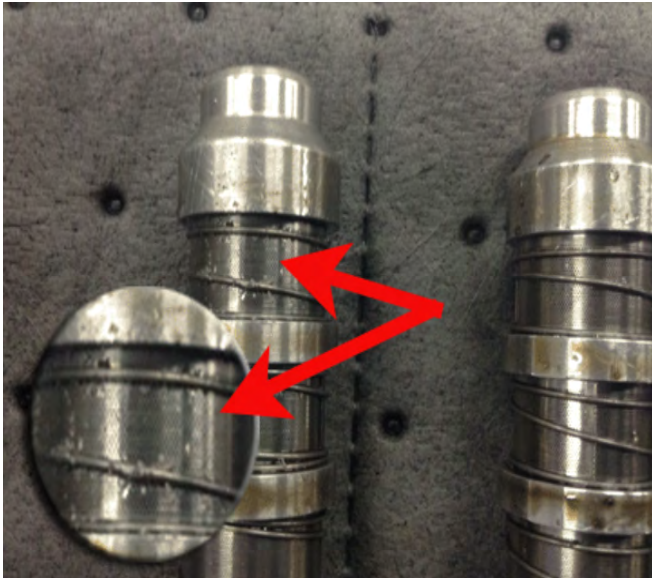
1. Inspect the oil control solenoids for metal debris. This shows the oil filter is in by-pass and unfiltered oil with bearing debris was pumped into the oil lubrication galleys, throughout the engine.

Any of the above 3 instances would be cause to replace the engine instead of repair.

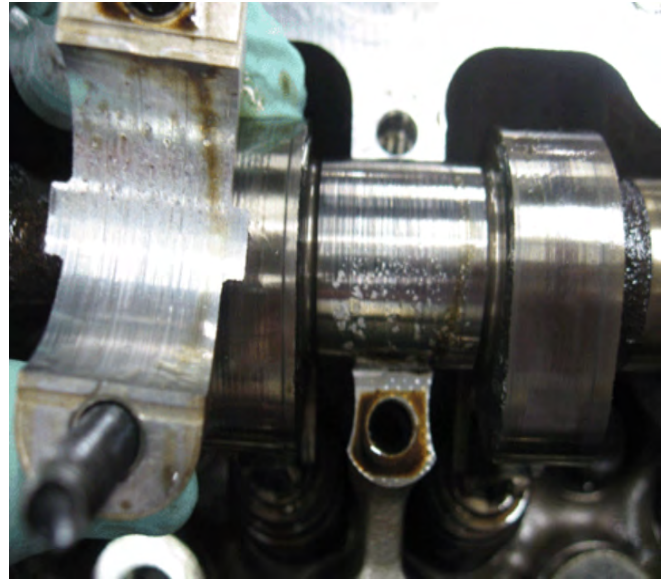
3966789

2. Inspect for damage to the cam caps journals and camshaft journals on the heads (obvious signs of metal through the cap).

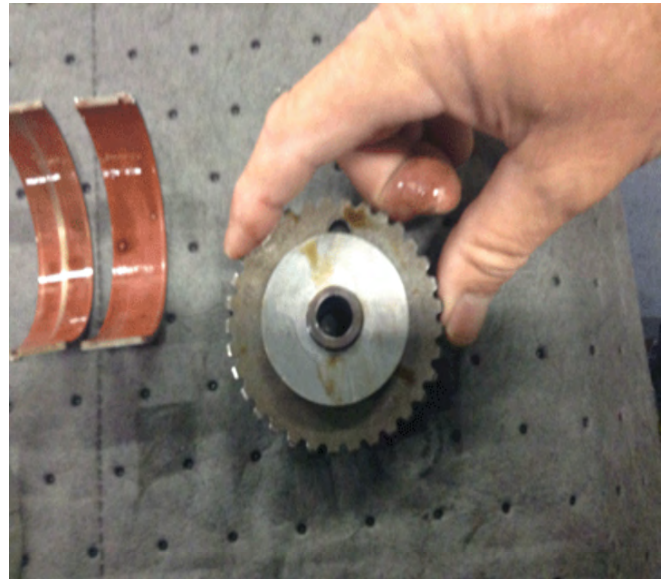
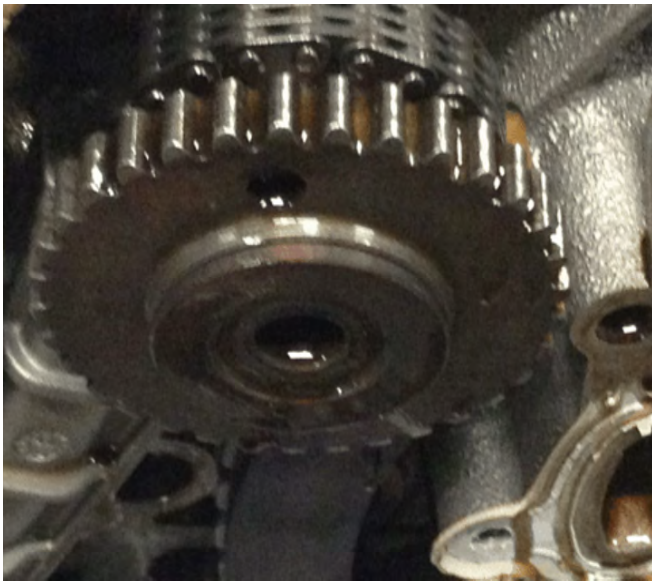
3. Inspect the timing chain idler sprockets for stiffness when turning (Should turn smooth and free).
