SERVICE BULLETIN

APPLICABILITY: 2015-2019MY Legacy and Outback NUMBER: 12-253-18R

SUBJECT: "Squeak" "Creak" or "Pop" -Type Sound from

Driver's Seat REVISED: 07/16/21

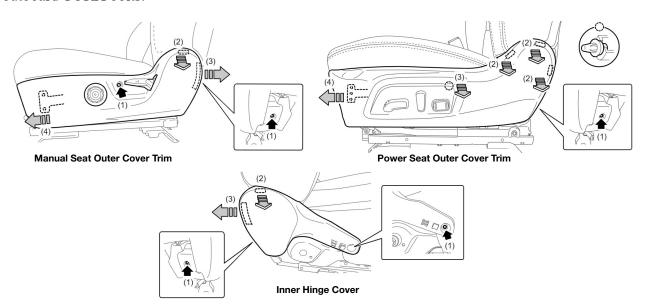
Step 5- After removing the two retaining screws (1) in the images below, **CAREFULLY** remove the inner hinge cover trim and outer seat cushion side trim panel. This will provide access to the outboard TORX bolts.

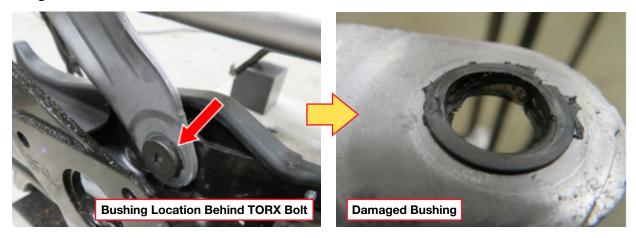
Step 7) Remove the link bolts using a T45 TORX bit to inspect the Teflon bushing underneath for damage.

NOTE: Only inspect one side at a time. If OK, re-install the TORX bolt and retorque to 15 ± 2 Nm (11 ft. lbs.). Most damaged Teflon bushings are found on the inboard side.

If any of the four Teflon bushing(s) are damaged, replace the seat cushion frame assembly following the procedure in the applicable Service Manual.
