SERVICE BULLETIN

APPLICABILITY: 2018-21 Crosstrek
SUBJECT: Cowl Panel – Design Change

NUMBER: 12-321-21
DATE: 07/19/21

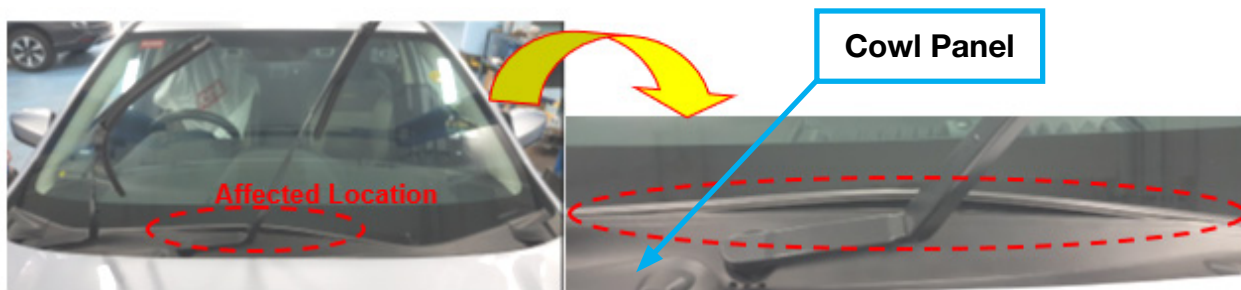
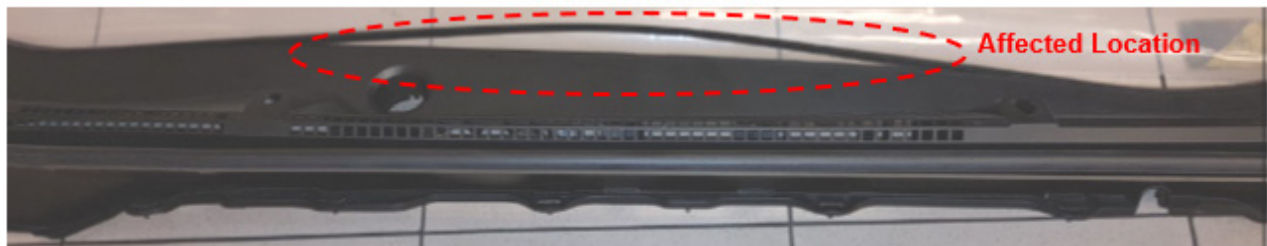
This bulletin announces a design change made to the cowl panel. These new parts utilize ten additional fixing points between the cowl panel and its rubber protector. This change was made to address a small number of cases where the rubber sealing portion had become separated as shown below. If this issue is confirmed, the cowl panel must be replaced.

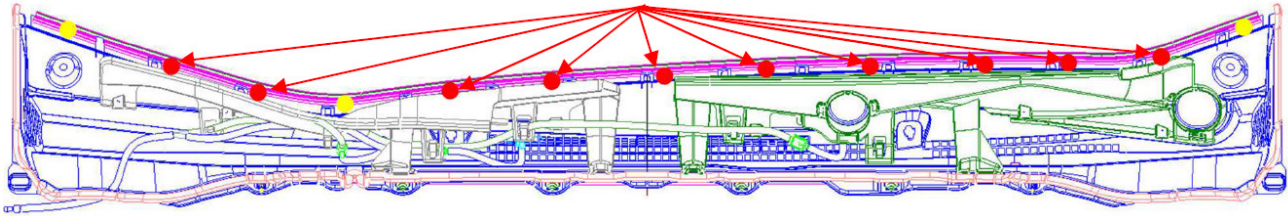
10 fixing points have been added to the new cowl panel.

Part Description	Part Number
COWL PANEL WITH CONVENTIONAL WINDSHIELD WASHERS	91419FL011
COWL PANEL WITH WIPER ARM INTEGRATED WINDSHIELD WASHERS	91419FL051
